NATIONAL TRANSPORTATION SAFETY BOARD

MATERIALS LABORATORY FACTUAL REPORT

Report No. 13-013

Place : Boston, Massachusetts
Date : January 7, 2013
Vehicle : Boeing 787, Registration JA829J
NTSB No. : DCA13IA037
Investigator-in-Charge : David Helson

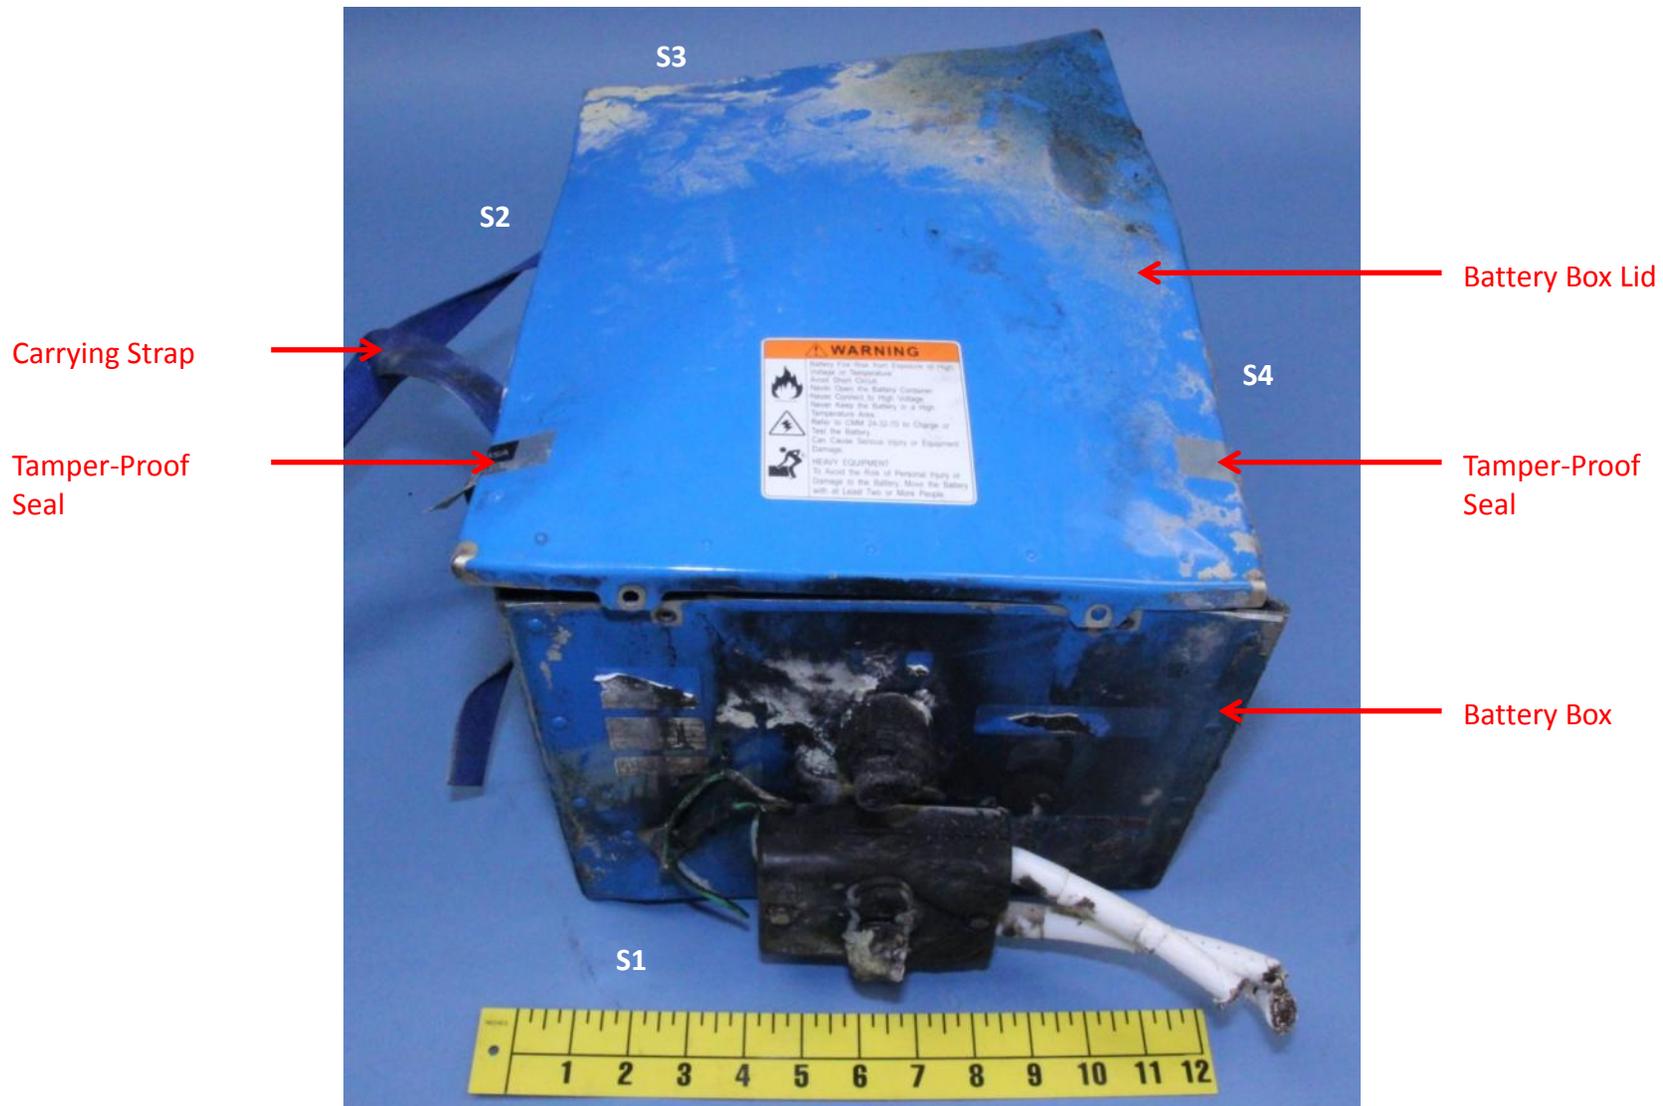
Figure 1. Accident battery as received by the NTSB laboratories.

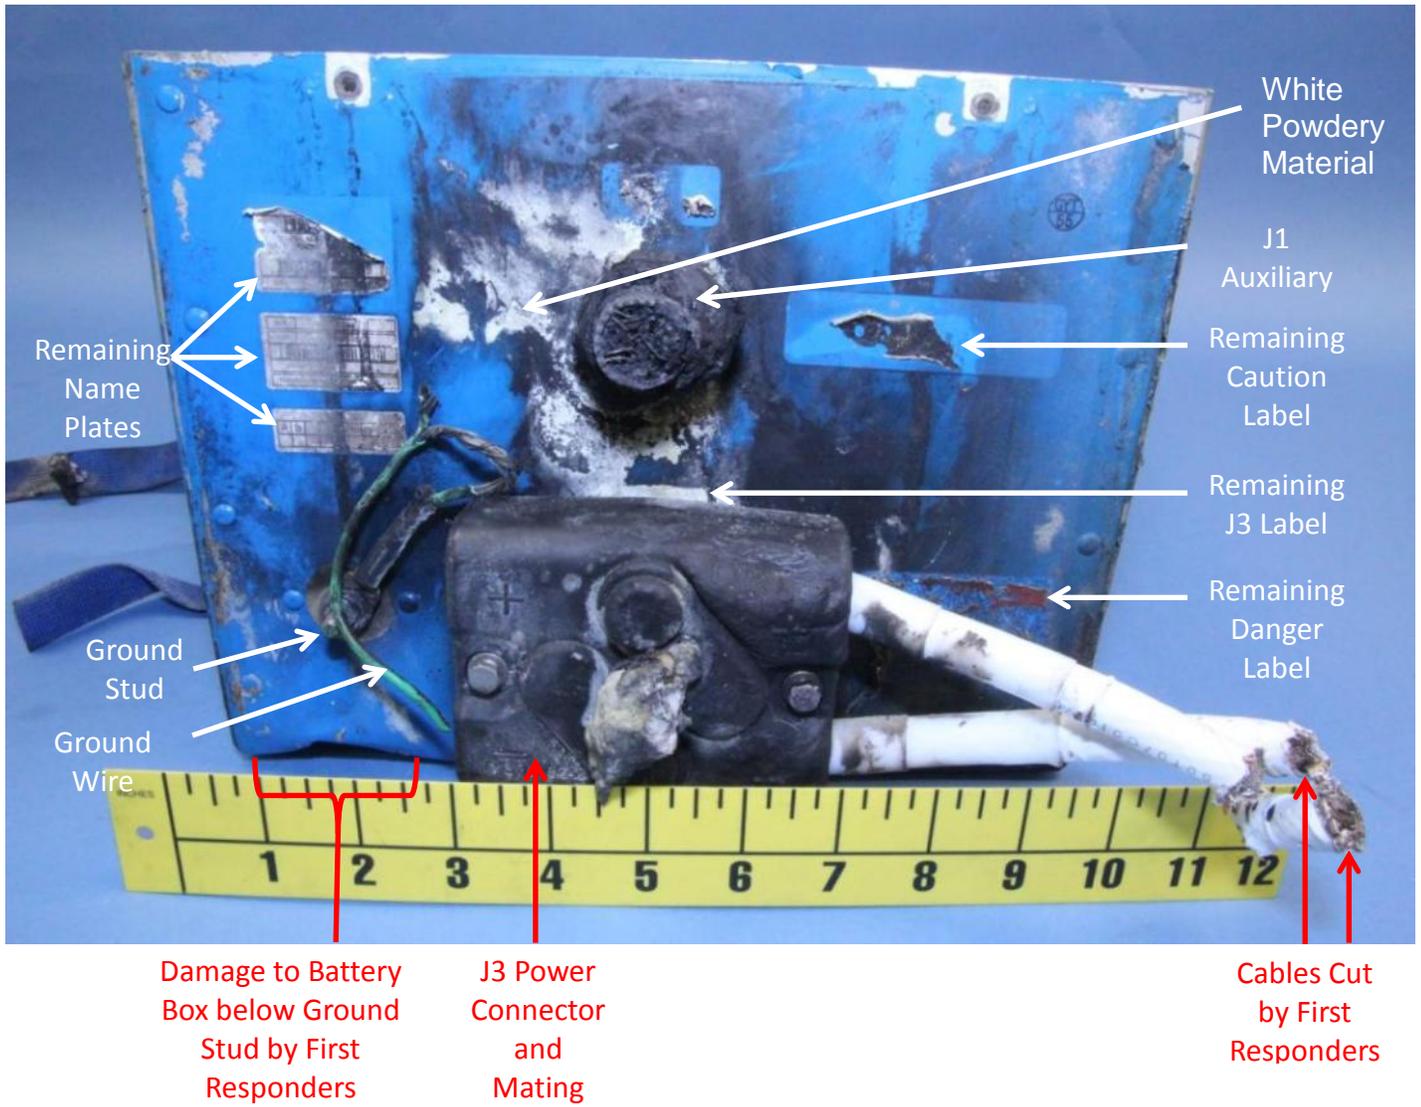
Figure 5. View of S1 exterior damage.

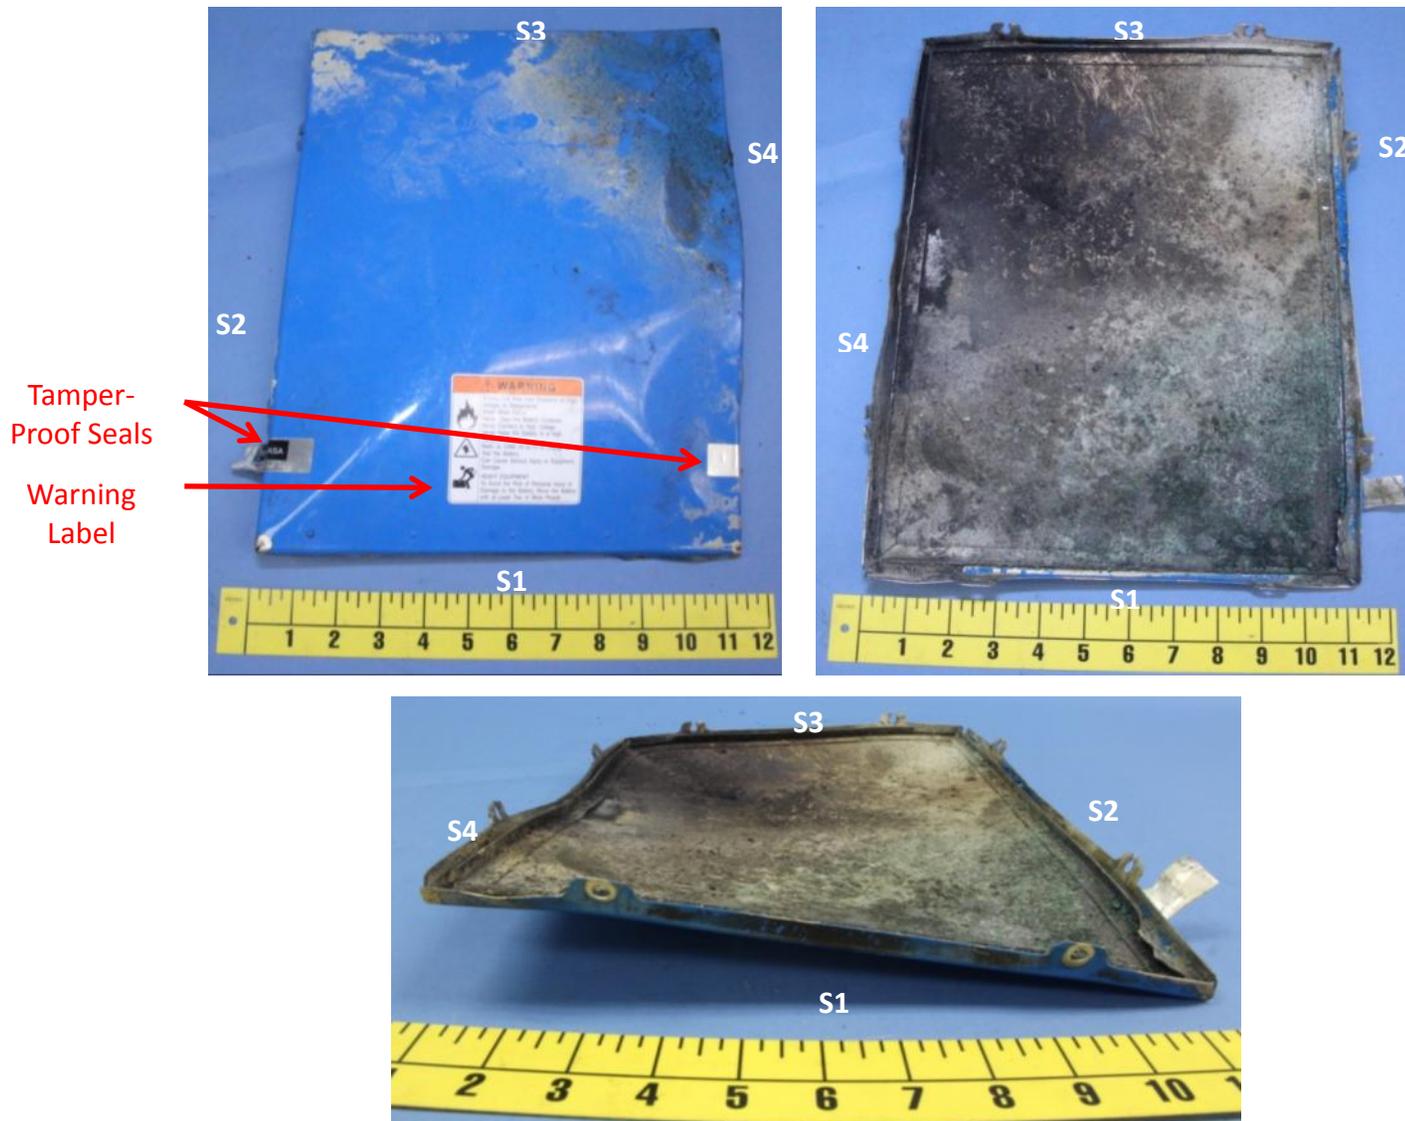
The battery arrived at NTSB headquarters with the lid affixed to the battery box by two of the eight original screws. The mounting tab eyelets on S2, S3, and S4 of the battery box lid were torn open (Figure 8). The screws from the torn mounting tabs remained affixed to the battery box with detached remnants of the eyelets still secured under the screw heads. A detailed description of the condition of the mounting tabs is provided in Section E5.

Figure 8. Top and bottom views of the battery box lid showing warning label and seals.

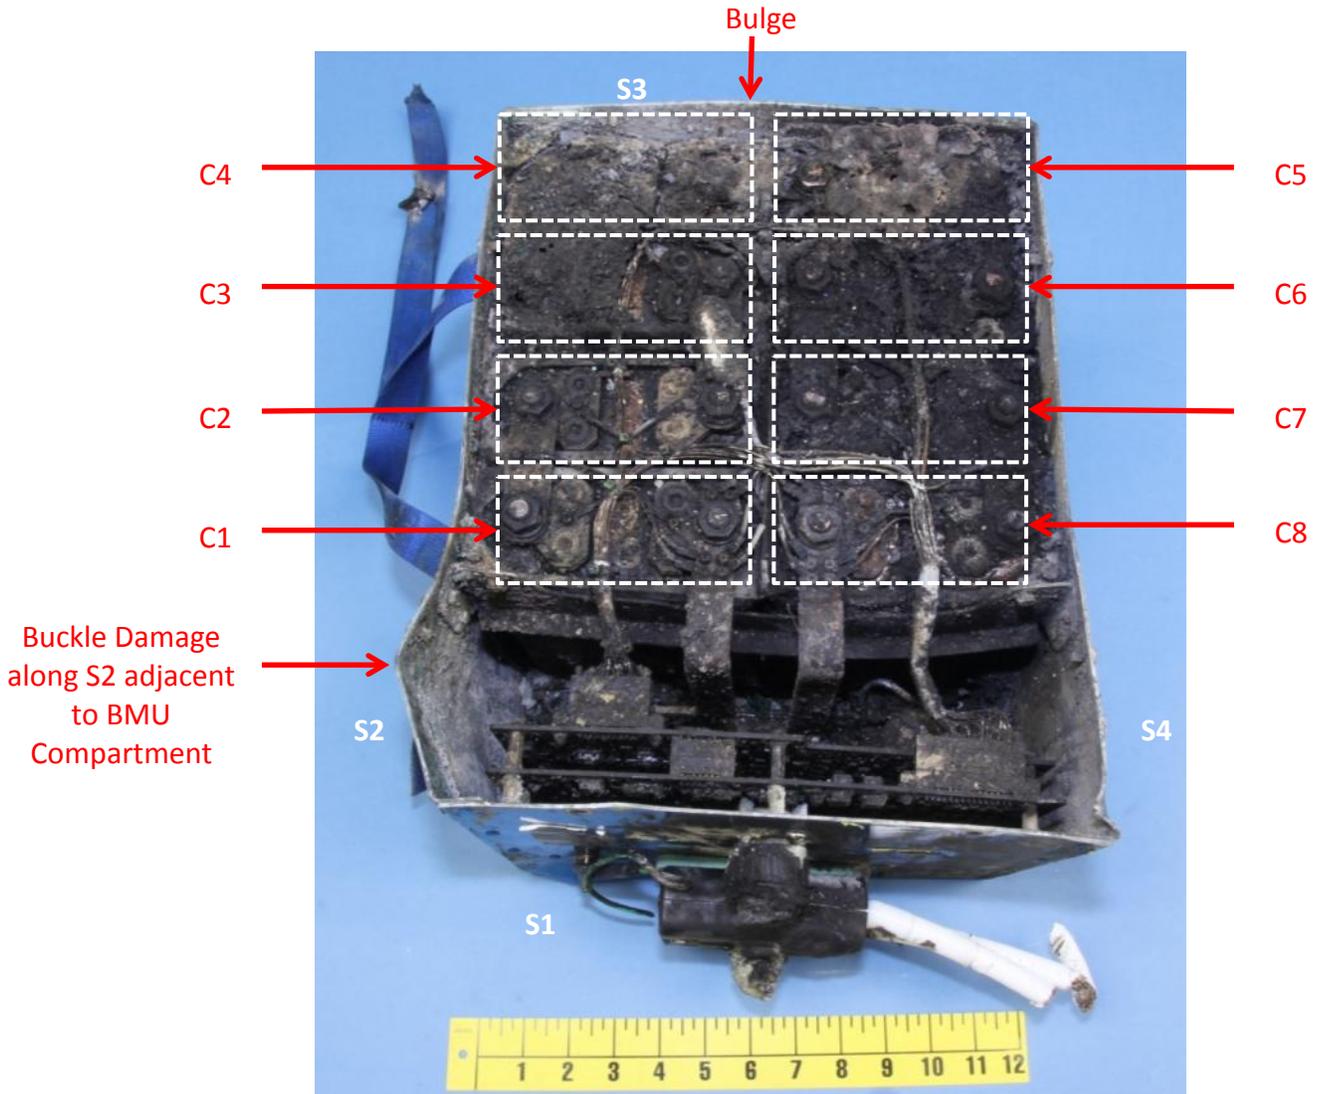
Figure 11. Opened battery box showing buckling and bulging.

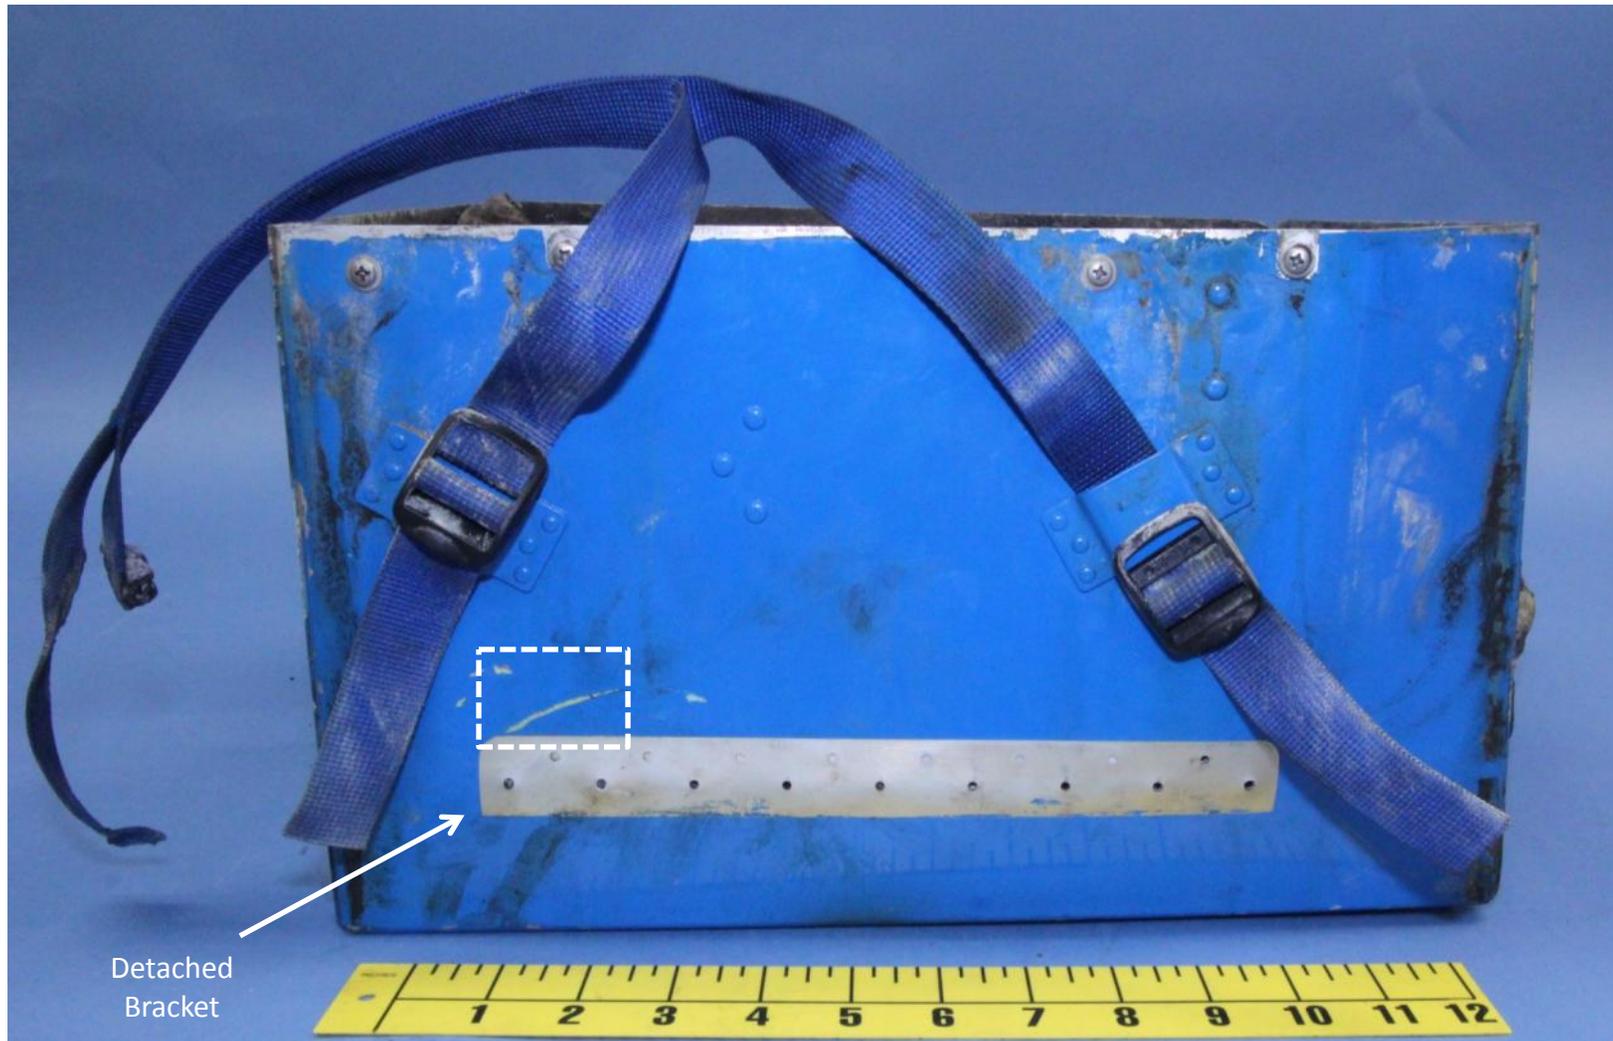
Detached
Bracket

The exterior of S2 of the battery box appeared to have sustained the least visible damage (Figure 12). The right angle mounting bracket on the exterior of the battery case was detached from the battery case during removal from the aircraft by firefighting personnel, there were minor gouges in the S2 wall just above the bracket location, and there was some sooty residue. The two brackets securing the synthetic webbing carrying strap remained and the portion of the synthetic webbing strap on this side of the case as well as the two black plastic buckles appeared dirty but undamaged.

Figure 12. View of S2 exterior damage showing the carrying strap and detached bracket. The white highlighted area shows a gouge.

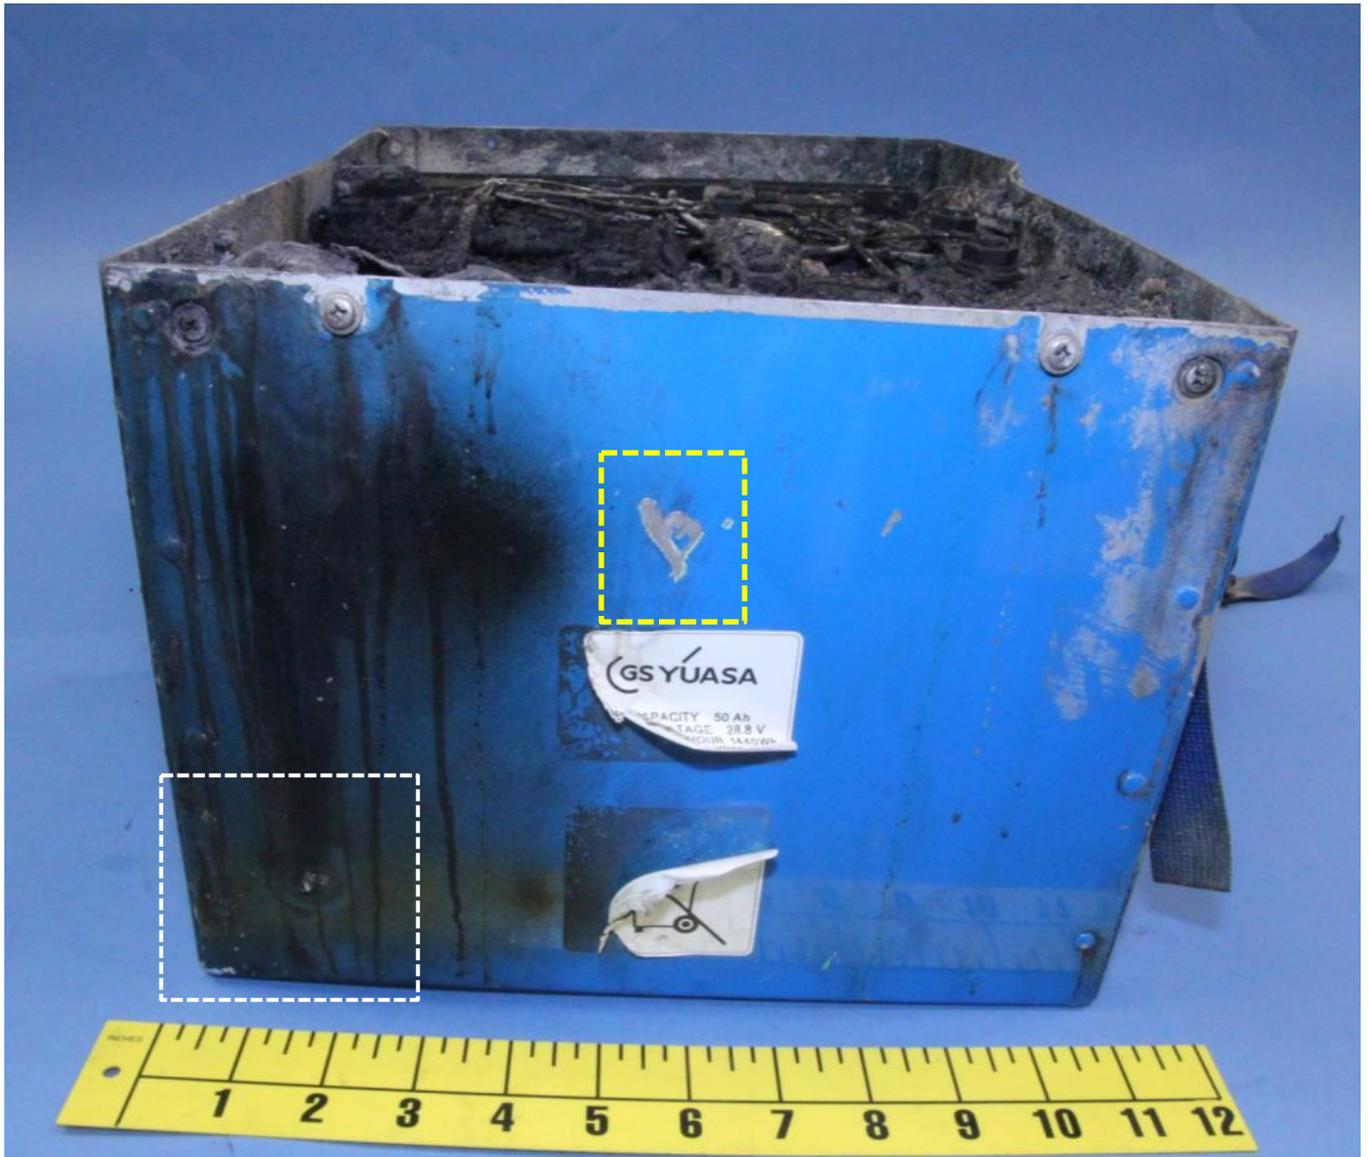
The exterior of S3 of the battery box, the rear of the battery box when it is installed in the EE bay cabinet, appeared minimally damaged on the side closest to S2 but appeared heavily damaged on the side closest to S4 (Figure 13). Two labels were still attached to the center of the S3 face but had partially disbonded on the S4 edge of the battery box. A gouge in the aluminum was present just above the label location. Vertical black streaks consistent with tracks from dripping liquid (now solidified) covered the S4 side and corresponded to the location of the damaged and elevated corner of the battery box lid. A roughly oval deposit of black residue covered the upper portion of the S3 face near the S4 edge. The most notable feature of S3 was a roughly circular distortion near the lower S3/S4 corner. This distortion was a paint discoloration approximately one-inch in diameter with a nodular protrusion in the middle. The center protrusion appeared metallic and extended horizontally out from the case a quarter-inch from the vertical plane. The distortion is further documented in Section F8.

Figure 13. View of S3 exterior damage. The white highlighted area is a nodular protrusion. The yellow highlighted area shows a gouge.

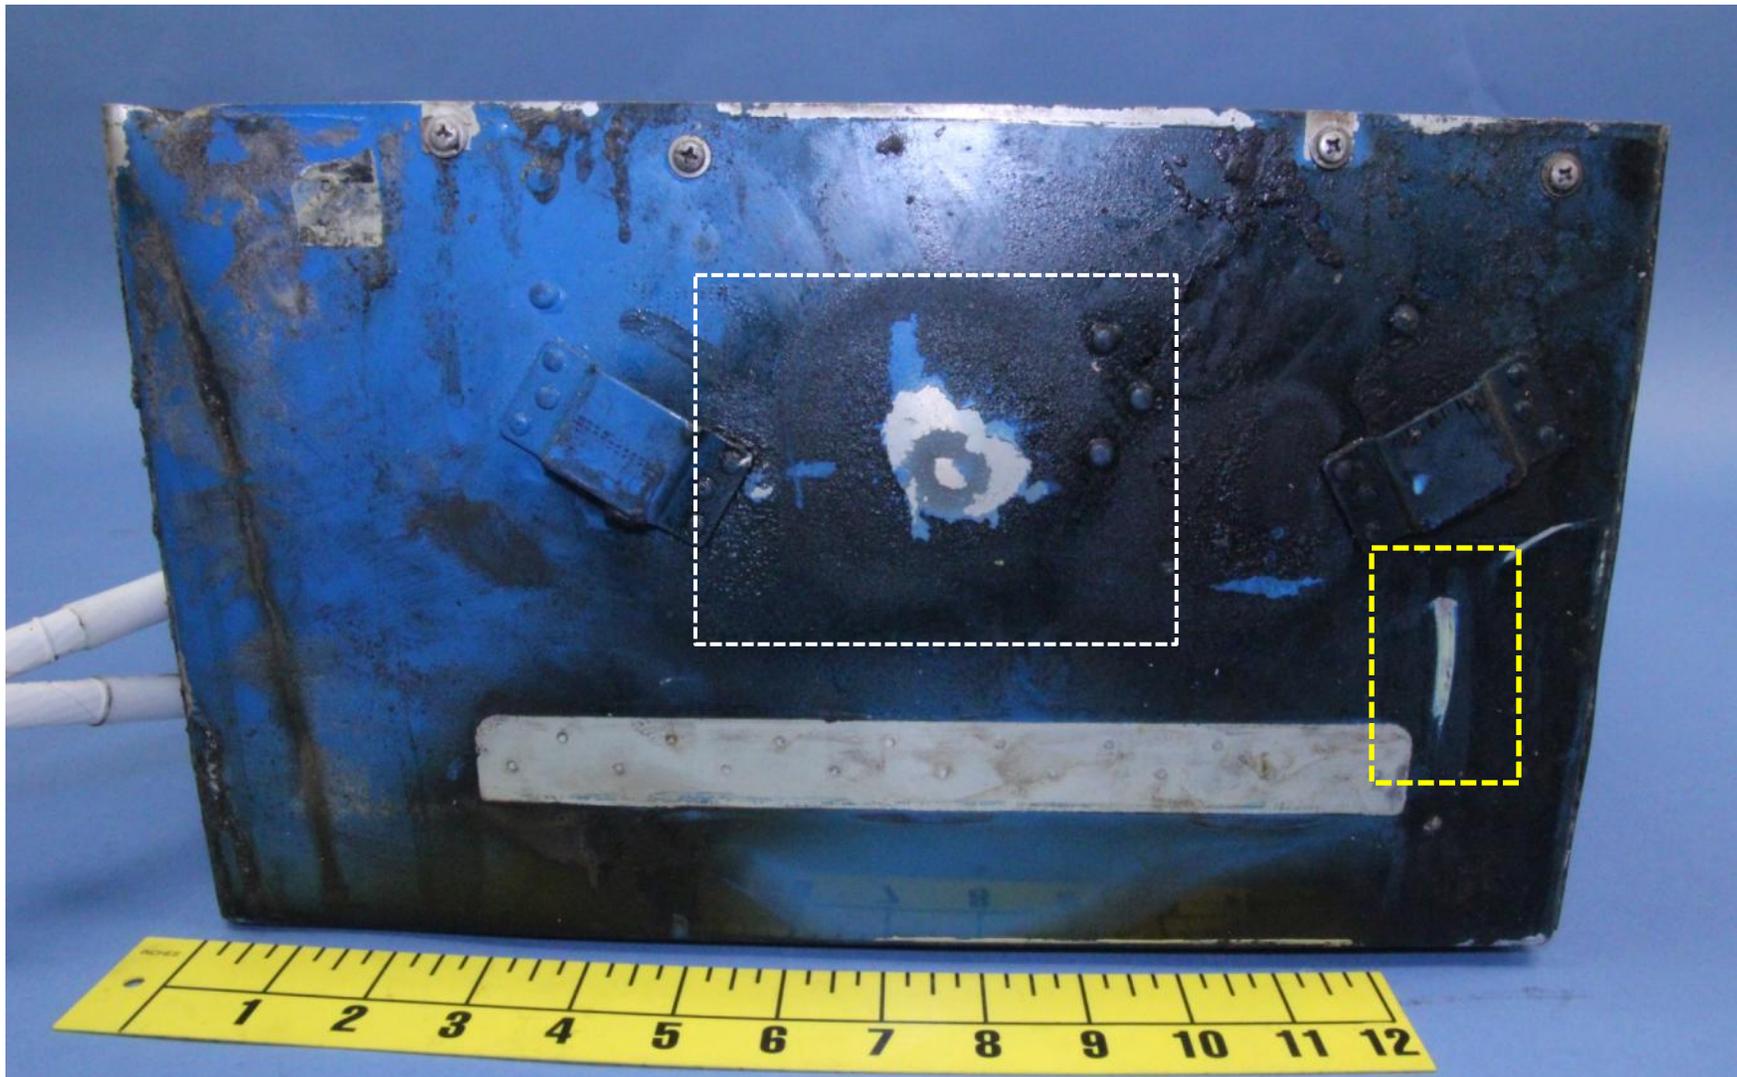
The exterior of S4 of the battery box appeared to have the most severe visible damage of the battery box sides (Figure 14). The exterior is heavily coated with black residue, concentrated closer to S3 of the battery. Thicker black deposits, consistent with melted synthetic webbing, were visible on the brackets that would have secured the straps and on the right side of the face closer to the battery box lid. However, remains of the torn tamper-proof seal are still present on the relatively less damaged forward portion of S4. The exterior mounting bracket for S4 of the battery box remained with the aircraft after removal of the battery from the aircraft by firefighting personnel, and a gouge in the aluminum is present half way up on the right hand side. S4 of the battery box also sustained damage to the paint and aluminum. Large, roughly circular areas of thermal damage to the paint were located at the same elevation as the cell vent discs are visible from the exterior. A distortion characterized by a deformation to the battery case was adjacent and opposite to the C7 vent. An area of thermal damage to the paint on the case was adjacent and opposite to the C6 vent. In both the C7 and C6 vent disc locations, the black residue on the case took on a different appearance from the surrounding residue and the aluminum appeared rounded outward. In the case of the C7 vent disc location, the paint and soot had flaked away leaving a relatively concentric appearance. Discolorations of the exterior paint on the box were also visible for the locations of C5 and C8, although these are partially obscured by the strap attachment brackets on the box.

Figure 14. View of S4 exterior damage. The white highlighted area corresponds with the location of the C7 vent. The yellow highlighted area shows a gouge.

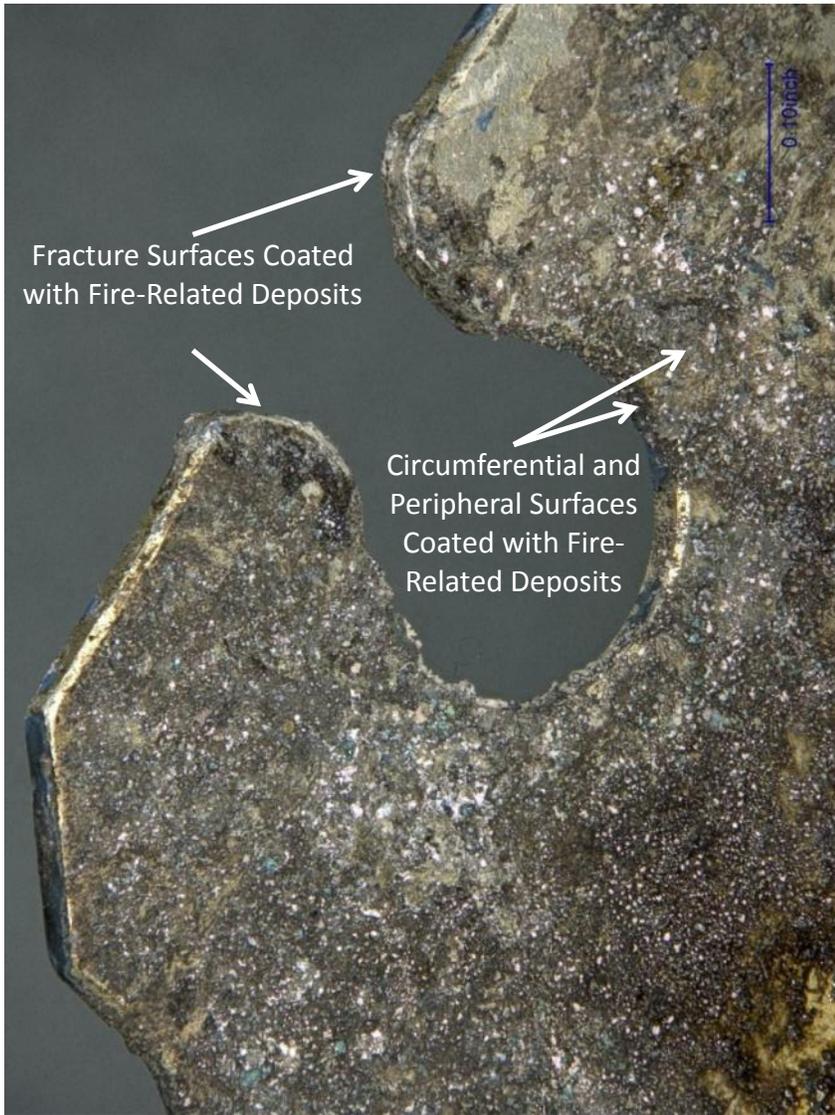
In general, the fractured and separated mounting tabs exhibited deposits consistent with exposure to a fire. The deposits covered the inner surfaces of the tabs that would normally form faying surfaces with the external surfaces of the battery box during normal installation. Some deposits were also noted on the exterior tab surfaces, including the surfaces covered by the bolt head during normal lid installation. A closer

view of the fractured S3A mounting tab reveals the presence of fire-related deposits on the fracture surface and the inner wall of the remaining bolt hole (Figure 18).

Figure 18. Close-up view of the fractured S3A mounting tab.

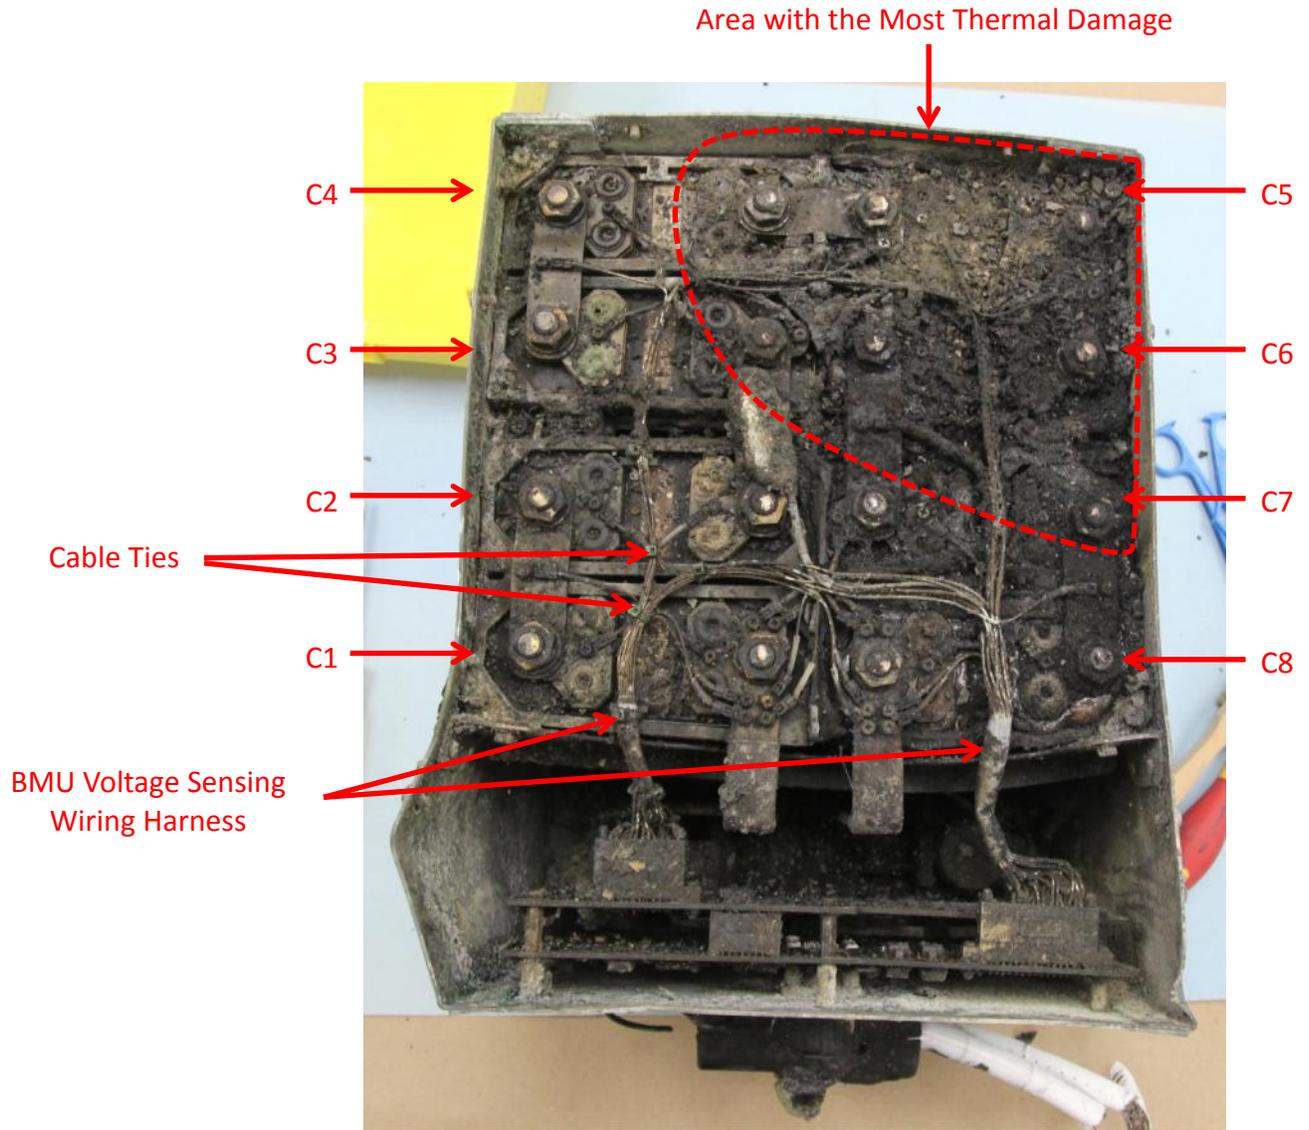
After sufficient removal of the charred debris from the top portion of the battery, the physical condition of the BMUs' cell voltage sensing wiring harness was evaluated (Figure 20). The overall appearance of the wiring harness was consistent with exposure to a high-temperature environment with areas of varying severity. The insulation on the wires was mostly intact but exhibited varying degrees of thermal discoloration and staining from the expelled battery cell contents (carbonaceous material, electrolyte, and cathode material). The area of most severe damage to the wiring harness was located above C5 and C6 and in the region left half (C1 to C4) side of the battery to the right half (C5 to C8) side of the battery. Over the left half, the insulation exhibited some thermal discoloration but remained intact, including cable ties securing the wiring harness to the upper fixation tray. In the area of the transition from the left side of the battery toward the area of the right side of the battery, the condition of the wire insulation progressively degraded from thermally discolored to charred and then altogether missing. The insulation over C5 and C6 was thermally damaged to the point where the insulation was missing, mostly in the position of C5, leaving the wires bare. A gradient of progressive improvement in the condition of the wiring insulation was observed going from the position of C6 forward, toward C8. At the position of C7, the insulation was charred; at the position of C8, it was thermally discolored. Four wires in the area of the transition between the left side of the battery to the right side of the battery were severed and found to be brittle. All of the screws attaching the wiring harness to the cell terminal plates and busbars were present and securely connected.

Figure 20. Battery top with debris removed.

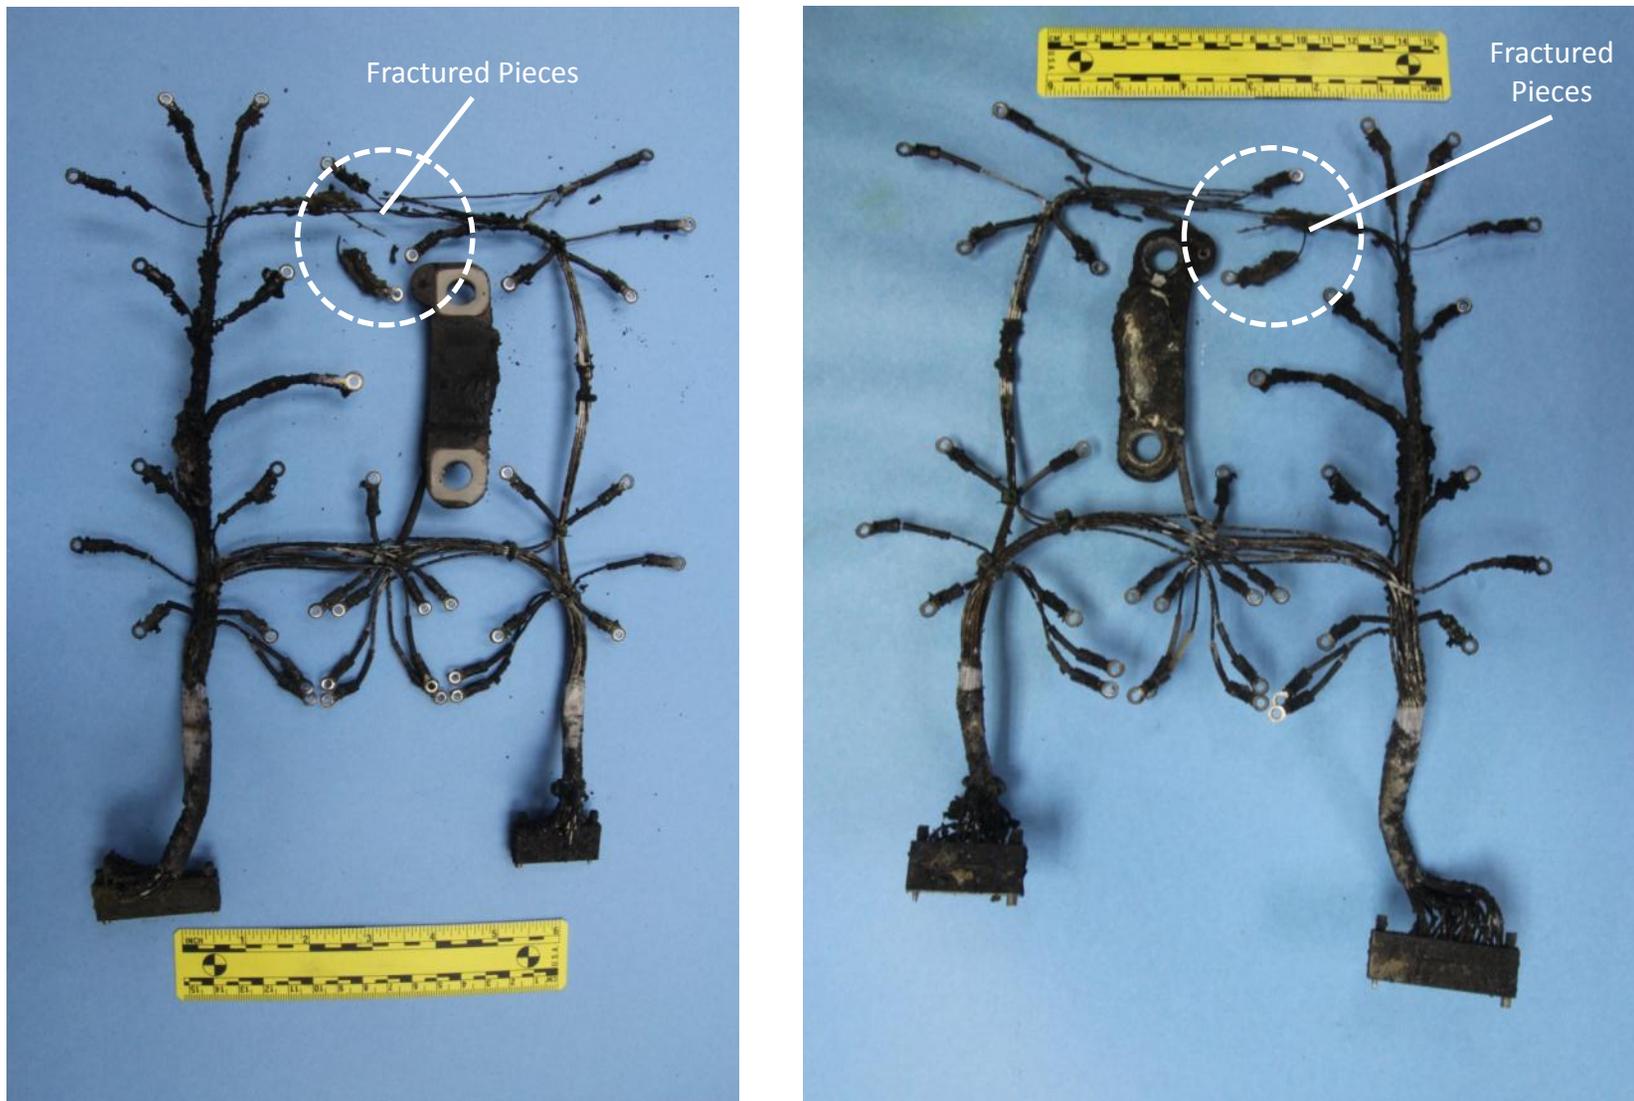
Upon removal of the wiring harness attachment hardware, it was necessary to gently pry on portions of the wiring harness to dislodge it from the remaining charred debris stuck to the top surface of the battery. Once all of the wiring harness was dislodged from the battery top, it was removed as a single unit, with the exception of one of the fractured pieces. The wiring harness was photo documented with the fractured pieces placed near their original position (Figure 21).

Figure 21. Wiring harness, as removed. The photo on the left is a view from the bottom. The photo on the right is a view from the top.

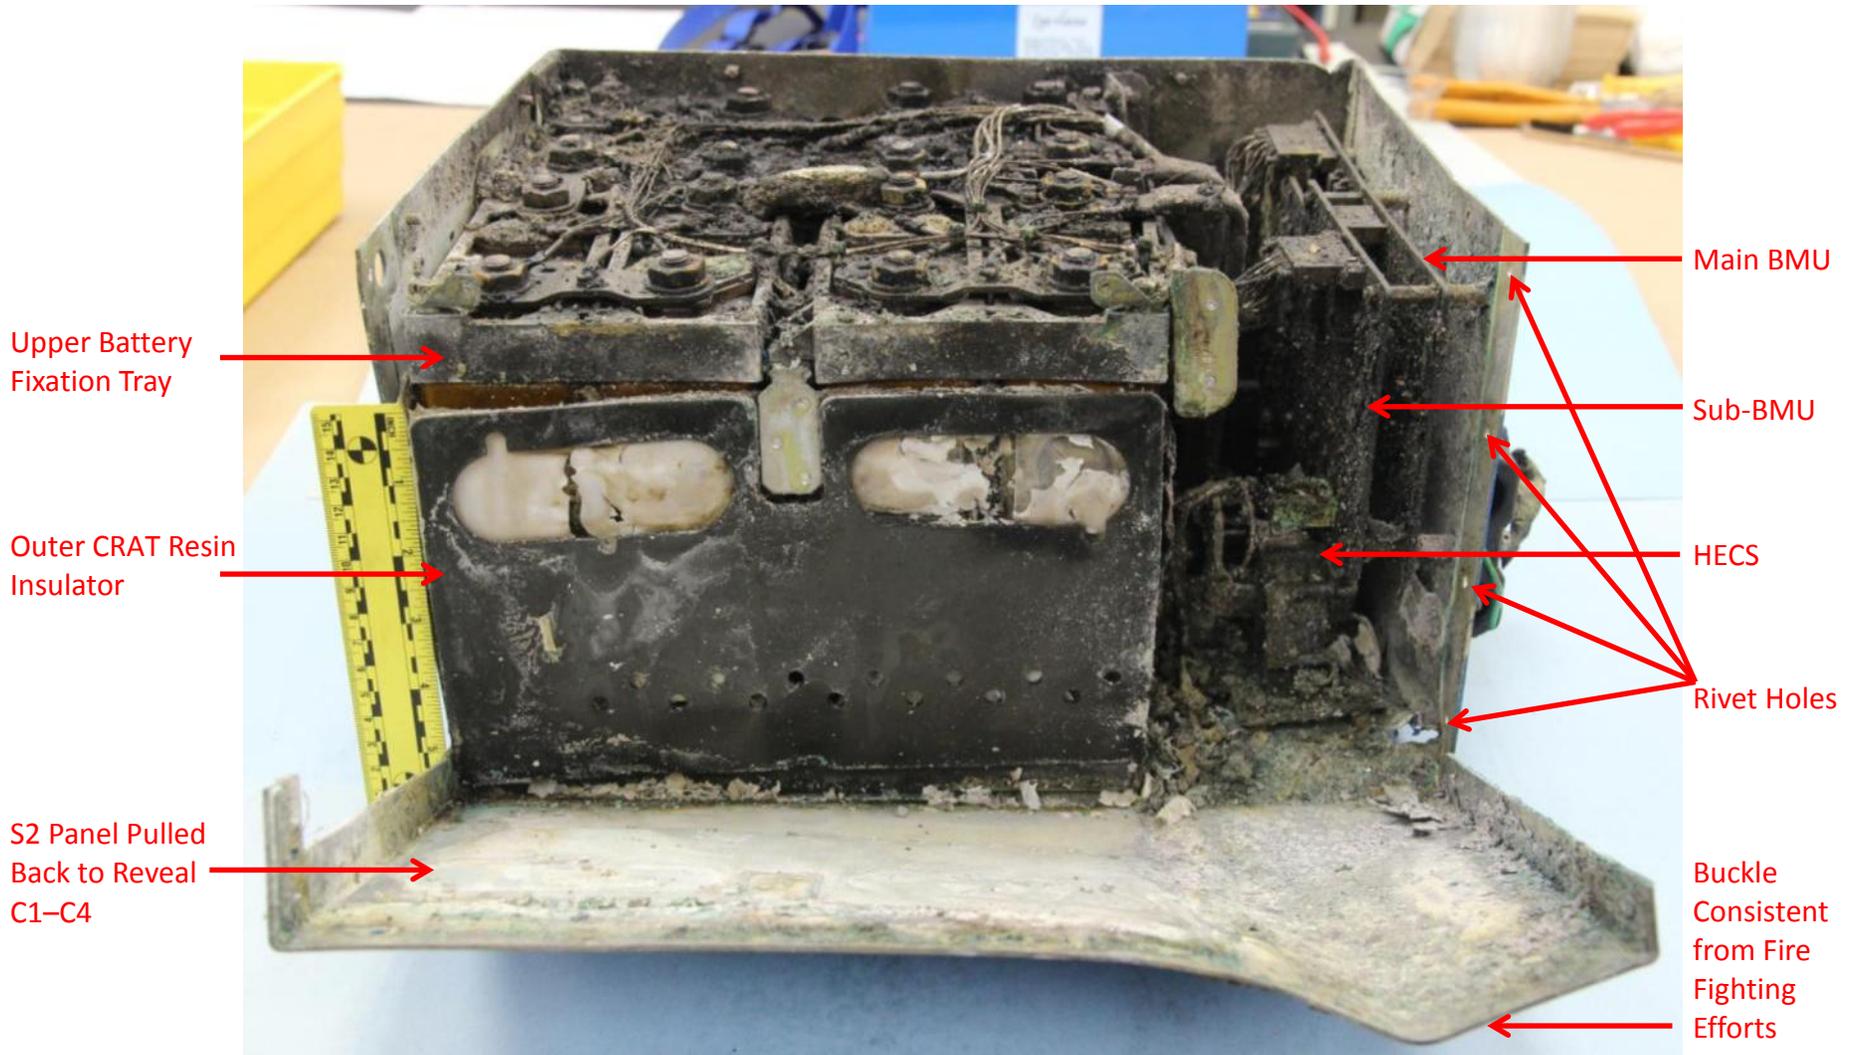
Folding down S2 revealed the position of C1 through C4 (Figure 22). The cells cases were obscured by the black-colored CRAT sheet of insulation remaining in place adjacent to the battery cells. Behind the CRAT insulation, through the oval cutouts along its top, a portion of the BPA-TP insulation was visible (Figure 23). The appearance of the BPA-TP insulation was white with brown hues and a flakey consistency with some missing sections. After removal of the BPA-TP, the cell cases were revealed (Figure 24). The interior surface of the folded down battery case S2 had a clean area identical in outline to the black CRAT insulation sheet (Figure 25). The remainder of the interior of the S2 side was coated with residue.

Figure 22. S2 view with battery box panel pulled back to reveal C1 through C4 and the BMU cavity.

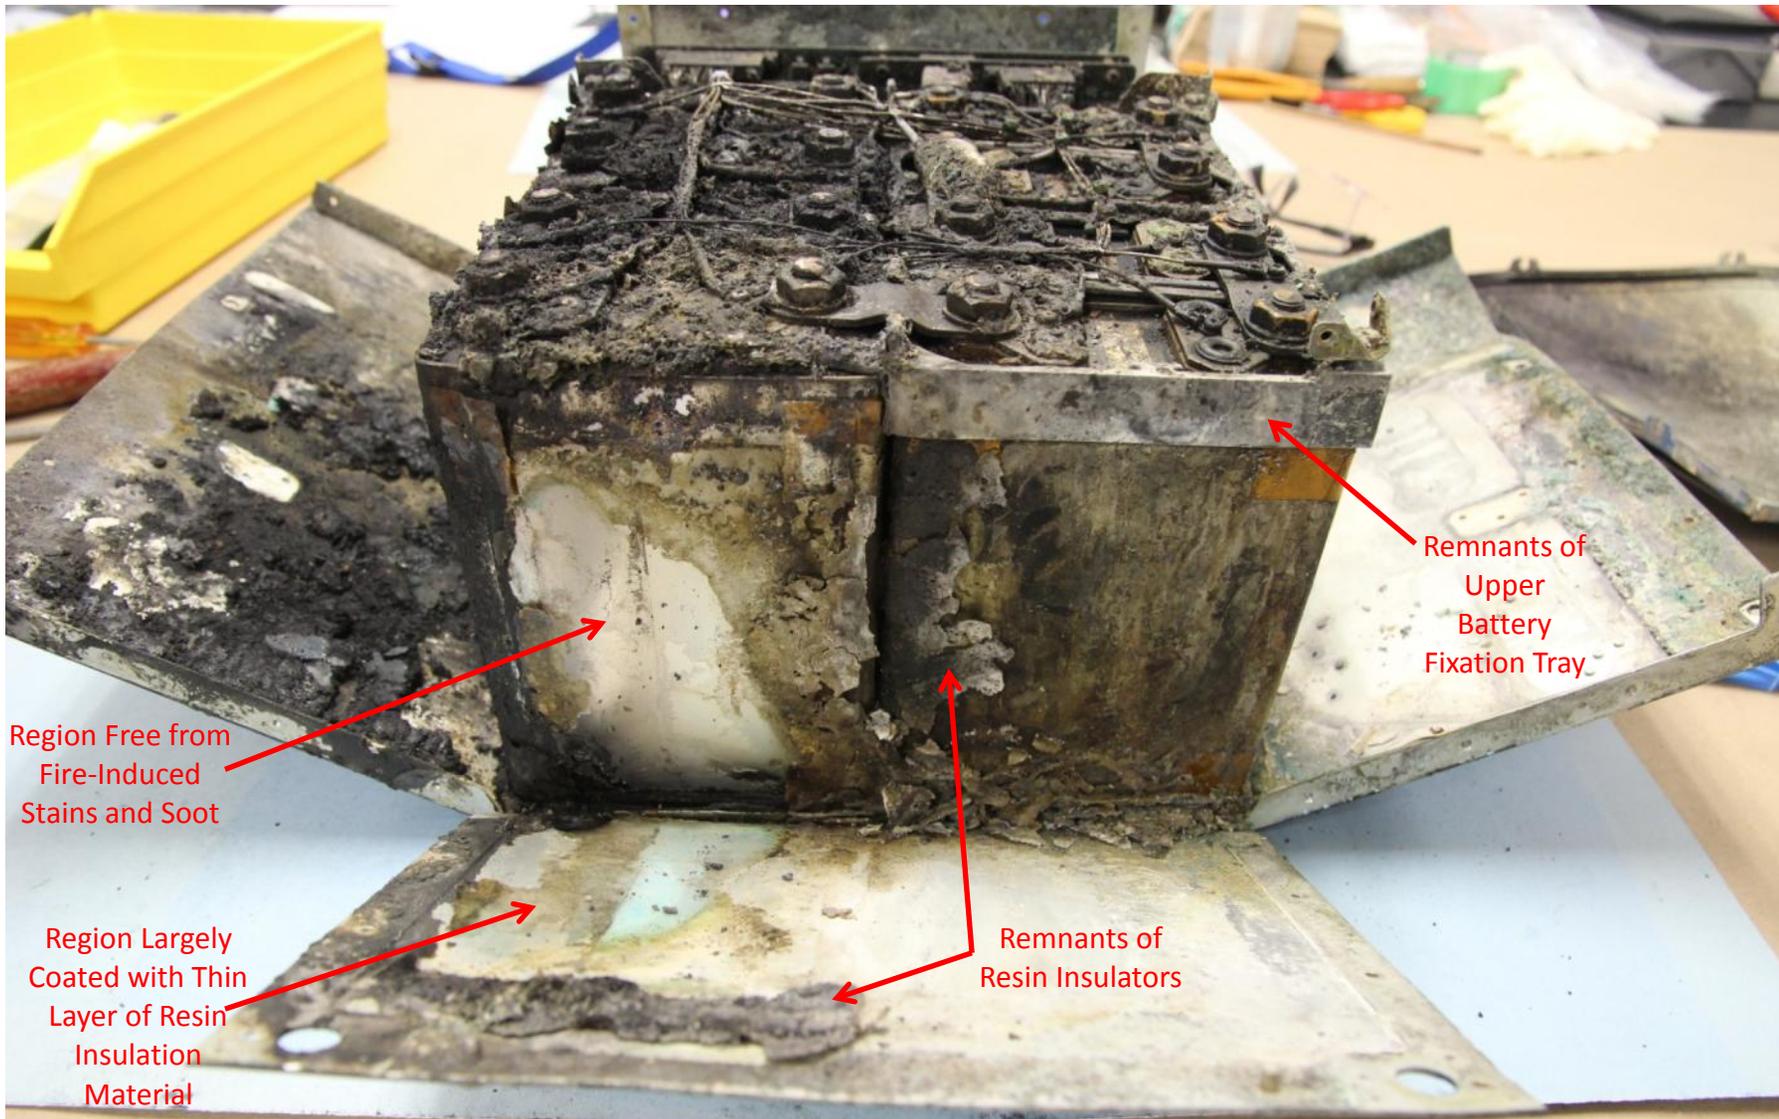
Folding down S3 of the battery case revealed the S3 side of C4 and C5 (Figure 28). The BPA-TP insulation along this side was thermally degraded and fragmented. The S3 side of C4 had staining resembling a flowing residue. The S3 side of C5 had similar staining but also exhibited a clean area on the cell case. A corresponding area was visible on the interior of the folded down S3 of the battery case (Figure 29). This area is adjacent to the fire-damaged resin found on the interior of S4 (Figure 30). The S3 area on the interior of the battery case corresponding to C5 had large portions of BPA-TP insulation adhering to it. The BPA-TP insulation appeared to have been pressed against the battery case and exhibited some thinning. The adhering BPA-TP also exhibited some blue staining. A higher-temperature spot was observed on the battery case with a corresponding spot on the C5 cell case (Figure 31), documented in detail in Section F8.

Figure 28. View of S3 with battery box panel pulled back to reveal C4 (right) and C5 (left).
