NATIONAL TRANSPORTATION SAFETY BOARD

MATERIALS LABORATORY FACTUAL REPORT

Report No. 13-013

Place : Boston, Massachusetts
Date : January 7, 2013
Vehicle : Boeing 787, Registration JA829J
NTSB No. : DCA13IA037
Investigator-in-Charge : David Helson

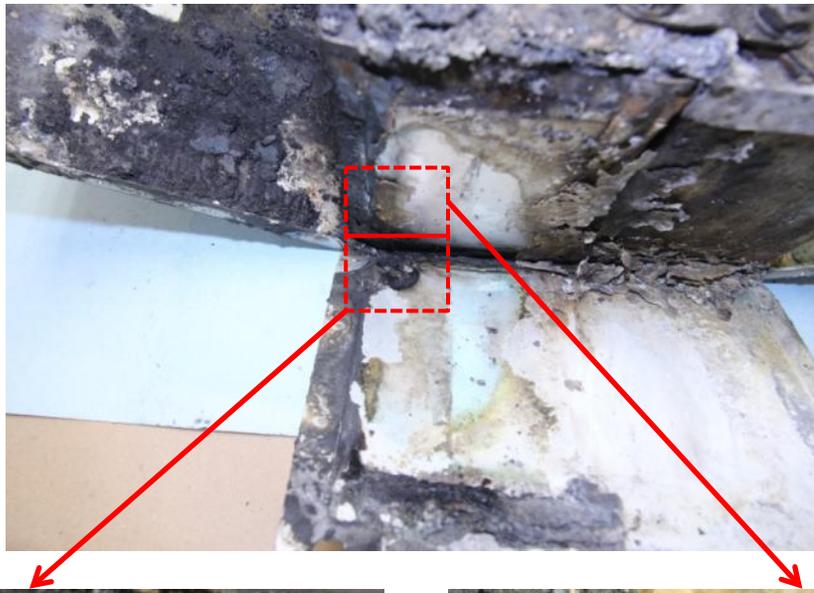
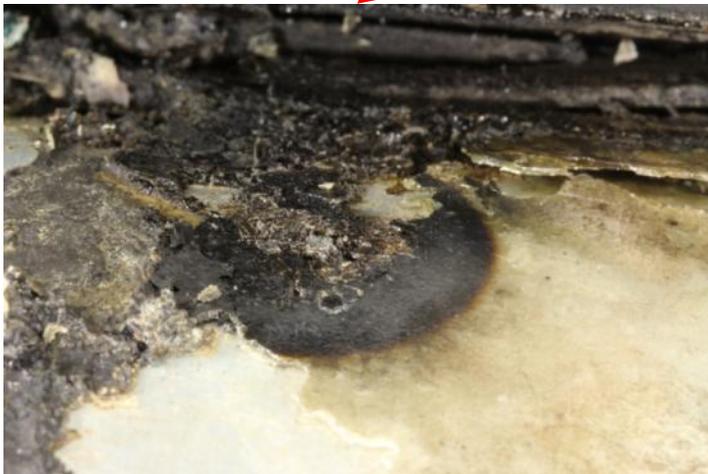
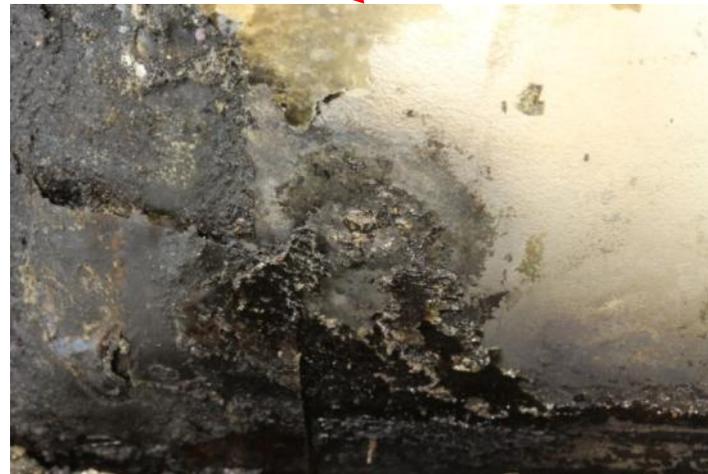
Figure 31. Closer views of a higher-temperature spot consistent with arc damage between C5 and the inside of S3 of the battery box.

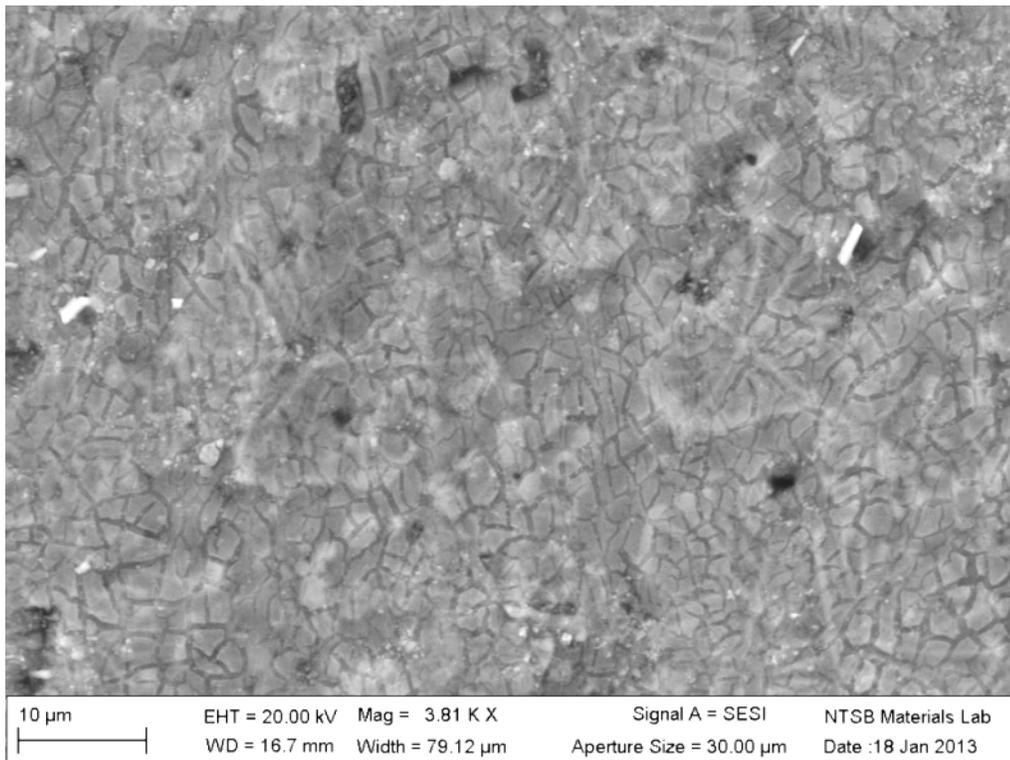
The defect was inspected using a scanning electron microscope (SEM). Figure 56 is a micrograph that illustrates the exterior of the protrusion. The surface of the defect exhibited a fractured, reticulated structure (Figure 57). This morphology is consistent with thin oxide layers that form on the surface of molten alloys while in contact with air. This thin surface oxide typically crumples and cracks as the alloy solidifies and contracts during cooling. Larger folds of the protrusion at the base are

Figure 57. SEM micrograph of the boxed area in Figure 56. The pattern is consistent with a fractured surface aluminum oxide layer that forms on aluminum alloys as it solidifies and cools.

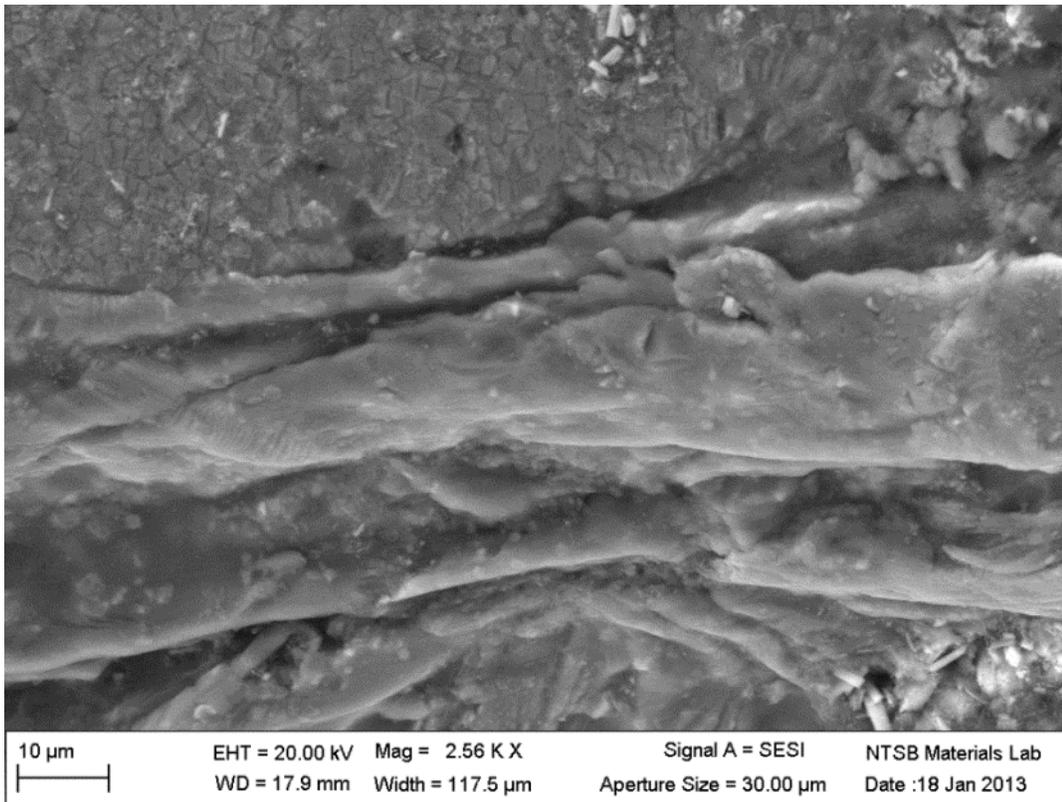
illustrated in Figure 58. The chemical composition of the defect was inspected using energy dispersive X-ray spectroscopy (EDS) and was consistent with the specified aluminum alloy (AA 6061). The dark-colored compounds on the exterior contained elevated levels of carbon, oxygen, sulfur, and other non-metallic elements typically comprising decomposition products.

Figure 58. SEM micrograph of the boxed area in Figure 56. The reticulated morphology of the base of the protrusion is typical of contracting experienced by metals during solidification.

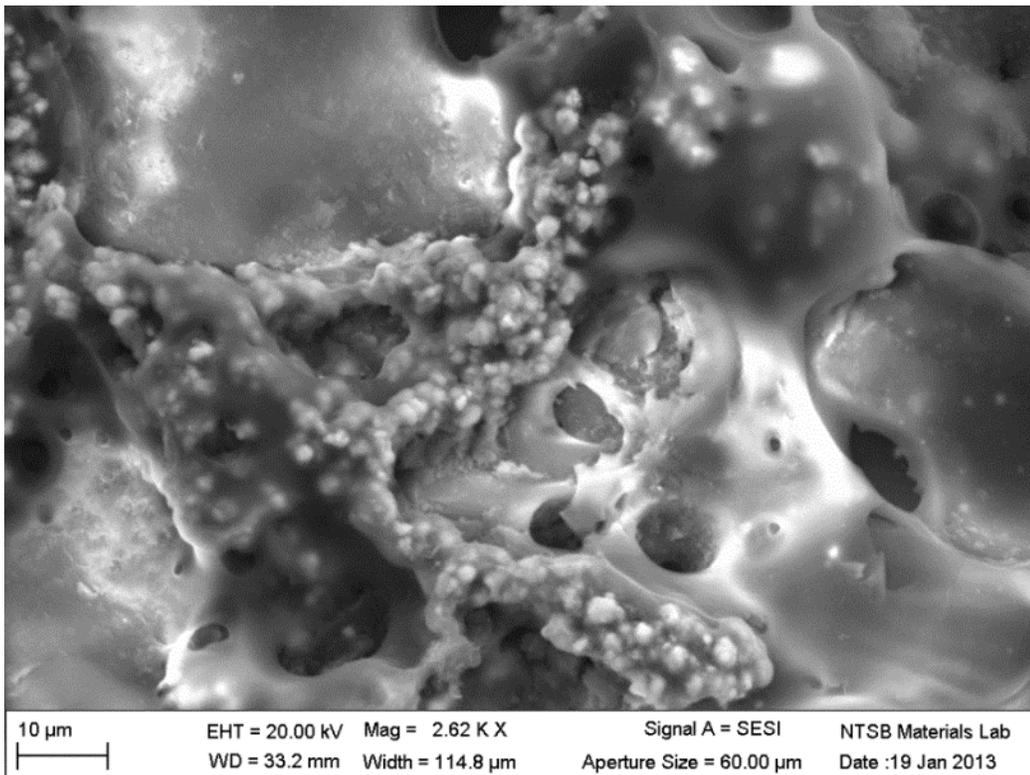
Figure 61. SEM micrograph of cobalt-based oxide particles embedded in carbon-rich decomposition products near the defect.

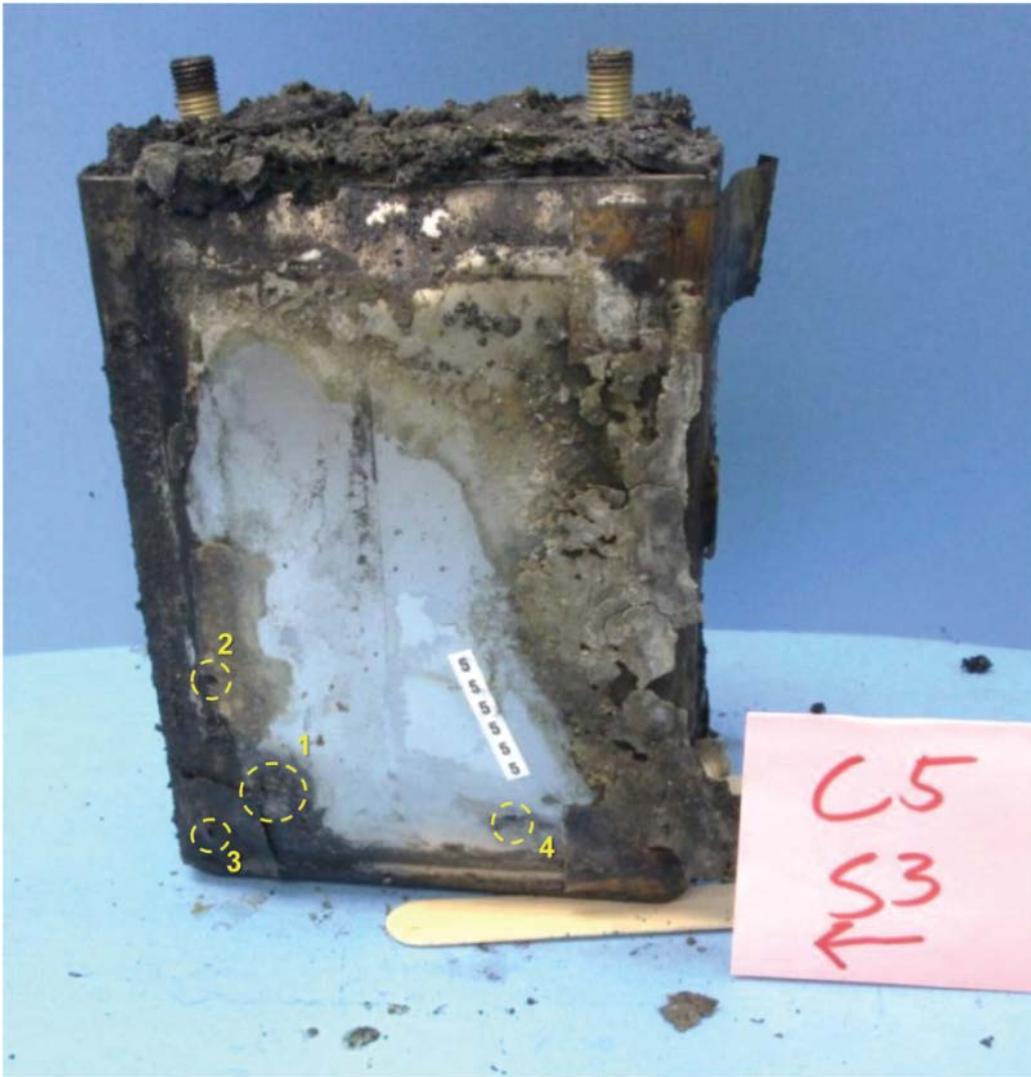
Figure 62 shows the battery cell case of C5 adjacent to S3 of the battery case. This cell had been damaged during the failure event, particularly on its periphery. On the lower portions of this side of the cell case, four holes were identified (labeled 1 through 4 in Figure 62). All of the holes exhibited dark, rough compounds consistent with decomposition products. Hole 1, as designated in Figure 62, which corresponds with the location of the protrusion on the battery case, is the largest in terms of size and decomposition compounds. The lower portion of the C5 cell case was excised and cleaned in order to facilitate inspection in the SEM.

Figure 62. The cell case of C5, facing the interior of S3 of the battery box. Four areas were found that exhibited heavy decomposition deposits about a round hole—these areas are labeled 1 through 4 (circles).

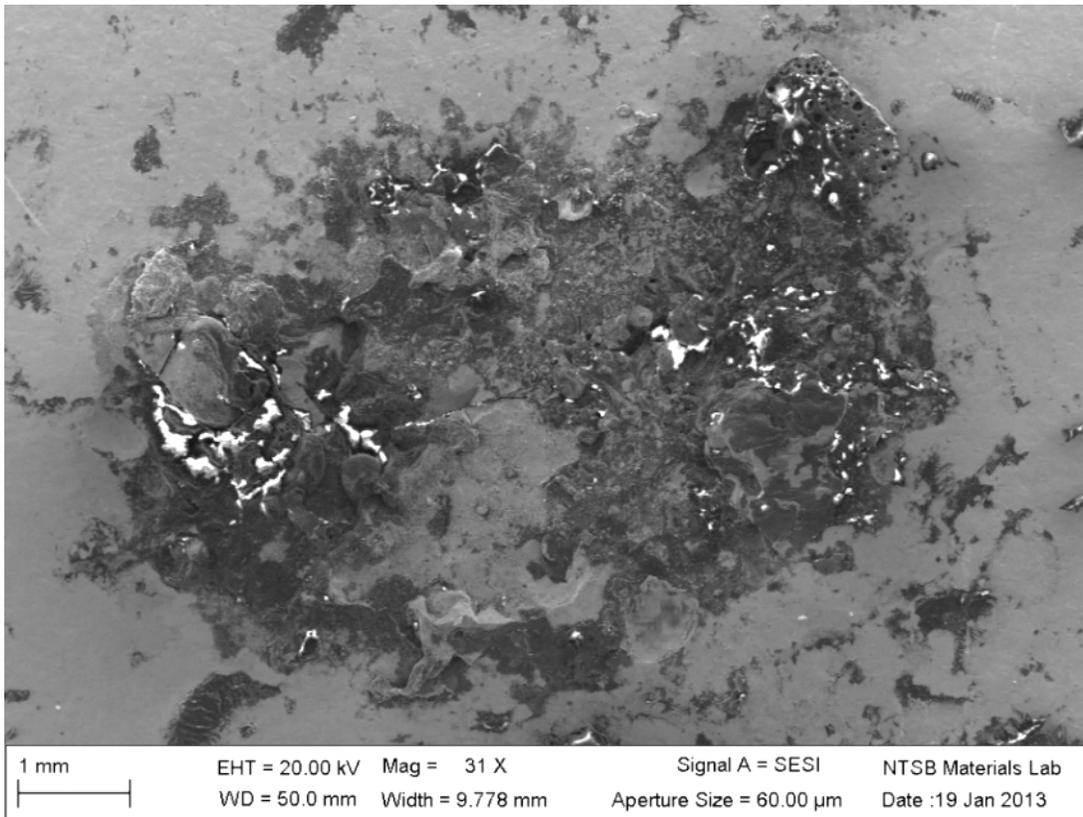
Figure 63 illustrates hole 1, as viewed from the exterior of the cell case. The hole exhibited a variety of compounds and alloys that were not part of the cell case material, type 304 stainless steel. Within the field of view, large, dark non-metallic areas were present with high concentrations of carbon, oxygen, sulfur, and alkali elements consistent with decomposition products. Within the field of view, large amounts of reticulated aluminum were found in and around the hole (Figure 64). Inspection by EDS showed this aluminum to be consistent with the battery case material. Elevated levels of cobalt, phosphorus, and fluorine were found in and near the hole, consistent with elements found in the cathode and electrolyte materials.

Figure 63. SEM micrograph of the hole 1 on the C5 cell case, from the exterior.

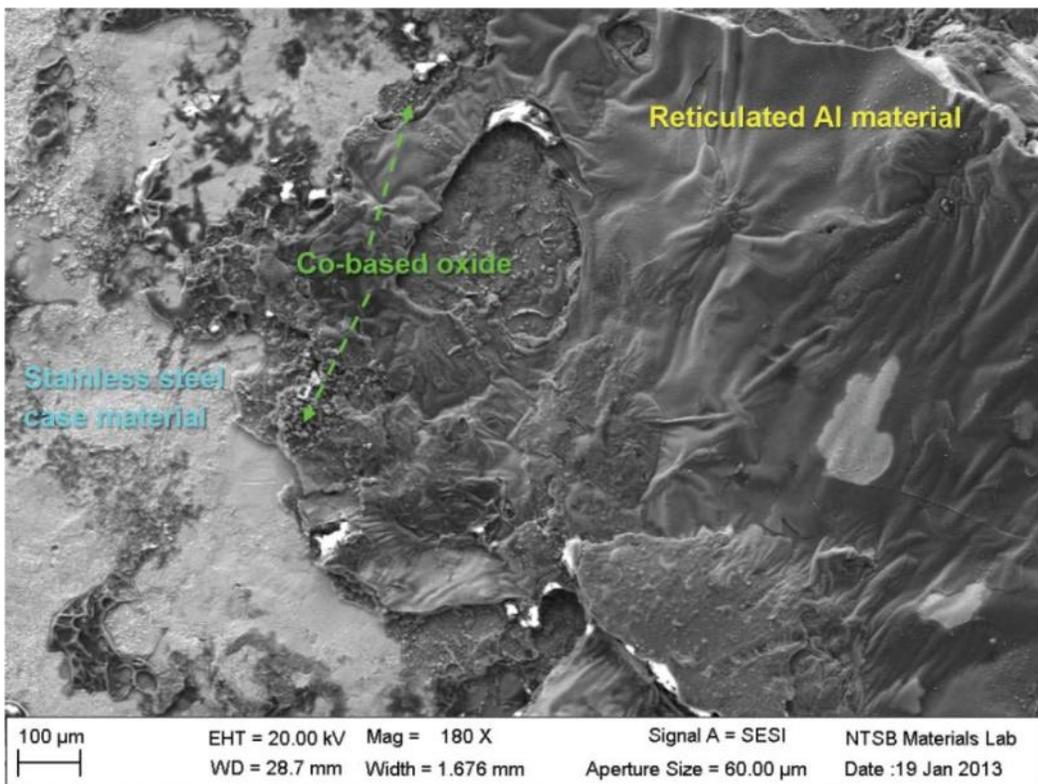
Figure 64. SEM micrograph of reticulated aluminum (dark) on the stainless steel case material (light) from the exterior of hole 1.

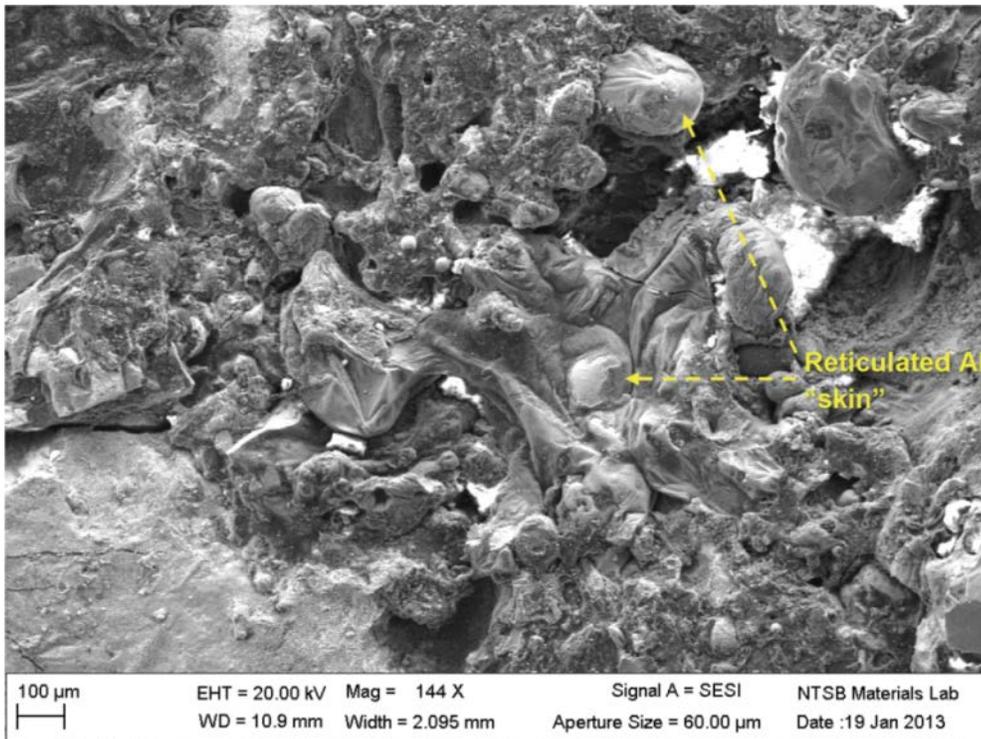
Figure 65. SEM micrograph of hole 1 from the exterior of the C5 cell case. This region exhibited rounded protrusions consistent with resolidified steel encompassed by an external layer of aluminum alloy.

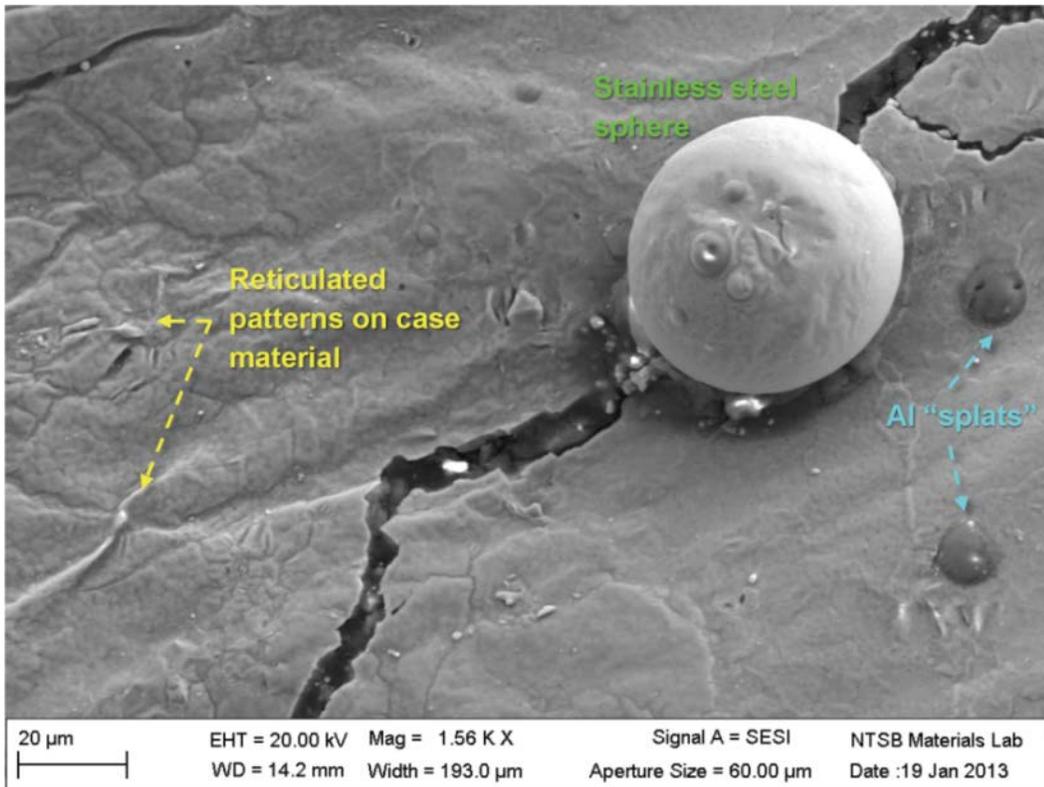
Examination of the three other holes on the C5 cell case revealed similar results. Figure 67 and Figure 68 display holes 2 and 3, respectively, from the interior of the case. Of note was the spherical globule located near hole 3 on the exterior of the case. The globule was consistent with type 304 stainless steel, and it exhibited a reticulated surface pattern. The case material was wrinkled near hole 3. There were also indications of metallization “splats” of aluminum alloy near the hole (Figure 69). The flattened shape of this metallization is consistent with the case material being near the molten aluminum temperature during deposition. Near hole 4, a depressed lamellar structure was observed in the case material (Figure 70). This surface morphology is consistent with incipient melting of the material, which occurs at temperatures high enough to cause some of the alloy constituents to liquefy.⁸

Figure 69. SEM micrograph of a spherical particle of stainless steel found near the exterior side of hole 3.

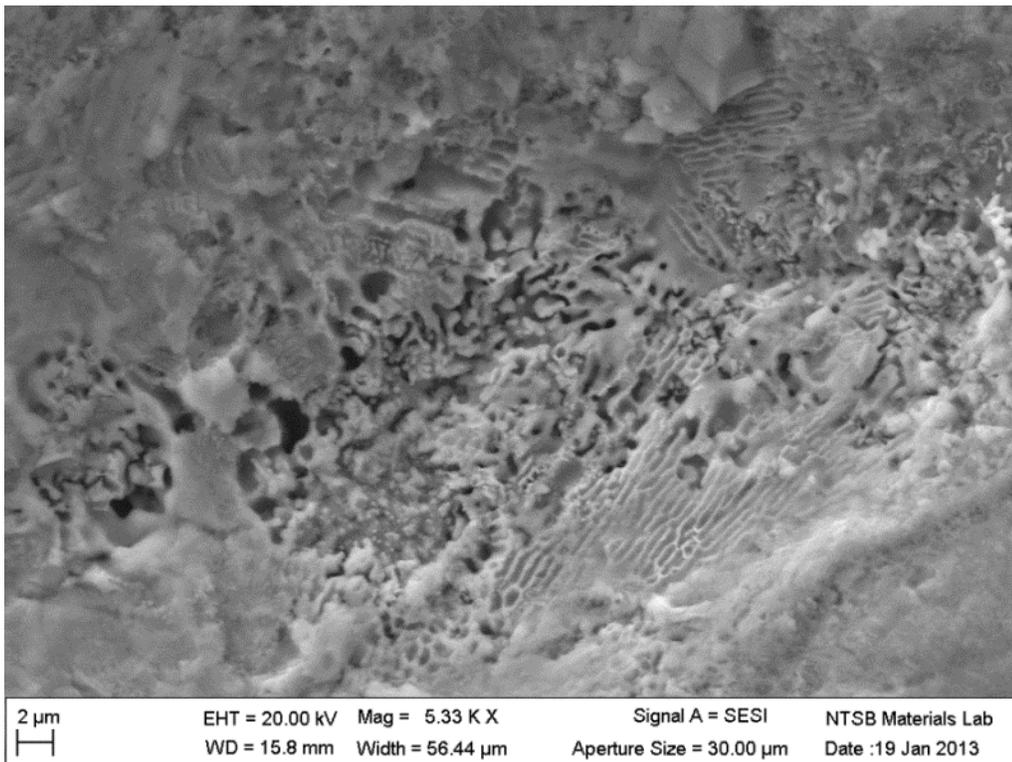
Figure 70. SEM micrograph of lamellar structure consistent with incipient melting near the exterior of hole 4.

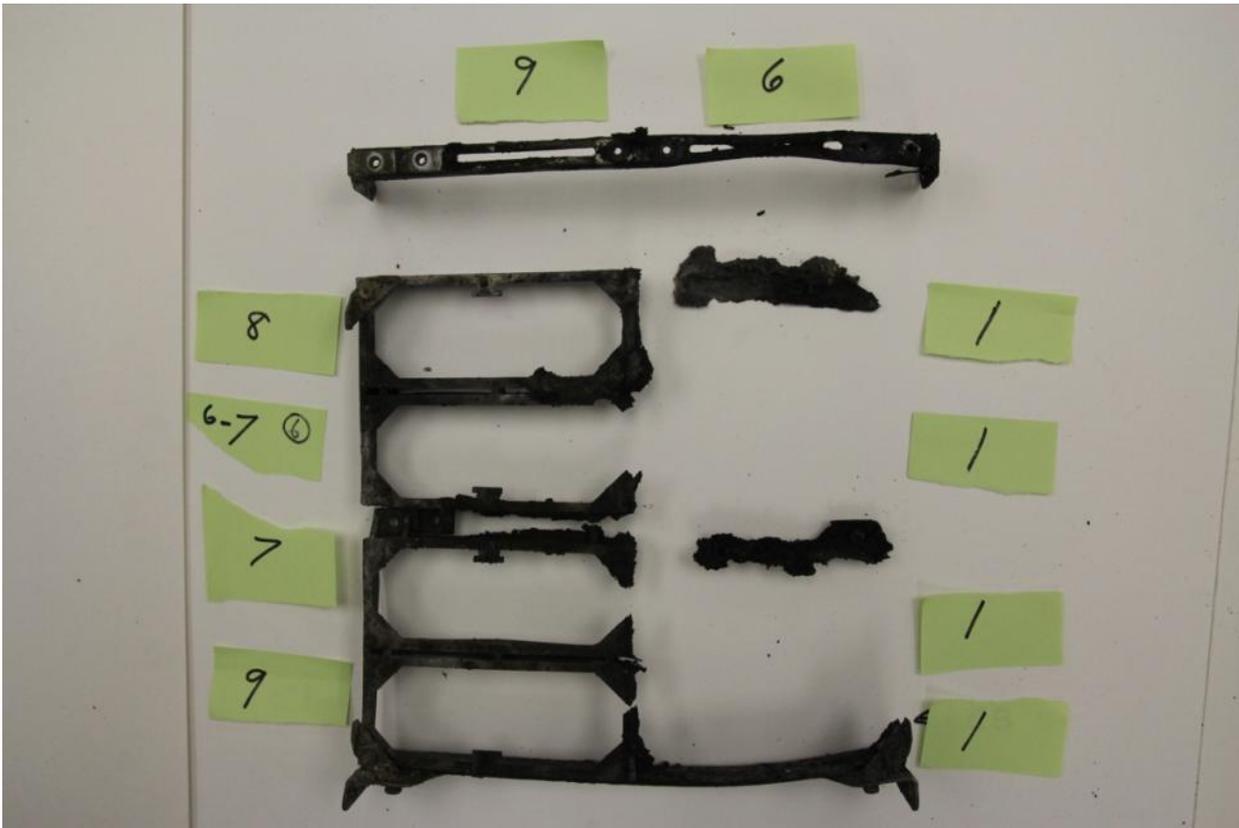
Figure 93. Upper fixation tray and brace bar damage assessment (10 = least damaged, 1 = most damaged).
