# BULLETIN

NUMBER 123

SUBJECT: Front Spar Interference

MODELS AFFECTED: All PA-20 and PA-22 Model Aircraft

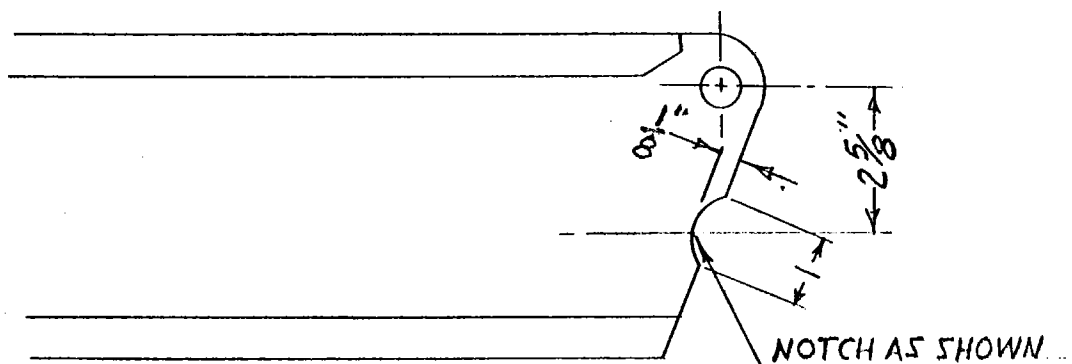
It is requested that an inspection be made to determine whether or not there is interference between the inboard end of the front spar web and the aileron pulley attachment bolt in the area of the front wing hinge fitting.

If there is less than one-eighth inch clearance between these two points, then the spar web should be filed out and sanded smooth in accordance with the following sketch:
