VSP-37
July 7, 1982

VENDOR SERVICE PUBLICATION

To: All Piper Distributors and CORPAC's
Subject: Bendix Service Bulletins 615, 620, 621

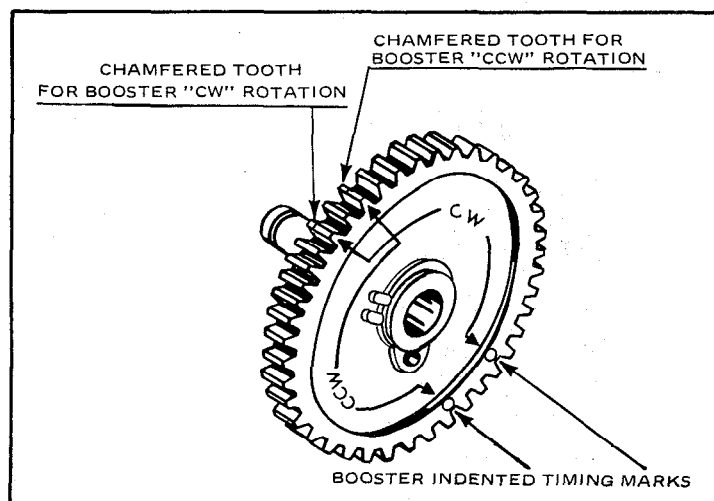
Figure 3. Timing Marks on Present Production Distributor Gear Kit Assembly 10-357586

3. If present production distributor gear as supplied in kit P/N 10-357586 is used (see figure 3) proceed as follows:

- Remove paint from booster timing positions with suitable solvent.
- Locate normal timing tooth between CW and CCW booster chamfered teeth and paint this tooth and the applicable inner timing mark with red Dykem or red lacquer in accordance with figure 4.

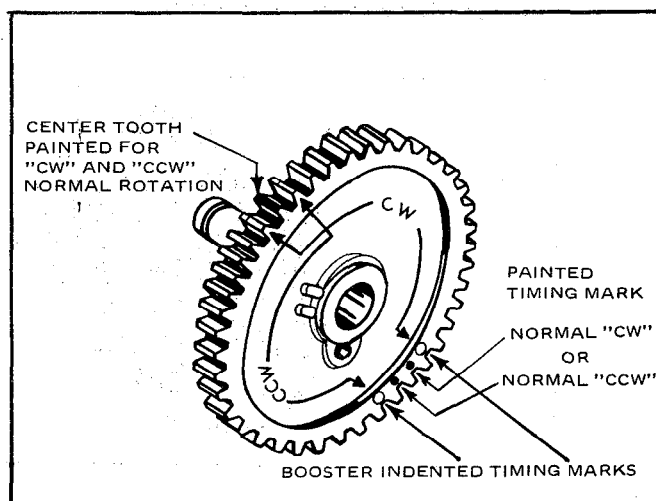
Figure 4. Present Production Distributor Gear Assembly with Additional Timing Marks Painted

The molded timing marks incorporated in new present production nylon spare part gears, as supplied in kit, P/N 10-357586, are for the booster timing position. Before installation of a new gear kit, the applicable normal timing mark and center tooth must be marked with red

Dykem or red lacquer as illustrated in figure 4.
