NUMBER 116

March 9, 1951

SUBJECT: Battery Box Lid

MODELS AFFECTED: Piper Model PA-20 Serial Numbers 20-553 thru 20-600 incl., 20-602 thru 20-623 incl., 20-627 thru 20-631 incl., 20-633 thru 20-641 incl., 20-643 thru 20-649 incl., 20-651, 20-654, 20-656, 20-660 and 20-662, also, Model PA-22 Serial Numbers 22-1 thru 22-33 incl., 22-35 thru 22-37 incl., 22-43, 22-51, 22-53 and 22-54.

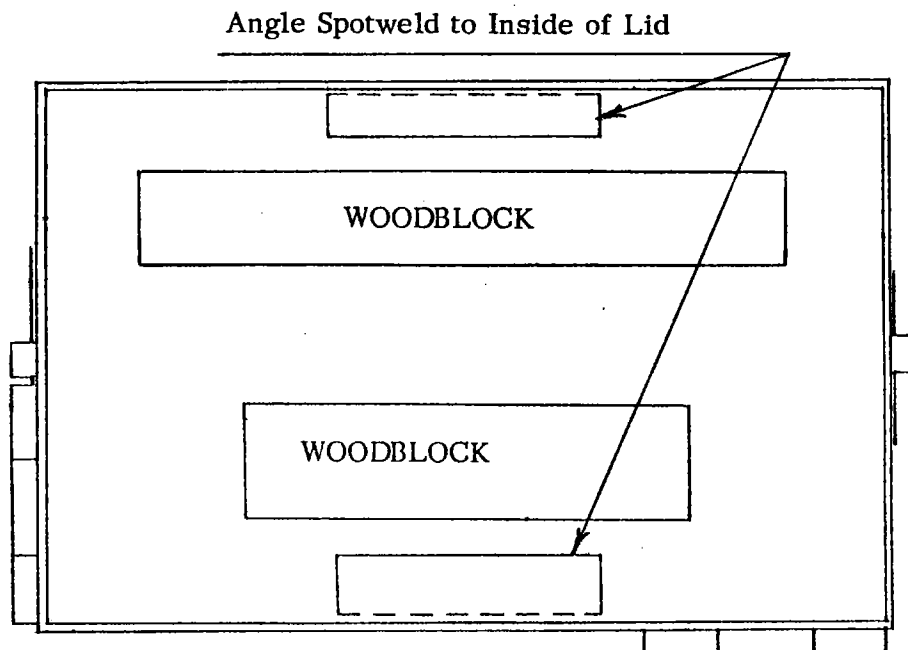
SKETCH #1

Lids of the type construction shown in Sketch No. 1 are satisfactory without rework.

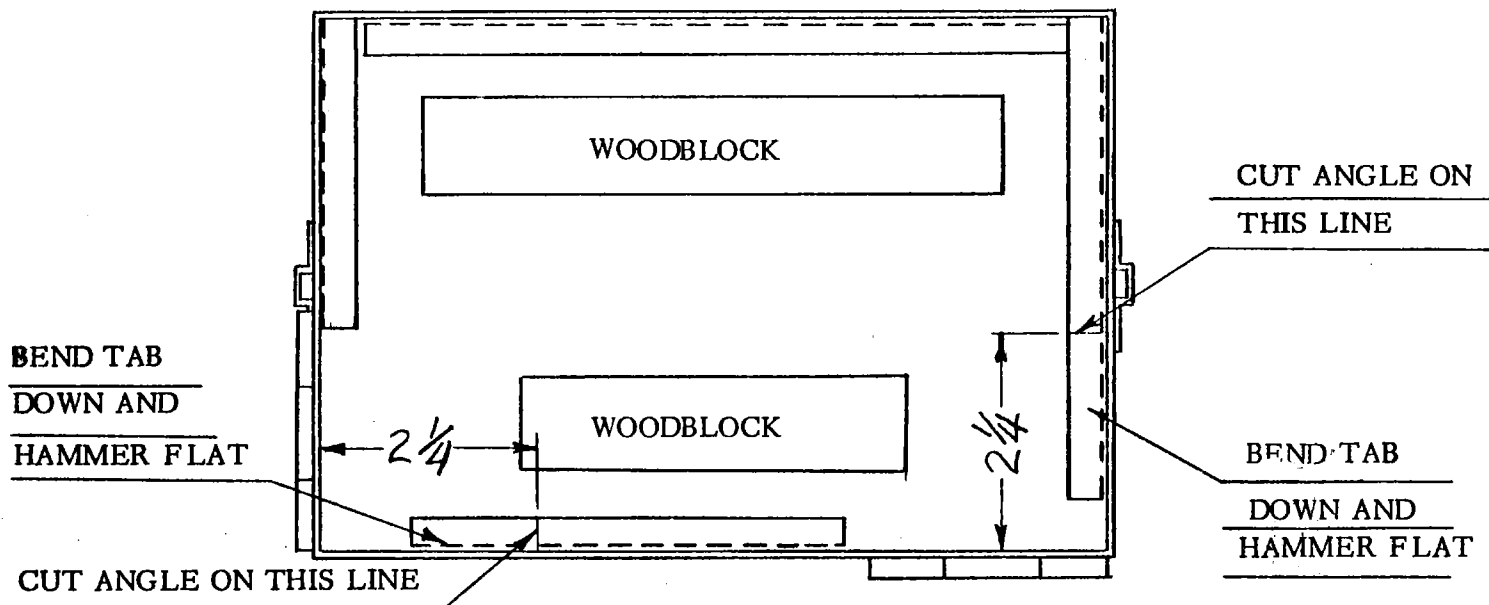
SKETCH #2

FOUR ANGLES SPOTWELD TO INSIDE OF LID

Lids of the type construction shown in Sketch No. 2 must be reworked as indicated.
