NUMBER 118

SUBJECT: Battery Box Lid Modification

MODELS AFFECTED: PA-16 Airplanes with Serial Numbers 16-1 and up;
PA-20 Airplanes with Serial Numbers 20-1 thru
20-802 inclusive; and PA-22 Airplanes with Serial
Numbers 22-1 thru 22-348 inclusive.

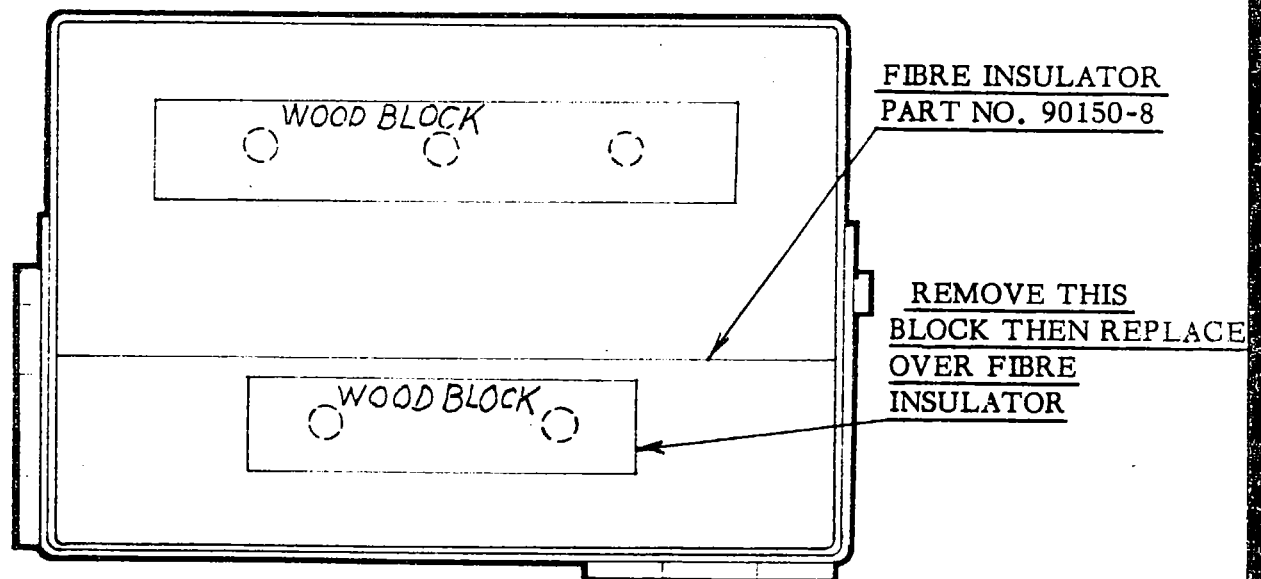
It is necessary that the battery box lids in the above listed airplanes be modified in accordance with the following instructions, to eliminate the possibility of "shorting" the battery terminal wing nuts.

Remove the wood block located between the battery cable openings. Place the fibre insulator, Piper Part Number 90150-8, inside the lid as shown in the following sketch. Replace the wood block using the same screws.
