NUMBER 148A

SUBJECT: Fuel Tank Caps

MODELS AFFECTED: PA-18-18A, L21B and PA-22

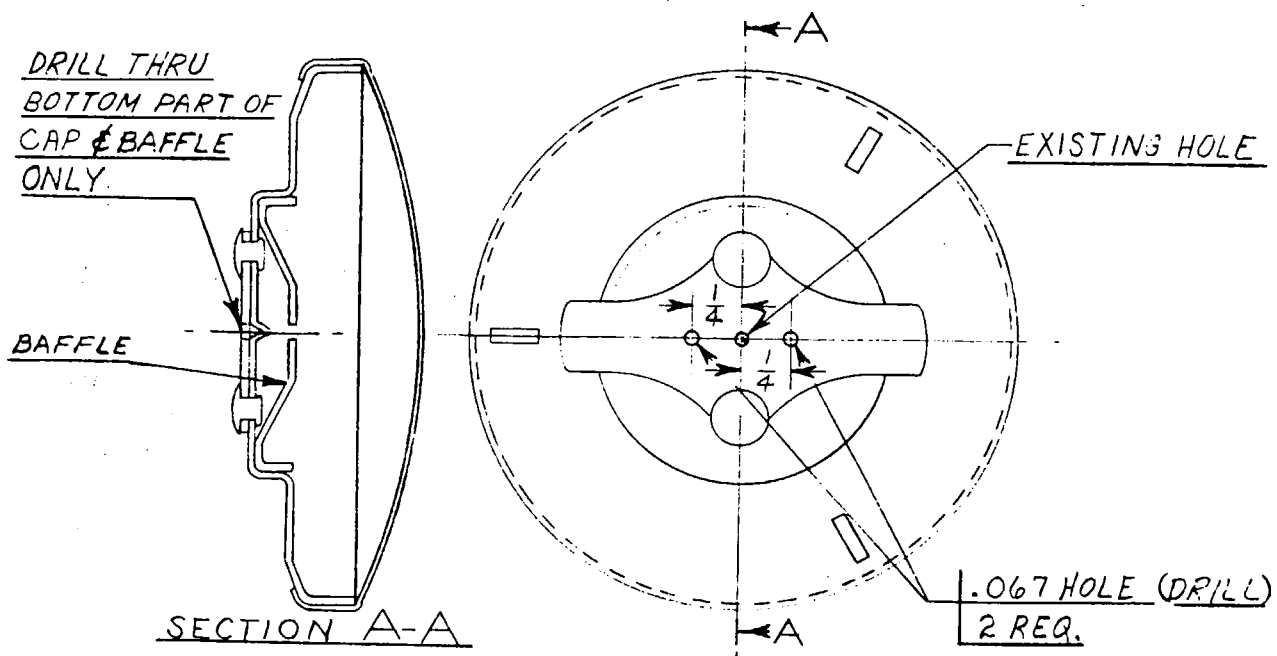
During the past four months we have received fuel tank caps from our vendor which were changed slightly in design. This design change created a possible hazard to the venting system and it is, therefore, requested that the fuel tank caps on all PA-18-18A's, Serials 18-5189 to 18-5412 inclusive and 18-5416 to 18-5419 inclusive, and all L21B's, Serials 18-4011 to 18-4042 inclusive, and all PA-22's, Serials 22-4334 to 22-4337 inclusive; 22-4339 to 22-4387 inclusive; 22-4389 to 22-4455 inclusive; 22-4457 to 22-4509 inclusive; 22-4511 to 22-4554 inclusive; 22-4556 to 22-4565 inclusive; 22-4567, 22-4569, 22-4570, 22-4572, 22-4573, 22-4575 to 22-4577 inclusive; 22-4580 to 22-4587 inclusive; 22-4589 to 22-4591 inclusive; 22-4597; 22-4599; 22-4602; 22-4603; 22-4605 and 22-4613 be immediately reworked by drilling two (2) .067 holes 1/4" away from the present vent hole located in the underside of the cap, in the center of the flat spring. See sketch on reverse side for drilling details.

It is also requested that all existing field stocks be reworked as well as fuel tank caps on affected aircraft models which have been replaced since September 26, 1956 from stock procured from the Piper Service Department. Fuel tank caps which are correctly vented can be identified by one of two methods:

- (1) Improperly vented caps have an internal floating rivet and can be identified by shaking. A rattle indicates a bad cap - no rattle indicates a good cap.
- (2) Properly vented caps are now identified by an "X" marked on the bottom side of the cap.
