Service Letter No. 136A

TO: Owners of PA-20 and PA-22 Airplanes with serial numbers  
20-1 through 20-923 and 22-1 through 22-775

SUBJECT: Chafing of Fuel Line and Fuel Valve Operation

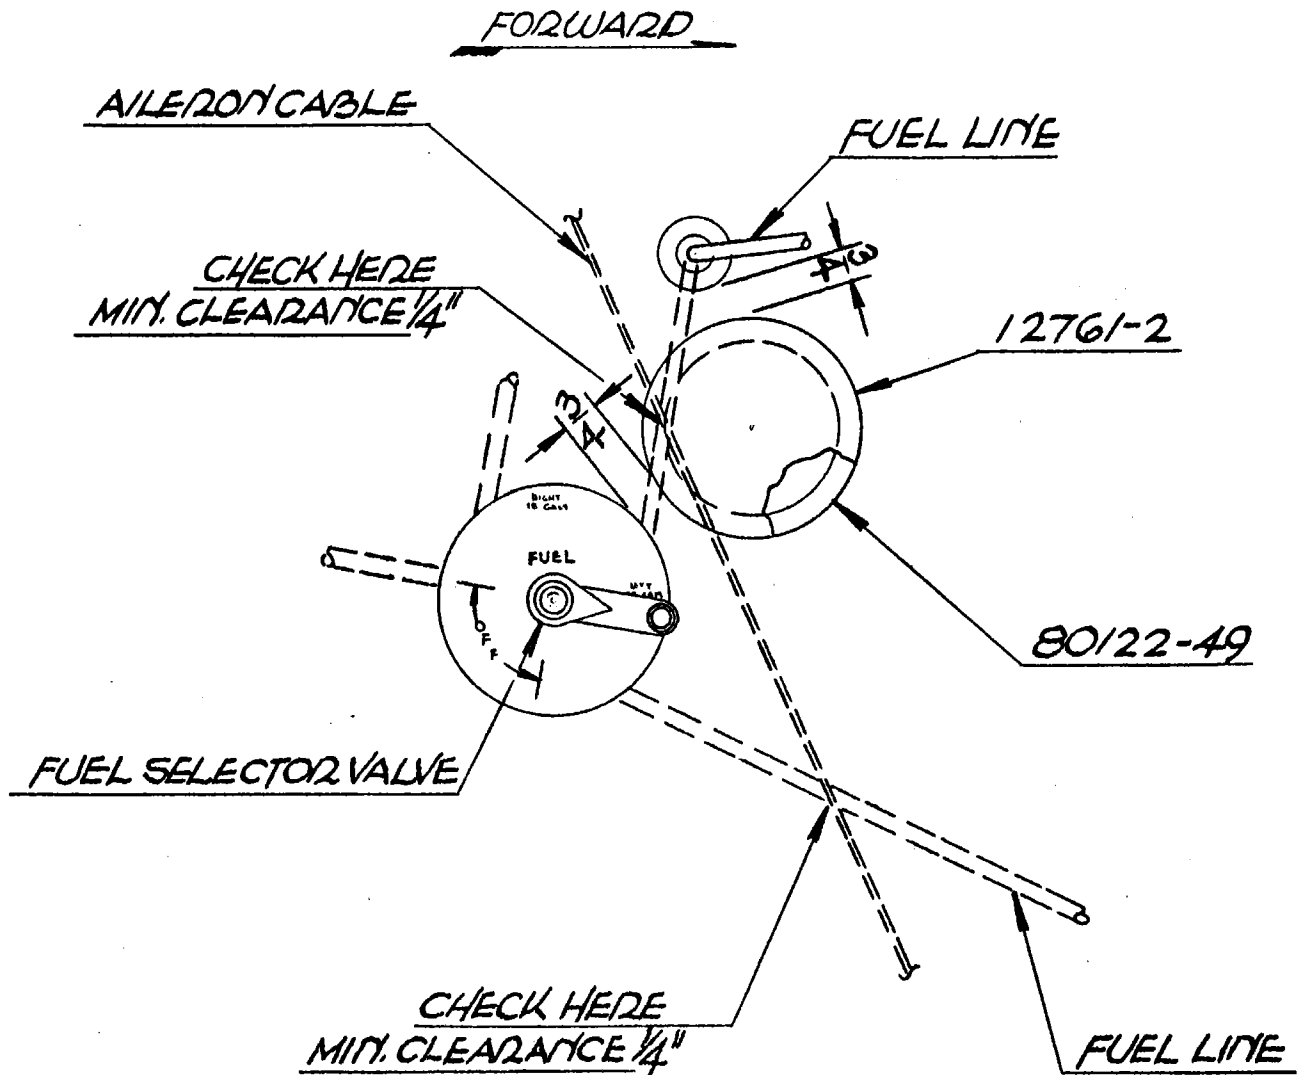
Sketch for Service Letter No. 136A

It is necessary that an inspection be made of the aluminum fuel lines forward of the fuel valve.

Inspect the fuel lines for evidence of chafing by the aileron control cable. Check the clearance between the fuel lines and the cable. If 1/4" or more clearance exists no further action is required. If 1/4" minimum clearance has not been provided, form the fuel lines by hand to obtain this minimum clearance. Exercise care while forming to avoid crushing or kinking the fuel lines.

VIEW OF LEFT SIDE FROM INSIDE CABIN

To accomplish this, dope the pyralin grommet, 80122-49, to the fabric inside the cabin as shown in the sketch. Cut away the fabric enclosed within the grommet.

Upon completion, install the cover, 12761-02, as shown in the sketch.
