SERVICE BULLETIN

No. 507

Piper Aircraft Corporation

Inspection of Fuel System Control Cables at Swivel Fittings.

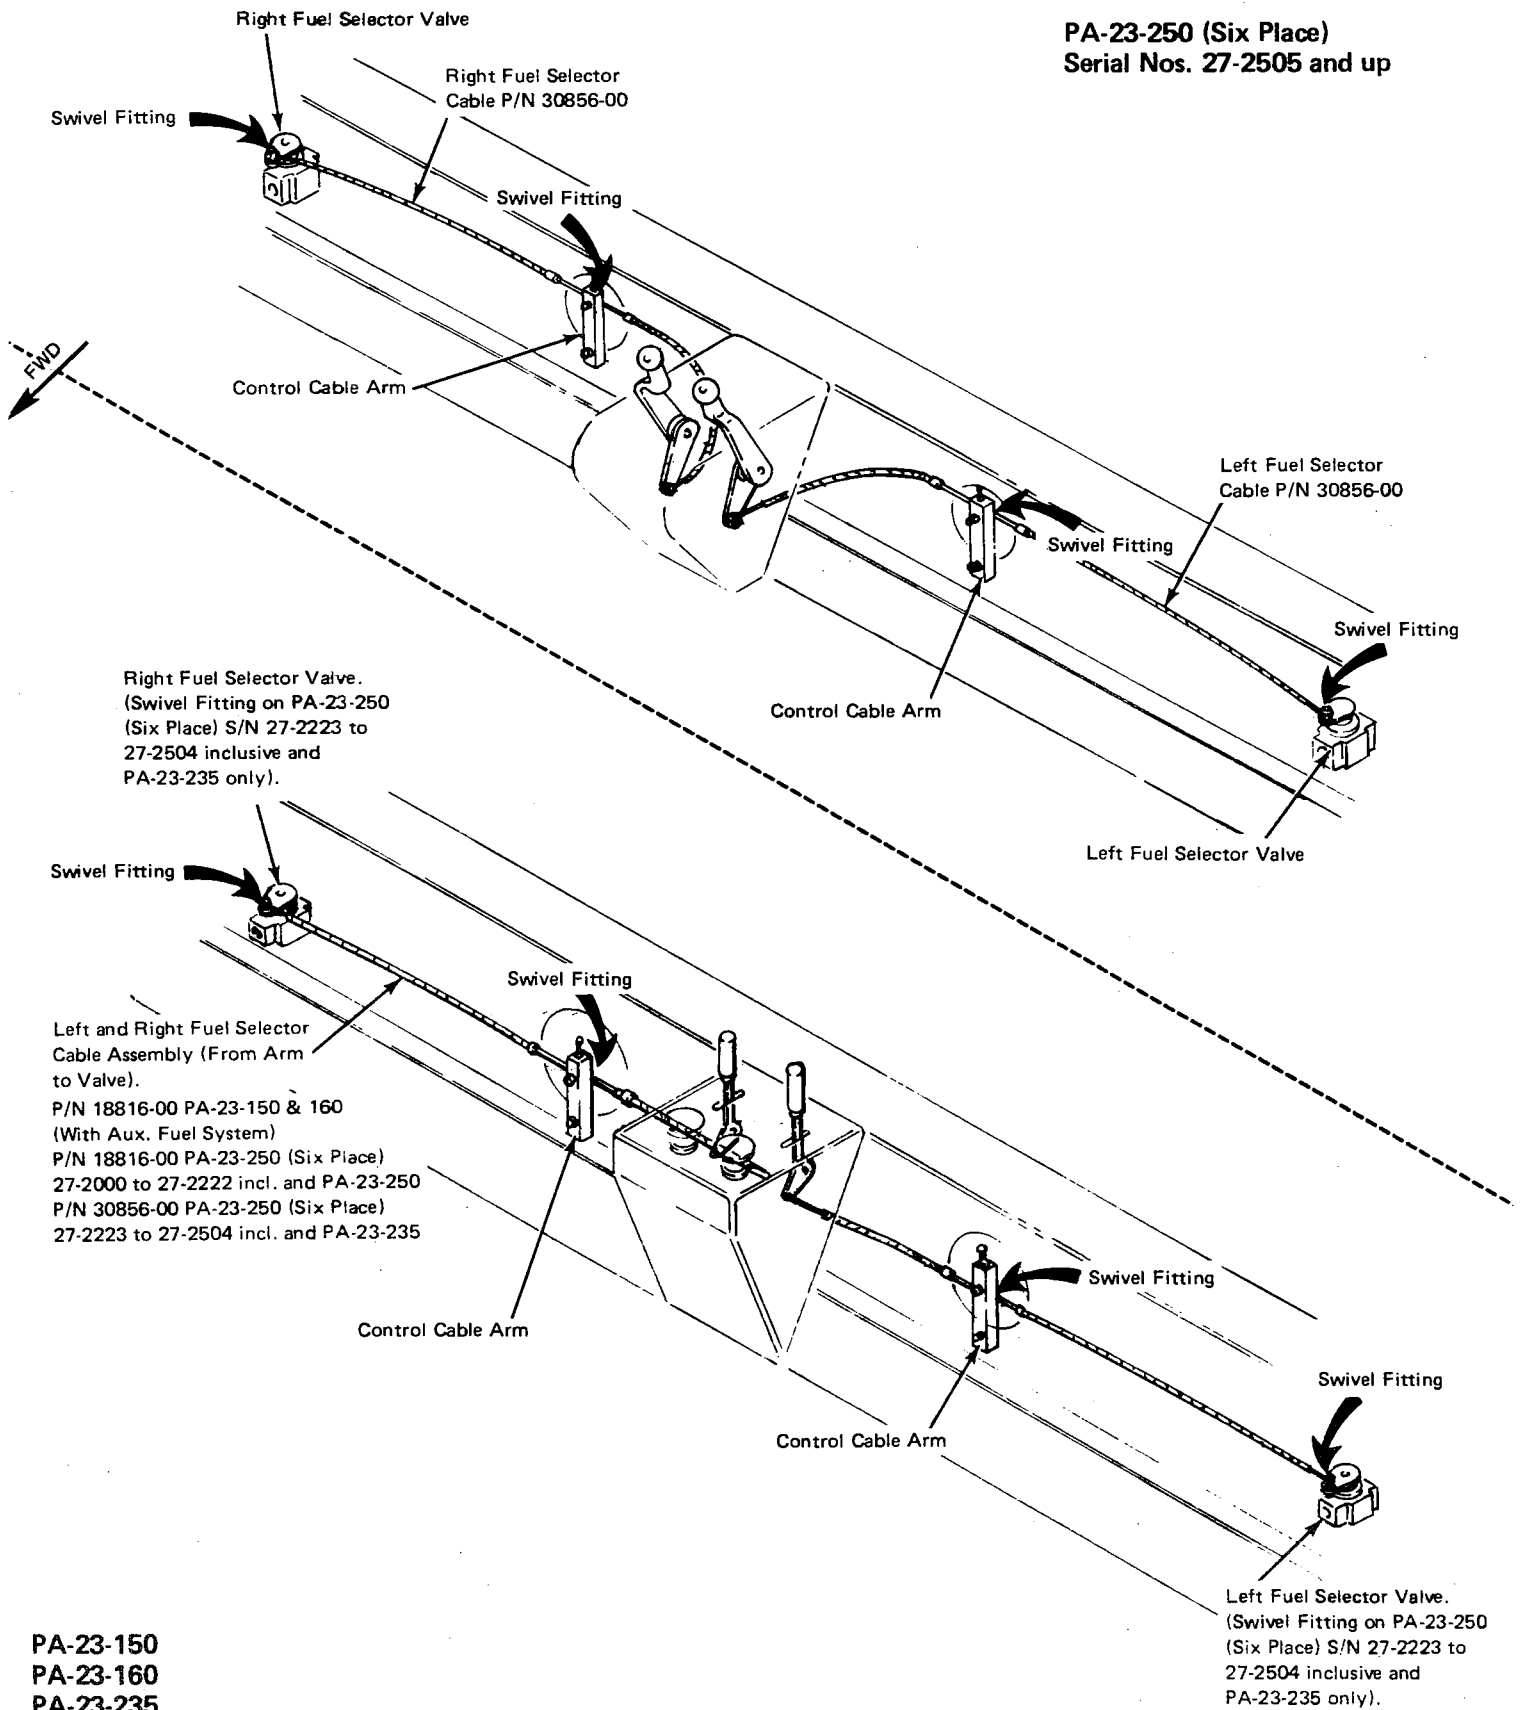
**PA-23-250 (Six Place)
Serial Nos. 27-2505 and up**

This service release provides instructions to inspect the fuel system control cables at the swivel fitting attachment points to detect binding, kinking or bending of the control cable inner wire, and to replace cable(s) exhibiting these conditions at the swivel fitting attachments. Note: PA-23, PA-23-235 and PA-23-250 Series - Left and Right Fuel Selector Cable Assembly (From Arm to Valve) only affected; refer to attached illustration.

1. Refer to appropriate service manual Fuel System section to insure fuel selector valve controls are properly rigged, and to gain access to control cable/swivel fittings.
2. Visually check control cable wires at the related swivel fittings for indications of binding, kinking or bending: have someone in the cockpit operate fuel controls while mechanic inspects the swivel fittings for indications of binding, kinking, and/or bending.
 - a. Replace cables(s) exhibiting any of above conditions.
 - b. Check system rigging per service manual, make proper log book entry indicating compliance with this bulletin and prepare aircraft for return to service.
 - c. If no binding, kinking or bending appears at the cable attachment points, check rigging per service manual, make proper log book entry indicating compliance with this bulletin and prepare aircraft for return to service.
