SERVICE BULLETIN

No. 338

Longitudinal Bulkhead Rivet Installation

PA-31P Navajo

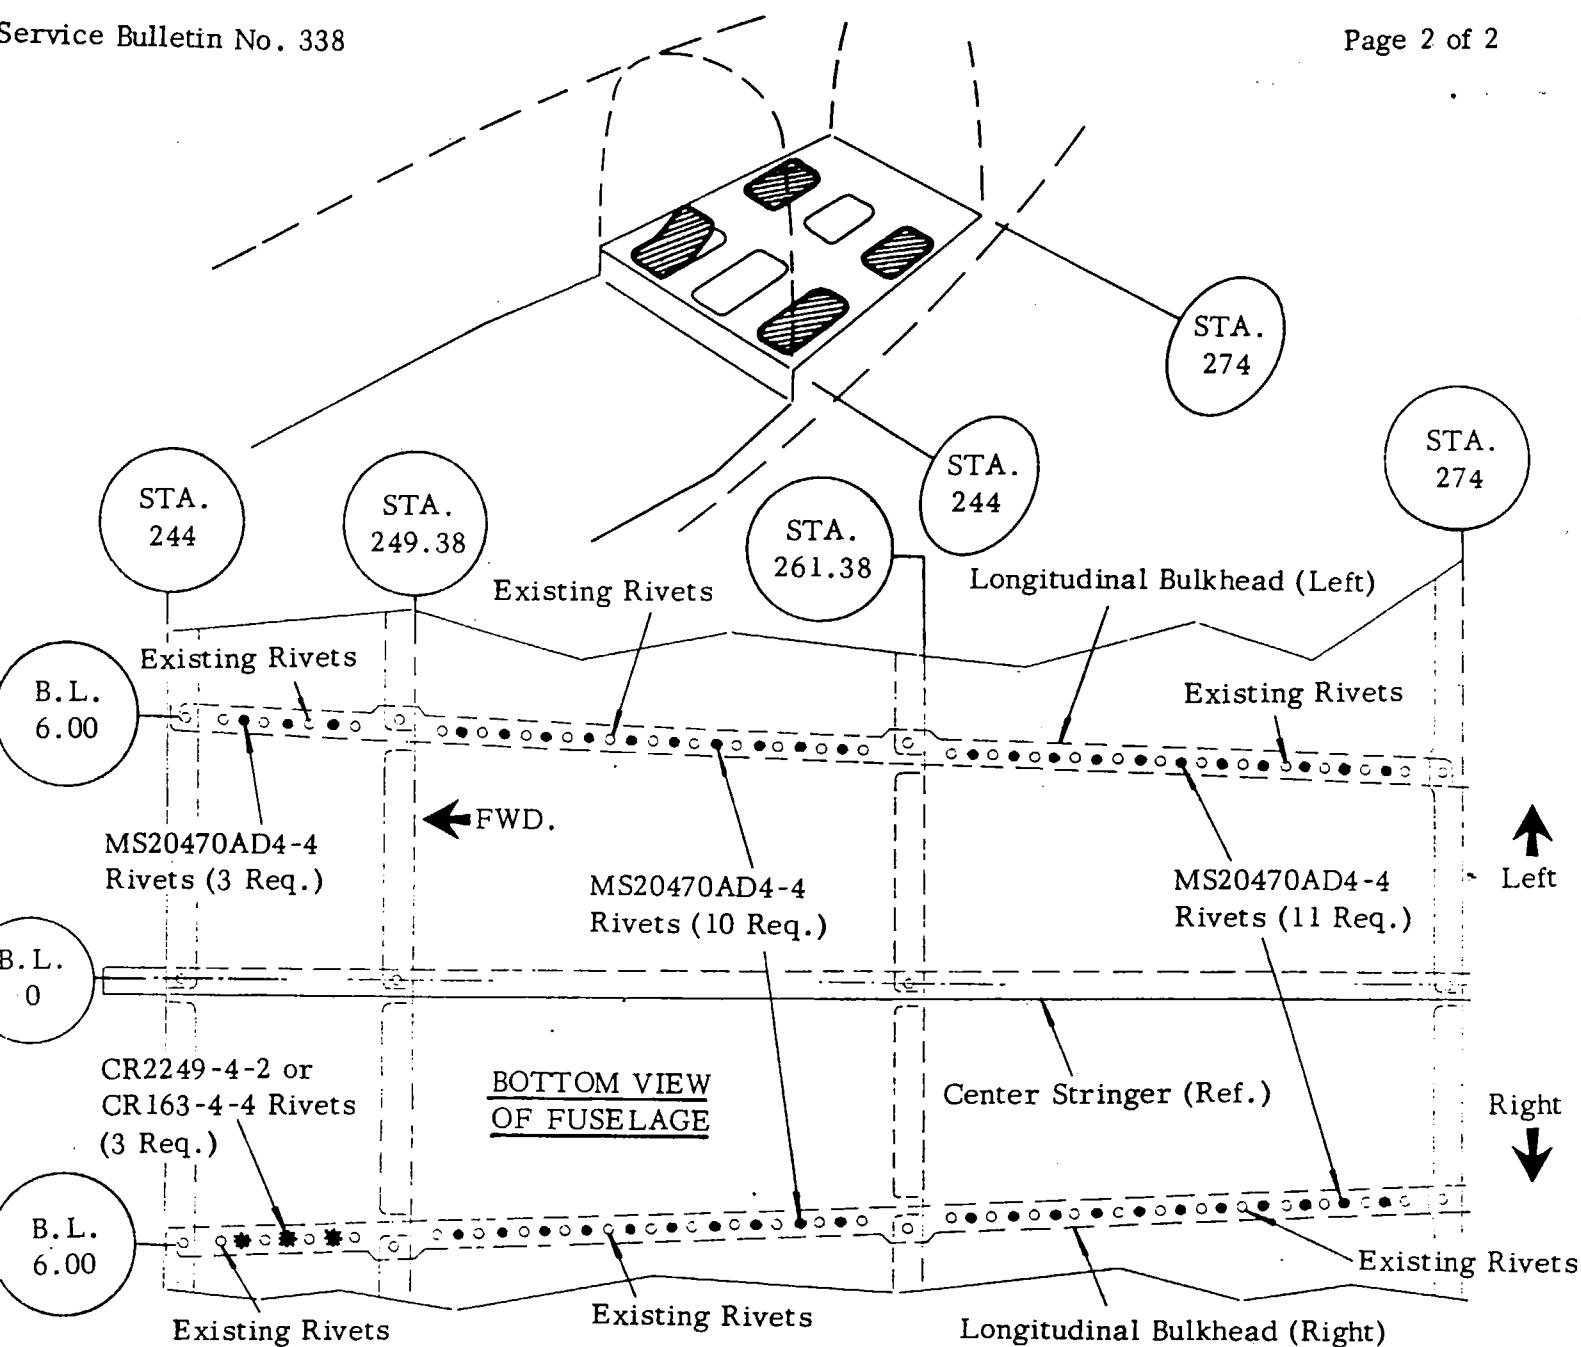
To provide inspection data and, if required, supply material and instructions for the installation of additional rivets on the lower fuselage aft section between the left and right longitudinal bulkheads, fuselage stations 244 to 274; refer to sketch on reverse side of this bulletin for a pictorial description.

1. Inspect the above referenced aircraft in the area referred to on the sketch on the reverse side of this bulletin to determine the type of rivets presently installed.
2. If flush rivets are installed, additional rivets must be installed in accordance with the sketch/instruction data on the reverse side of this bulletin; refer to Material Required, below for rivet identification.
3. If brazier (round-head) rivets have been installed, no further action is required regarding this Service Bulletin.

1. Remove cargo net attachment plates from baggage compartment floor and lift carpet to gain access to floorboard.
2. Remove the two left outboard and right rear outboard access covers. Remove as many screws as possible from the right forward outboard access cover and carefully raise to gain access to the longitudinal bulkhead aft of Sta. 249.38.

3. Locate existing flush rivets in bottom skin at left and right longitudinal bulkheads, and draw a pencil line thru center of rivets from Sta. 244 to Sta. 274.

4. On the left longitudinal bulkhead, between Sta. 244 and Sta. 274 and on the right longitudinal bulkhead, between Sta. 249.38 and Sta. 274, mark and drill #30 holes midpoint between existing rivets as shown. On the right longitudinal bulkhead, between Sta. 244 and Sta. 249.38, mark and drill three #27 holes midpoint between existing rivets as shown. CAUTION: Use a drill stop so drill penetration is no more than 1/2 inch.

5. Install forty-five MS20470AD4-4 (P/N 420 216) in the #30 holes and three CR2249-4-2 (P/N 522 882) or CR163-4-4 (P/N 422 897) in the #27 holes as shown.

6. Reinstall access covers, carpet and cargo net attachment plates. Restore aircraft finish.
