## MAINTENANCE AND CERTIFICATION

### Smoke in the Cabin—Landing Light Switch Failure

*The following occurrence resulted in two aviation safety advisories from the Transportation Safety Board of Canada (TSB).*

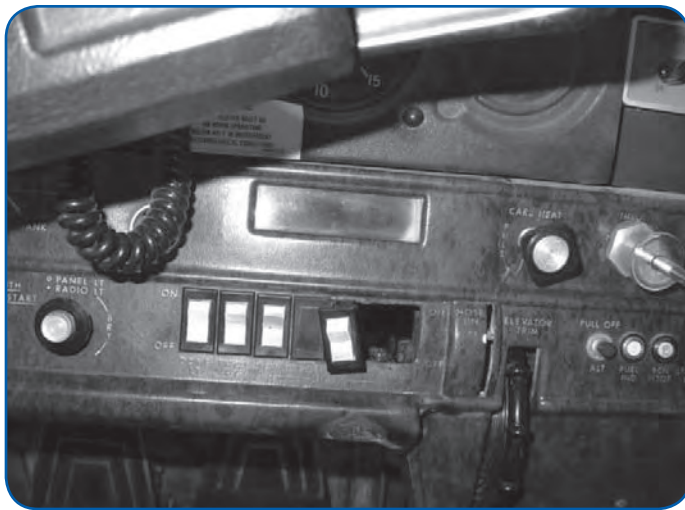
On September 24, 2007, a Cessna 152 aircraft took off from the Oshawa Municipal Airport, Ont., with the pilot and passenger on board, destined to Kingston, Ont. Just after clearing the control zone, the pilot and passenger noticed an electrical odour and observed a small fire and smoke emanating from the bottom of the left dash panel where the aircraft lighting switches were located. The passenger, sitting in the right front seat, reached for and discharged the fire extinguisher. The fire was quickly extinguished, but the extinguishing agent clouded the cockpit, reducing visibility. The cockpit windows were opened and visibility improved considerably. The aircraft returned to the Oshawa airport and landed without further incident. The pilot suffered a minor burn to his leg when the plastic instrument panel melted and dripped onto his jeans. The TSB issued Final Report A07O0264 on January 14, 2009, regarding this occurrence.

*Front of instrument panel*

The TSB determined that the landing light switch installed in the occurrence aircraft was beyond its design capability and therefore was unsuitable for the circuit it was controlling. Excessive heat from arcing and oxidization within the switch weakened the switch structure and contact support, allowing the contacts to fall out or be exposed. Arcing from the contacts caused oil residue to flash, which ignited a nearby dust accumulation and started the fire. Combustion was sustained by the plastic instrument panel. The TSB stated that similar landing light switch systems are incorporated on most

The TSB suggested that Transport Canada (TC), in co-ordination with the FAA and the aircraft manufacturer, may wish to take action to mitigate or eliminate the threat of fire caused by AC-rated switches in the landing light DC circuit of Cessna 152 aircraft.

The FAA took action to mitigate or eliminate the threat of fire caused by AC-rated switches in the landing light DC circuit of Cessna 152 aircraft. Cessna co-operated with the FAA by issuing Mandatory Service Bulletins MEB09-3 and SEB09-6 dated May 11, 2009, to remove and replace all subject switches used in the landing light as well as the taxi light and rotating beacon circuits in the 100-, 200- and 300-series Cessna models with service life greater than four years. This includes the Cessna 152-series aircraft. These bulletins are to be accomplished within the next 400 hours of operation, or 12 calendar months, whichever comes first. A review of the database shows less than 1 percent of the fleet has been affected by this type of failure. Therefore, the FAA's course of action has been to disseminate the concern by issuing a Special Airworthiness Information Bulletin (SAIB) CE-09-42, which is available at [www.faa.gov/aircraft/safety/alerts/SAIB/](http://www.faa.gov/aircraft/safety/alerts/SAIB/).

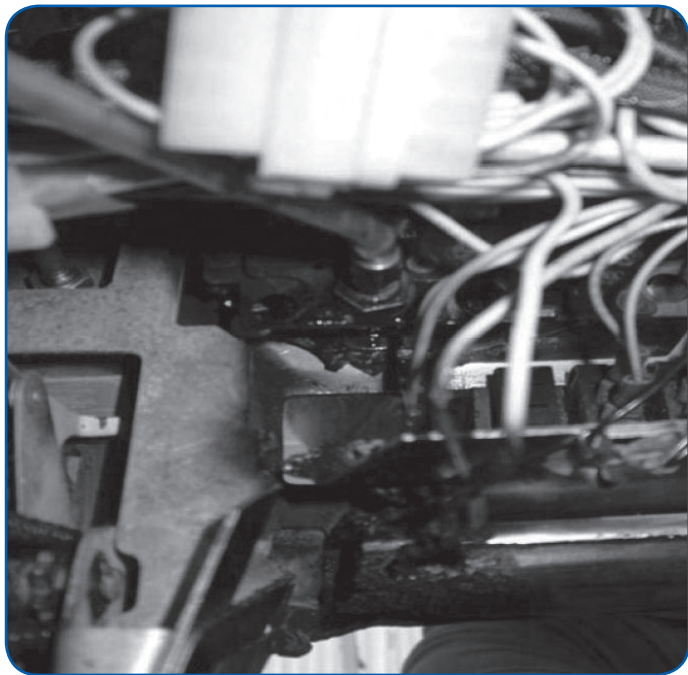
The switch was identified as a rocker-style switch rated at 10A 250VAC, 15A 125VAC, 3/4HP125-250 VAC. No DC ratings were found for this switch. The switch showed evidence of melt damage beginning at the base and progressing upward on both sides. The same damage was evident on the interior of the switch. The switch exterior had a thick coating of dust and an oily residue, which was also found inside the switch. A scanning electron microscope (SEM) and energy dispersive spectroscopy (EDS) analysis of the residue indicated that it might have been engine oil.

The landing light circuit wires remained attached to the contact but showed evidence of fire damage near where the contact enters the switch. The contact was coated with the plastic casing material and when the surface was examined there was evidence of repeated arcing, which had severely eroded the contact's surface. Arcing within the landing light switch could have provided the ignition source necessary for a fire to start. The dust covering evident on the switch and the oil residue provided by possible seepage from the oil pressure gauge line located above the switch may have provided the kindling necessary to start a fire. The oil would consistently reach its flash point when exposed to arcing, and when it was in proximity to the dust it would cause the dust to ignite. A small section of the plastic instrument panel was tested for flammability by introducing a direct flame to the

Rear of instrument panel

plastic. The piece of panel readily ignited and sustained flame. It also produced gases that were quite harsh when inhaled, and without sufficient ventilation may cause some incapacitation to the pilot.

According to the U.S. Federal Aviation Administration (FAA) Advisory Circular 43.13-1B, chapter 11 (pages 11–17), because of the initial current encountered by switches controlling 28 VDC lamp loads (incandescent lamps), the switches should have a derating factor of 8. This aircraft's switch controls a 250-watt lamp in a circuit powered by 28 VDC, and should have a minimum DC current rating of 71 amps. The switch from the aircraft had an AC rating. The Advisory Circular has a warning that reads "Do not use AC derated switches in DC circuits. AC switches will not carry the same amperage as a DC switch." The switch manufacturer was contacted and provided with the landing light circuit and switch information. After evaluating the information, they confirmed that the switch was not designed to handle the lamp loads described.
