## Possible Solutions for the Battery Problem on the Boeing 787

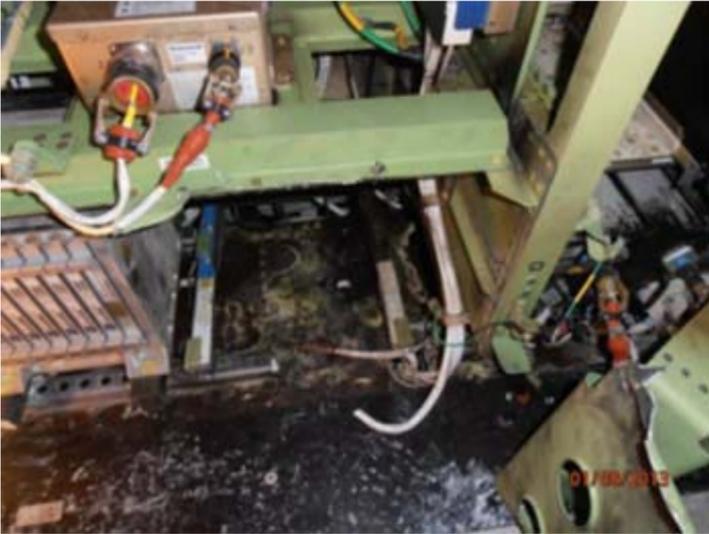
**Figure 1: Damage in aft electronics bay caused by a burning battery in a Boeing 787**

The incident happened after arriving at the gates in Boston from a flight from Narita, Japan. The fire was difficult to extinguish; smoke and flames didn't break with the dry chemical of a fire extinguisher and airport firefighters used liquid Halotron.

After fewer than 100,000 flight hours, two main batteries in the Boeing 787 Dreamliner failed. This contradicts Boeing's estimate as part of certification that a smoke event involving the new Li-ion battery should only occur once in 10 million flight hours. More than a smoke event occurred, and one battery disintegrated in a thermal runaway with fire and the spewing of electrolyte that caused damage to the electronics bay (Figure 1). The Federal Aviation Administration (FAA) grounded the entire fleet of B-787 as a result.

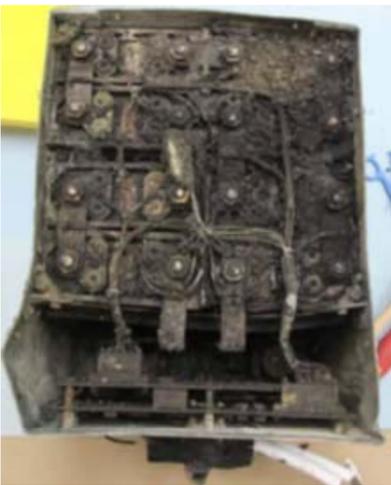
**Figure 2: JAL Event Battery**

The jarred remains of the failed B-787 main battery featuring 8 GS Yuasa LVP10 lithium-ion cells. The safety circuit at the connector end of the battery is unable to stop a thermal runaway once in progress.

CT scans done on the failed main battery of the B-787 reveal a similar breakdown that prompted the 2006 recall: a damaged electrode in one of the eight Li-ion cells apparently caused an electrical short that triggered a thermal runaway with fire. Lithium Cobalt Oxide (Li-cobalt) is known to be less stable than other lithium-based systems. For consumer product wanting optimal runtime, Li-cobalt works well, but large formats have additional challenges. Figure 2 illustrates the damaged main aircraft battery.
