NATIONAL TRANSPORTATION SAFETY BOARD

MATERIALS LABORATORY FACTUAL REPORT

Report No. 13-013

Place : Boston, Massachusetts
Date : January 7, 2013
Vehicle : Boeing 787, Registration JA829J
NTSB No. : DCA13IA037
Investigator-in-Charge : David Helson

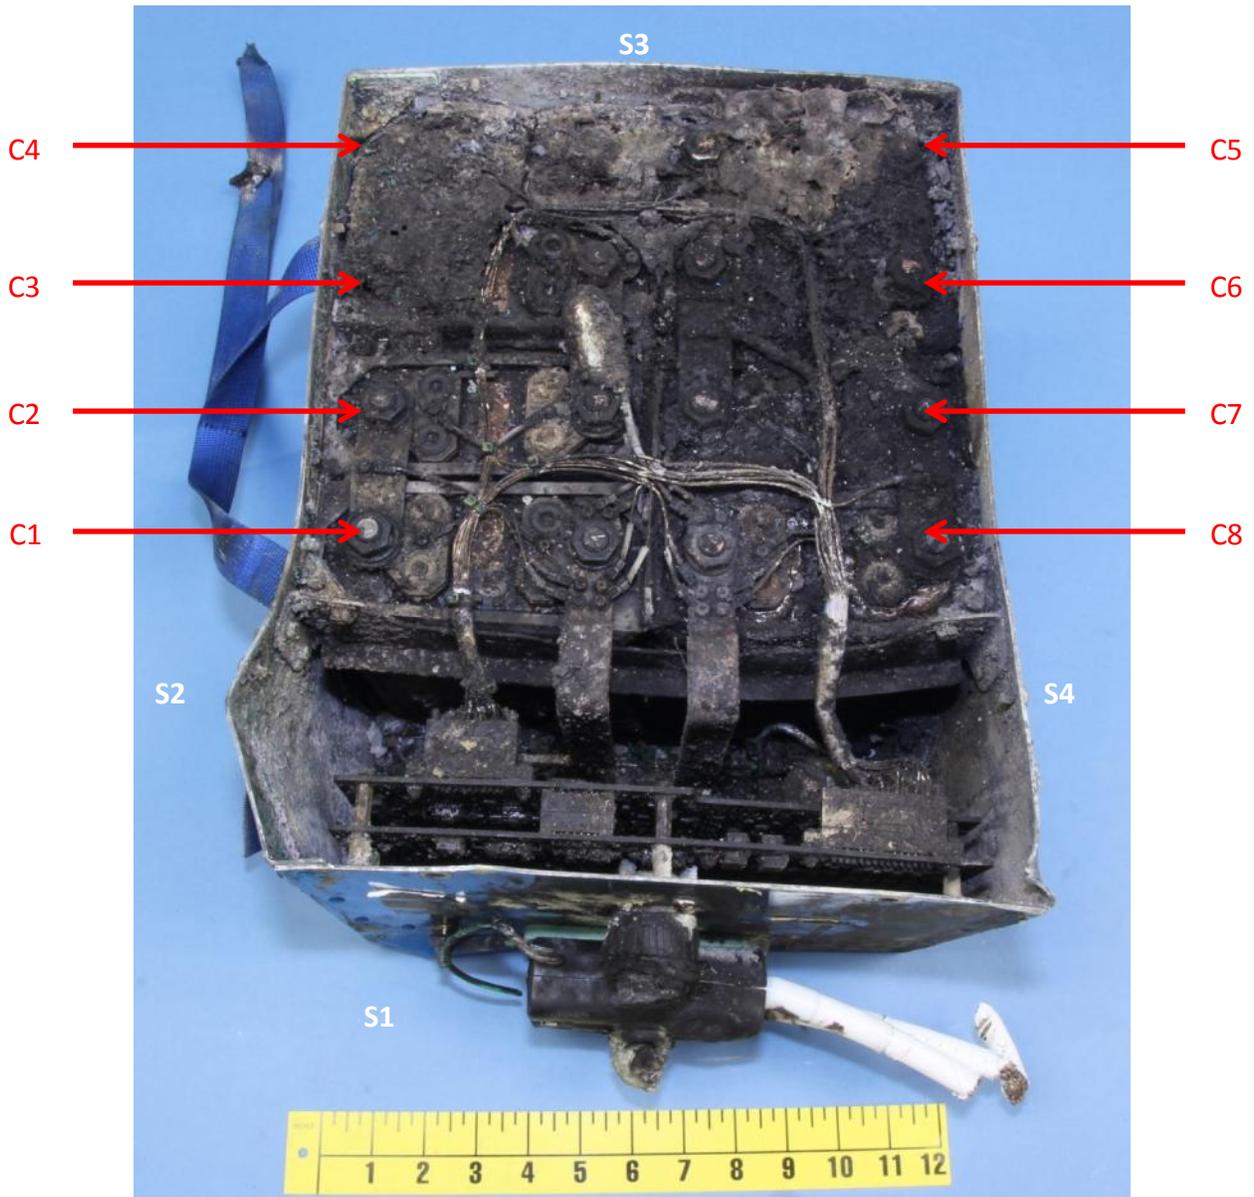
Figure 2. Opened battery box with approximate cell locations.

The upper insulation cover sheet was not found intact in the incident battery (Figure 2). However, portions of melted insulation consistent with the cover sheet material were found adhering to areas of the cell tops.

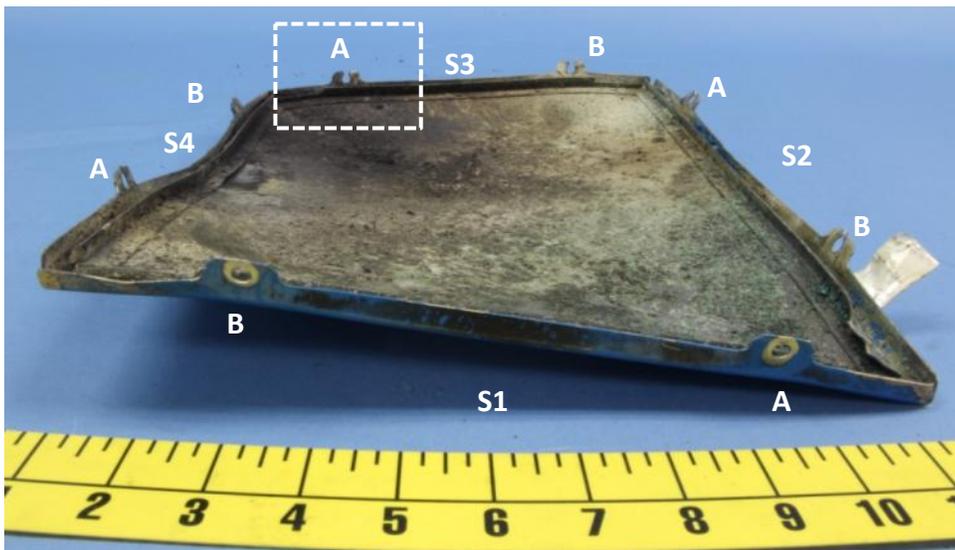
Figure 16. View of the underside of the battery box lid showing the positions of the tabs. The tabs are labeled A and B on each edge of the lid. The highlighted area shows the fractured S3A tab (a close-up view is shown in Figure 18).

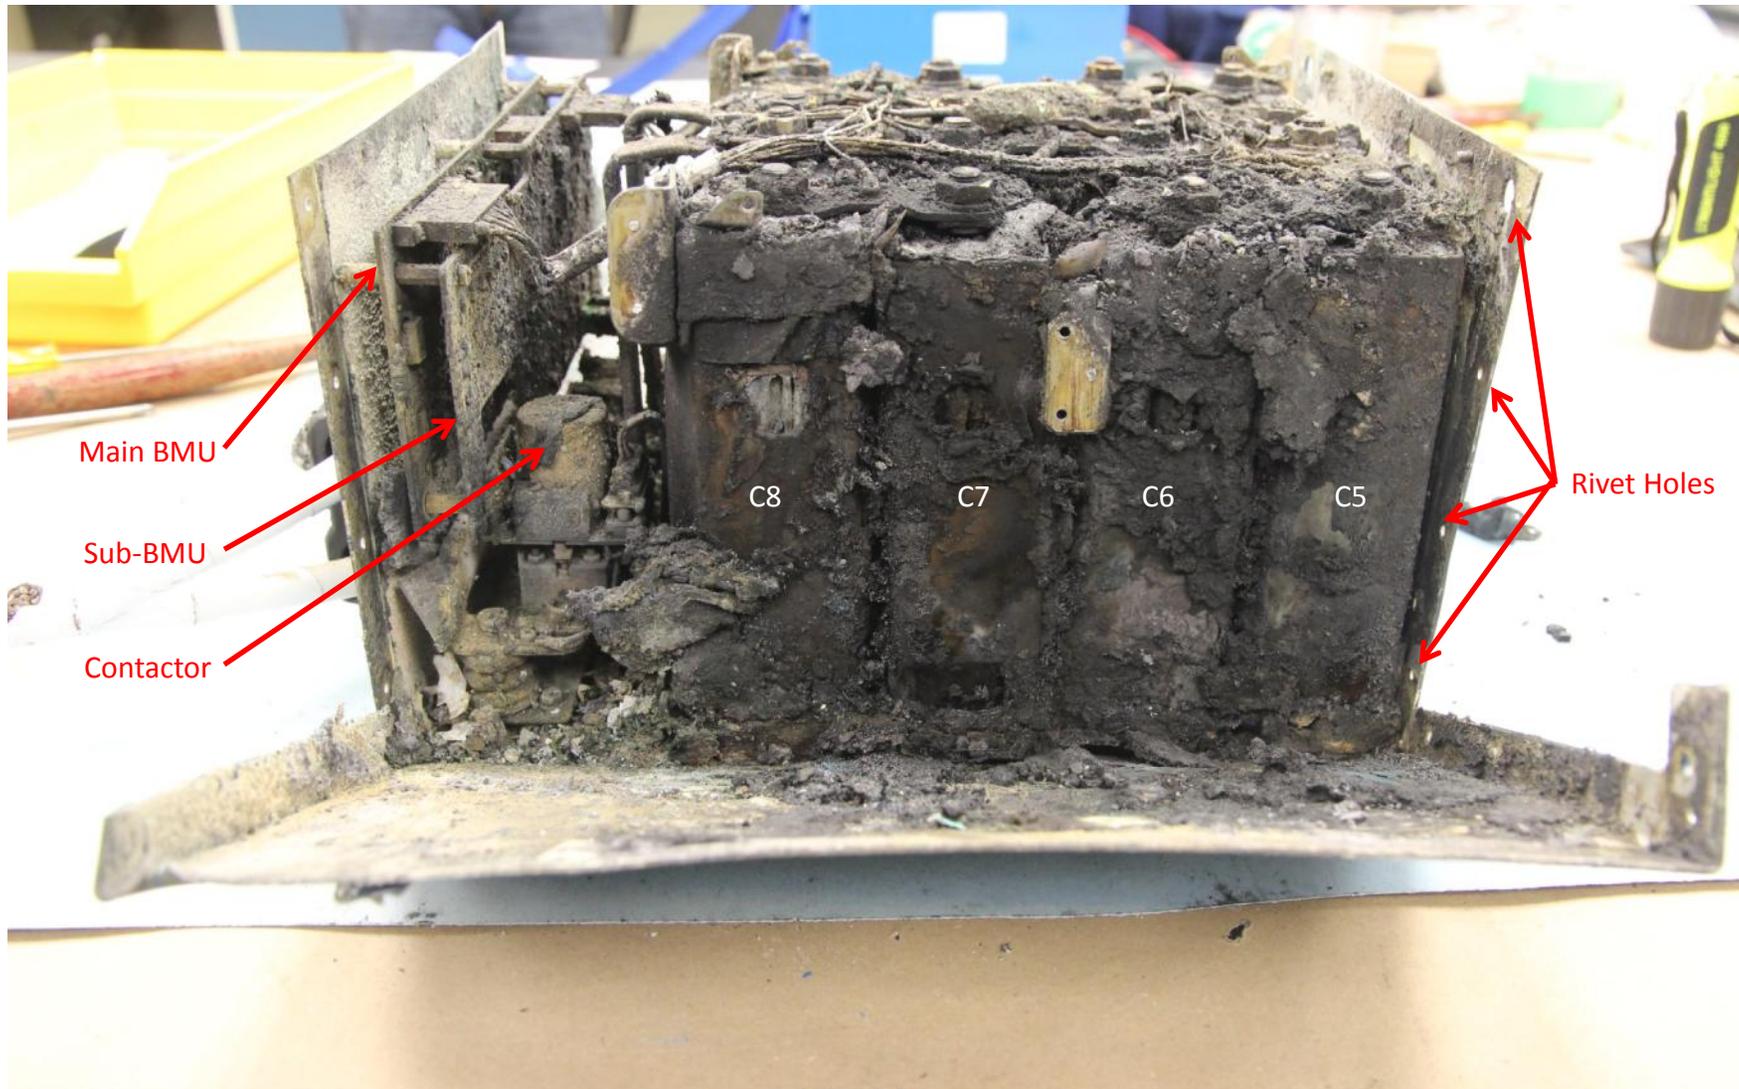
Folding down S4 revealed the position of C5 through C8 (Figure 26). The cells exhibited a darkened charred appearance with portions of the charred insulation materials adhering to them. Both of the layers of insulation, the black CRAT sheet, and BPA-TP were charred and indistinguishable from each other. The interior surface of the folded down battery case S4 had portions of the charred insulation materials adhering to it in areas where the insulation was in contact with it (Figure 27). The remainder of the interior of S4 was coated with residue.

Figure 26. View of S4 with battery box panel pulled back to reveal C5 through C8.

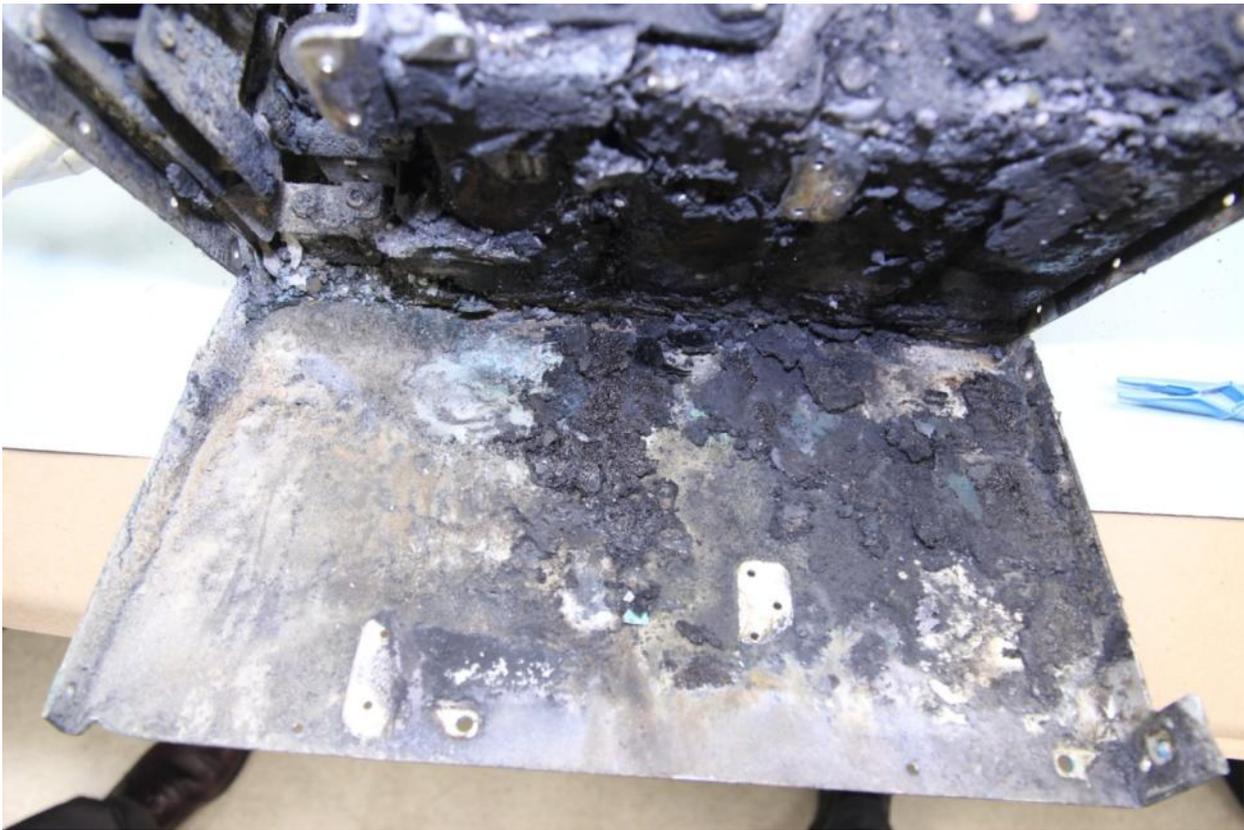
Figure 27. S4 battery box side interior.

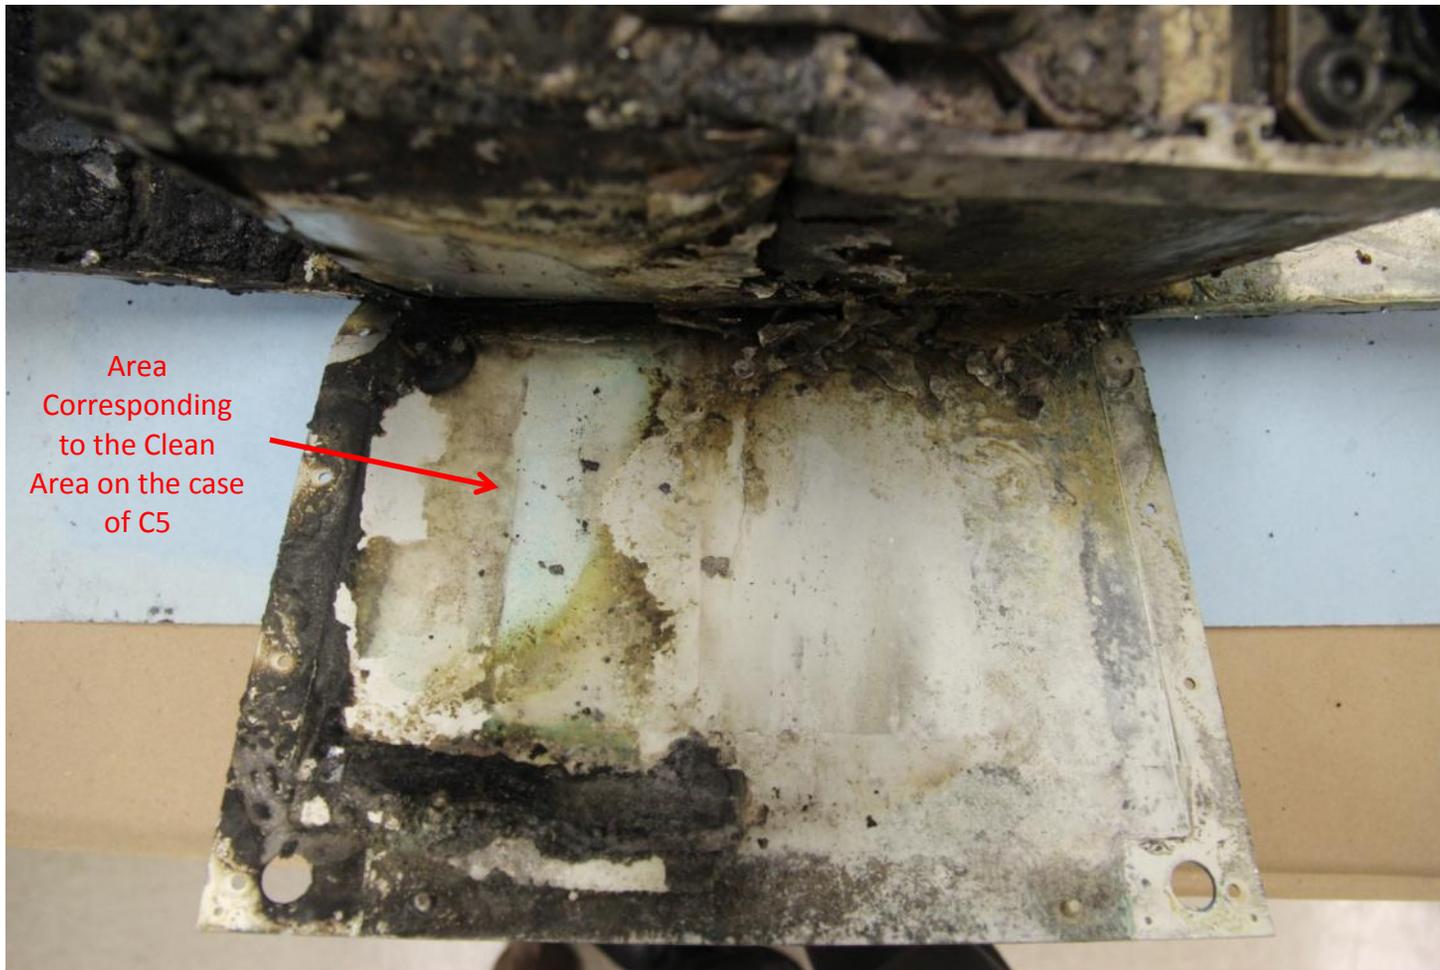
Figure 29. S3 battery box side interior.

Folding down S3 of the battery case revealed the S3 side of C4 and C5 (Figure 28). The BPA-TP insulation along this side was thermally degraded and fragmented. The S3 side of C4 had staining resembling a flowing residue. The S3 side of C5 had similar staining but also exhibited a clean area on the cell case. A corresponding area was visible on the interior of the folded down S3 of the battery case (Figure 29). This area is adjacent to the fire-damaged resin found on the interior of S4 (Figure 30). The S3 area on the interior of the battery case corresponding to C5 had large portions of BPA-TP insulation adhering to it. The BPA-TP insulation appeared to have been pressed against the battery case and exhibited some thinning. The adhering BPA-TP also exhibited some blue staining. A higher-temperature spot was observed on the battery case with a corresponding spot on the C5 cell case (Figure 31), documented in detail in Section F8.

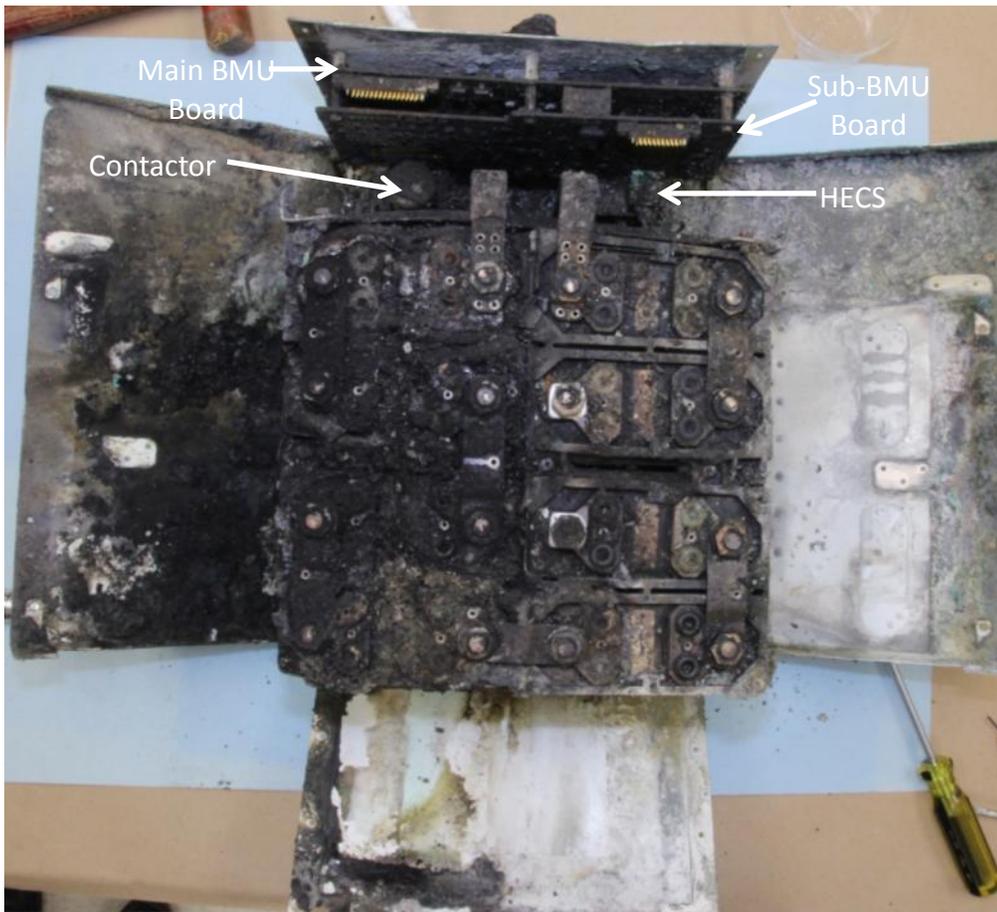
Figure 32. Top view showing the BMU, HECS, and contactor locations.

The battery assembly contained two BMU boards, a HECS, and a contactor that were located in the forward portion of the battery box (Figure 32). The contactor was removed first to provide clearance for the removal of the BMU boards. The two BMU boards were then removed from the battery case after disconnecting them from the sensing wiring harness and then unscrewing them from the stand offs which held them fixed to S1 of the battery case (Figure 33). Following the removal of the BMU boards, the HECS was removed.

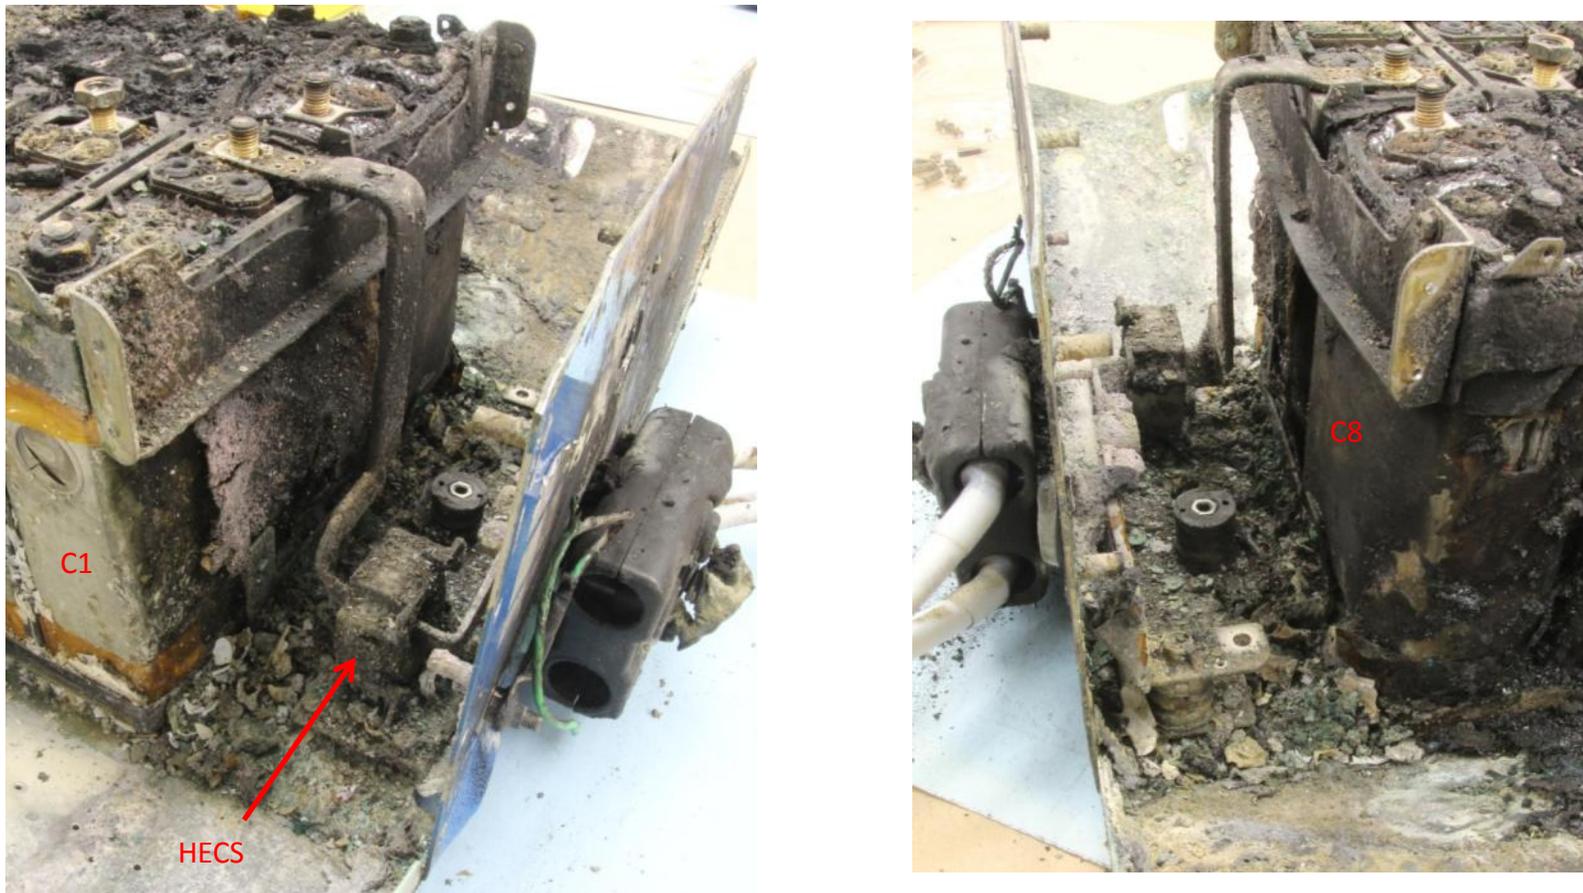
Figure 33 shows the condition of the insulation on S1 of the battery pack between the BMU space and the S1 faces of C1 and C8. Some insulation remains on the S1 face of C1, however there is no visible presence of insulation remaining on the S1 face of C8.

Figure 33. Photos of the BMU boards and contactor removed. The photo on the left is a view from S2. The photo on the right is a view from S4.

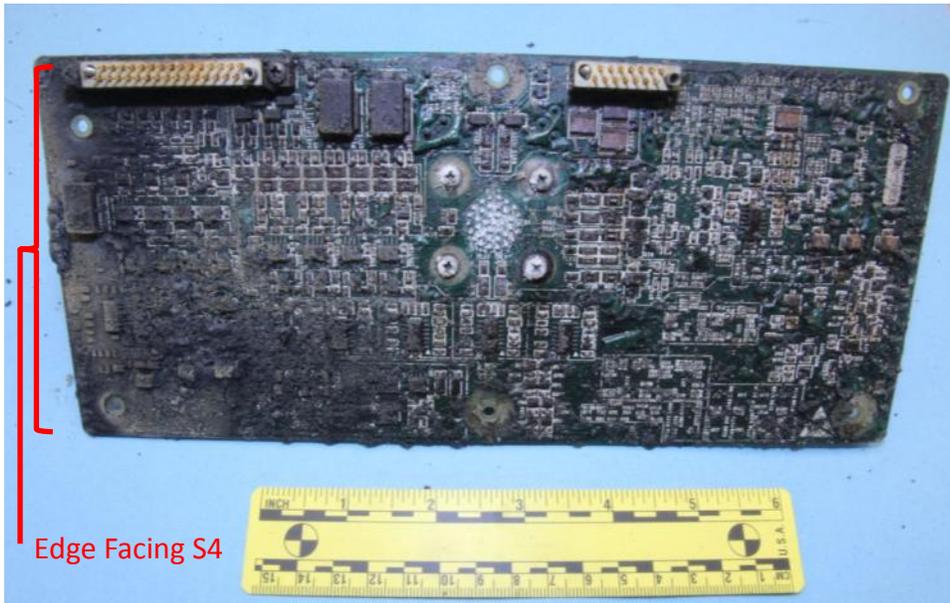
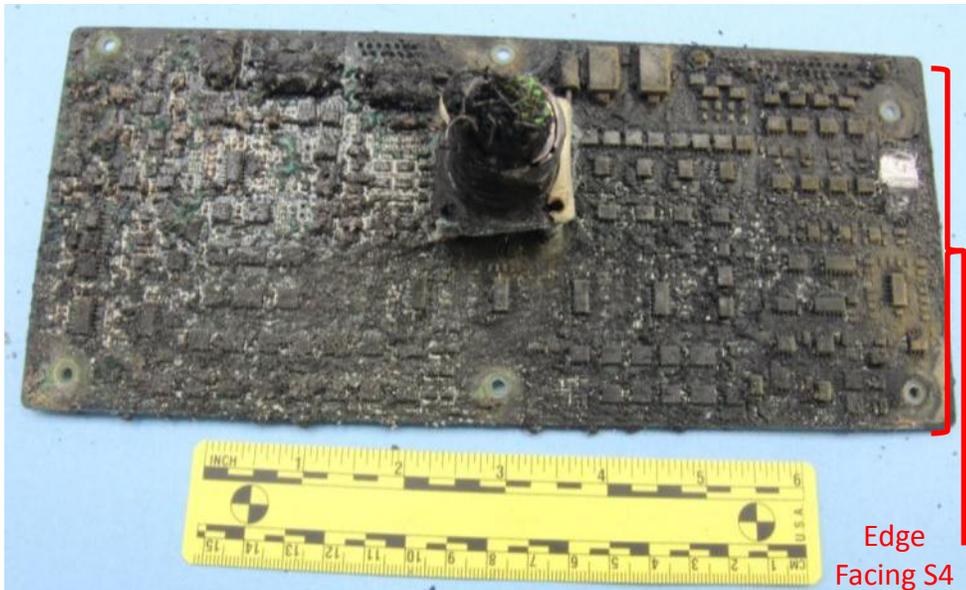
The main BMU board was thermally damaged and covered with residue (Figure 34). There was evidence of reflowed solder present on the board and some instances of separated semiconductor chips. The sub-BMU board had sustained similar thermal

Figure 34. Main BMU board. The top photo shows the side facing the interior of the battery box. The bottom photo shows the side facing the exterior of the battery box.

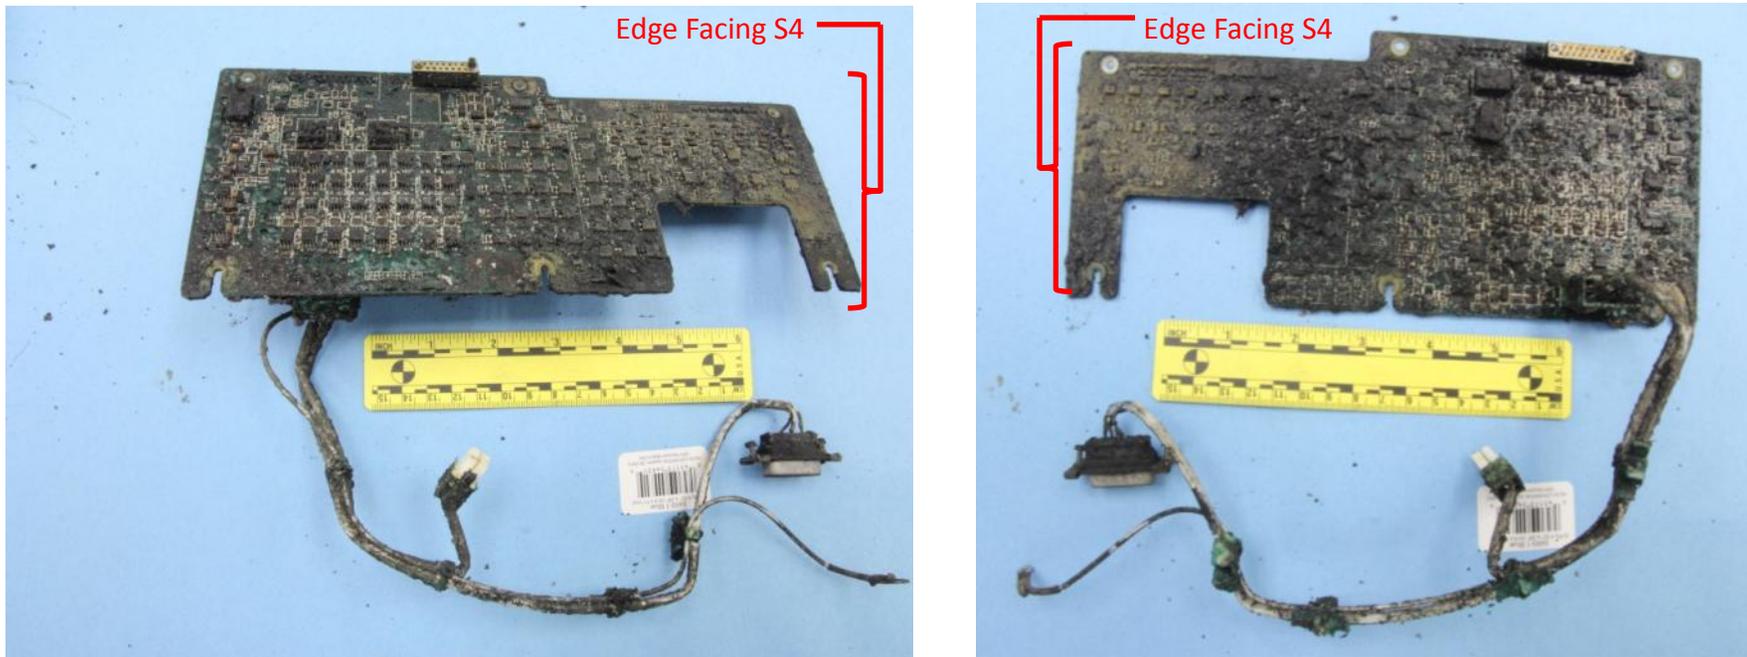
damage (Figure 35). Overall, the thermal damage appeared more severe on the sides of the BMU boards that were closer to the S4 side of the battery box.

Figure 35. Sub-BMU board. The left photo shows the side facing the exterior of the battery box. The right photo shows the side facing the interior of the battery box.

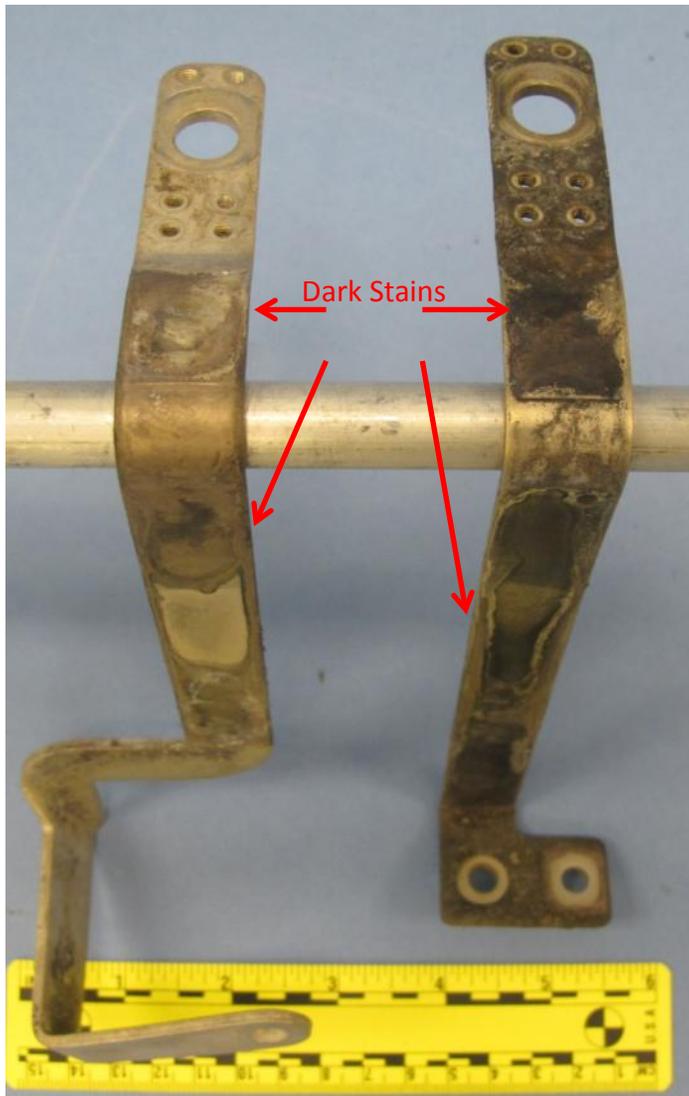
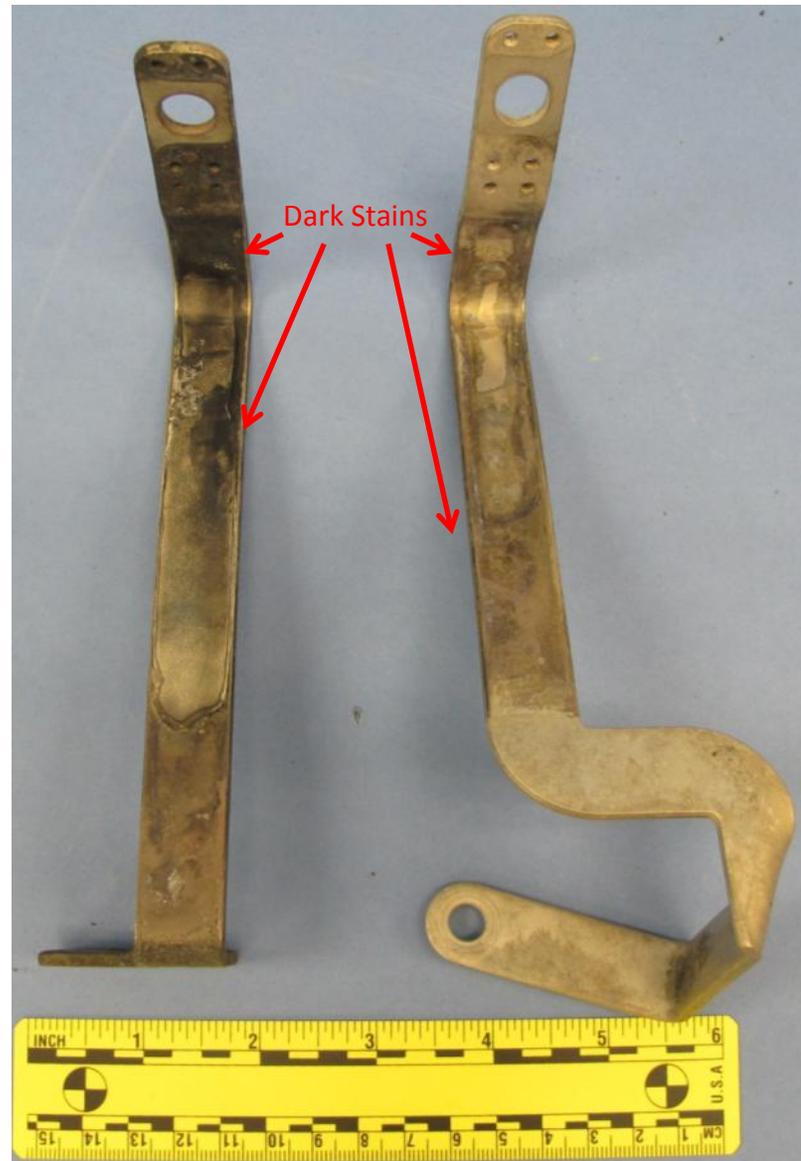
Figure 44. Two views of the C1-J3 and C8-contactor busbars.

The elastomeric insulators on the C1-J3 and C8-contactor busbars were removed to expose the surfaces of the busbars underneath, as demonstrated in Figure 44. In a number of places, the insulation adhered to the busbar surface, leaving a film of elastomer on the surface of the busbar. The surfaces under the insulation were stained, consistent with exposure to heat inside the battery box during the fire. No dark oxides or interference colors associated with high-temperature resistive heating were observed on surfaces of the C1-J3, C8-contactor, or contactor-J3 busbars.

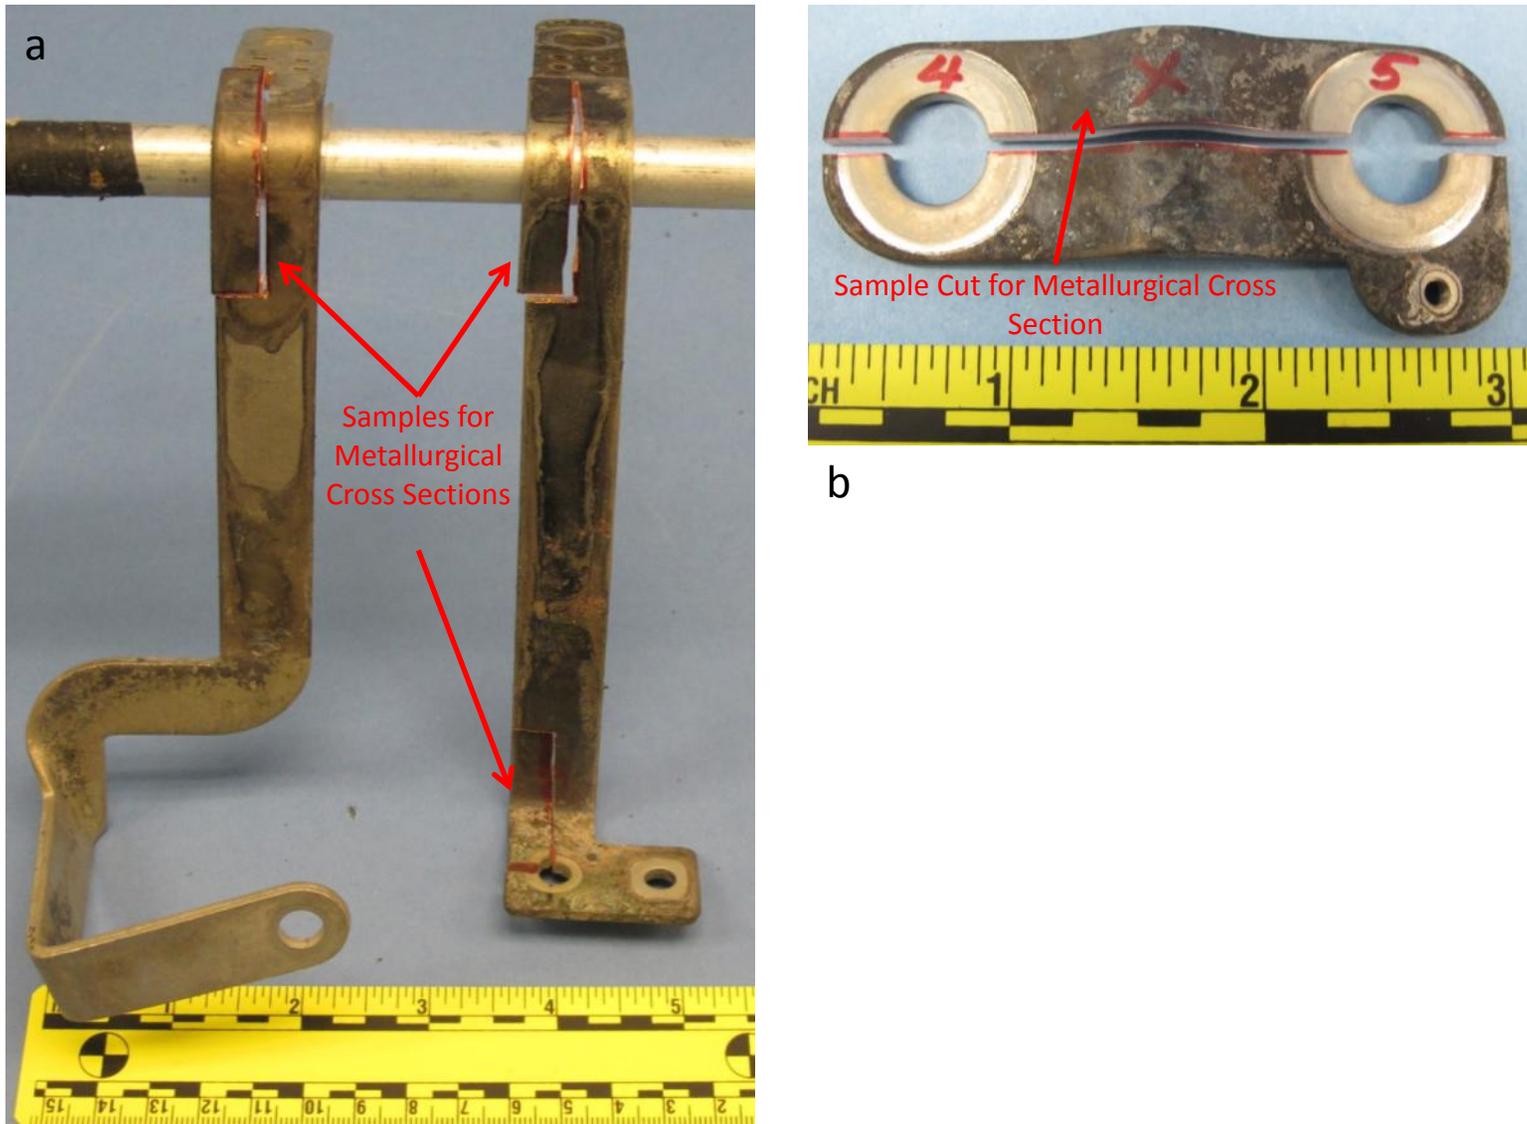
Metallurgical cross sections of some of the busbars were prepared in order to facilitate microhardness testing and microstructural evaluation. Figure 45 (a) shows the sections taken of the 90° bends closest to the battery terminals for the C1-J3 and C8-contactor busbars. Figure 45 (b) shows the section of the C4-C5 busbar. The cross sections were mounted, polished, and microhardness tested in accordance with ASTM E384 - 11e1.⁶ The locations of the microhardness indentations are displayed on Figure 46 and Figure 47. The mounted samples were then microetched in accordance with ASTM E407 - 07e1.⁷ No microstructural changes, such as grain growth associated with localized heating, were observed.

Figure 45. Sections of components from (a) C1-J3 and C8-contactor and (b) C4-C5 busbar.

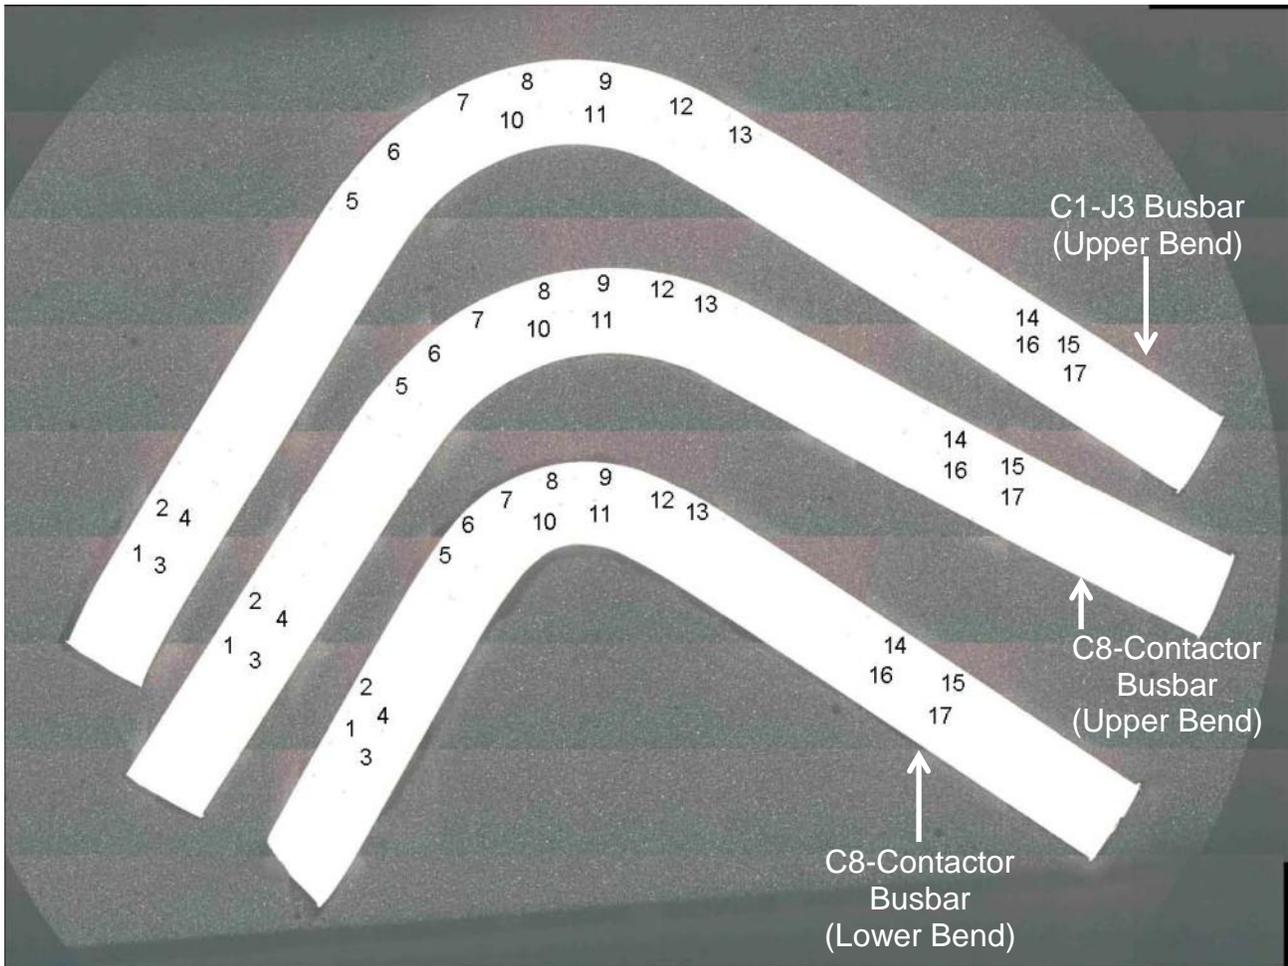
Figure 47. Microhardness indentation locations of the C1 J3 and C8 contactor busbars.

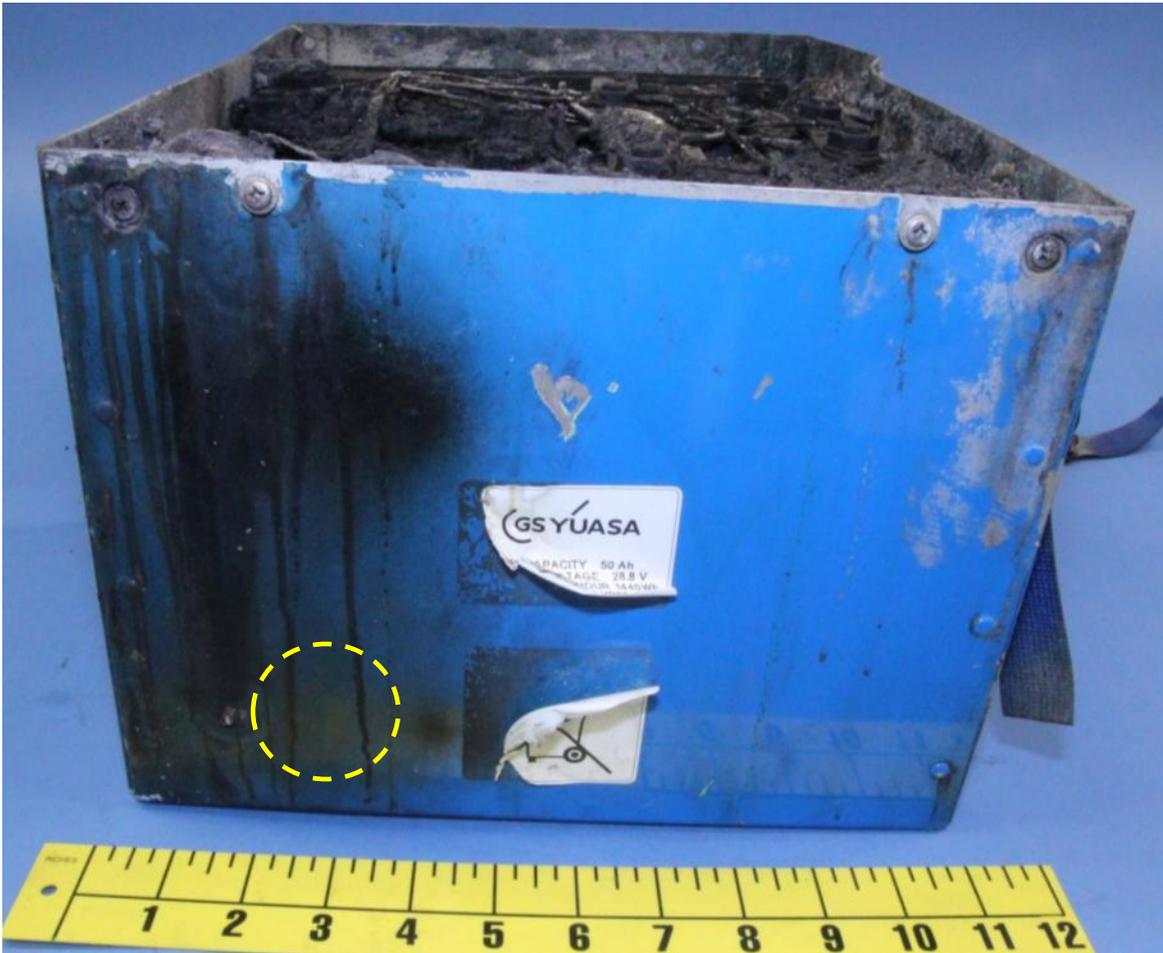
Figure 48. S3 of the exterior of the battery box. The highlighted area shows the small protrusion on the lower left side. This area is magnified in Figure 49.

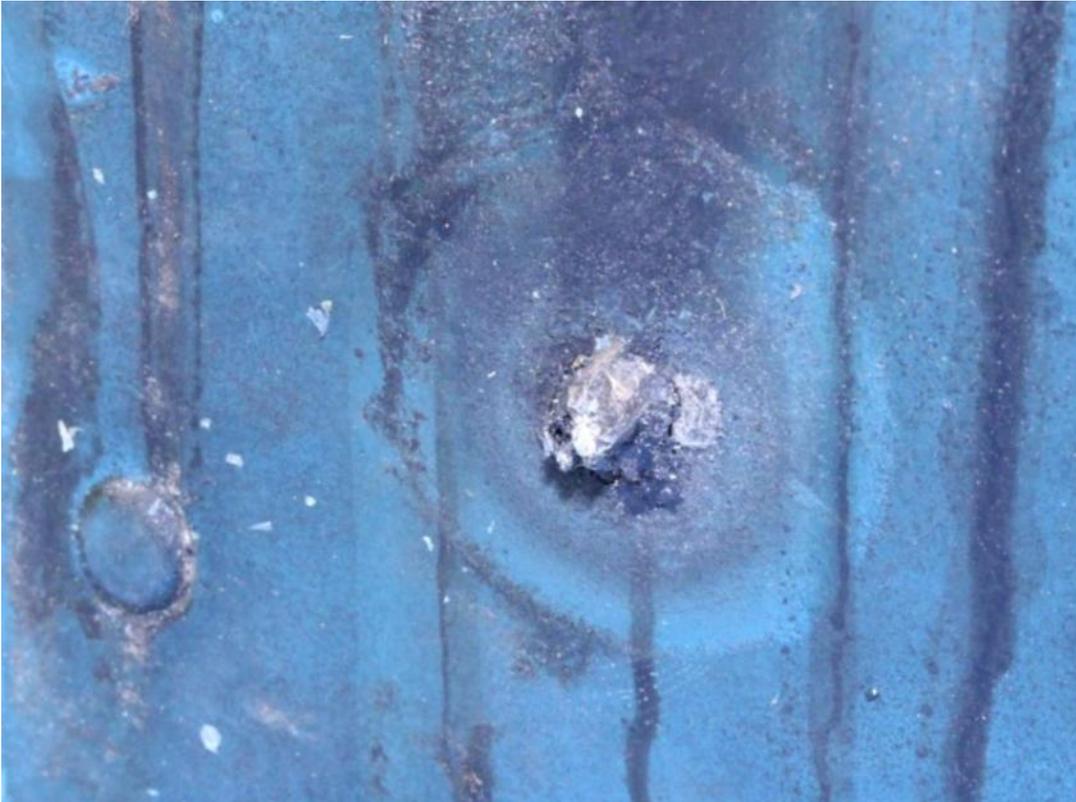
Figure 49. The protrusion from the exterior of S3 of the battery box, as received.

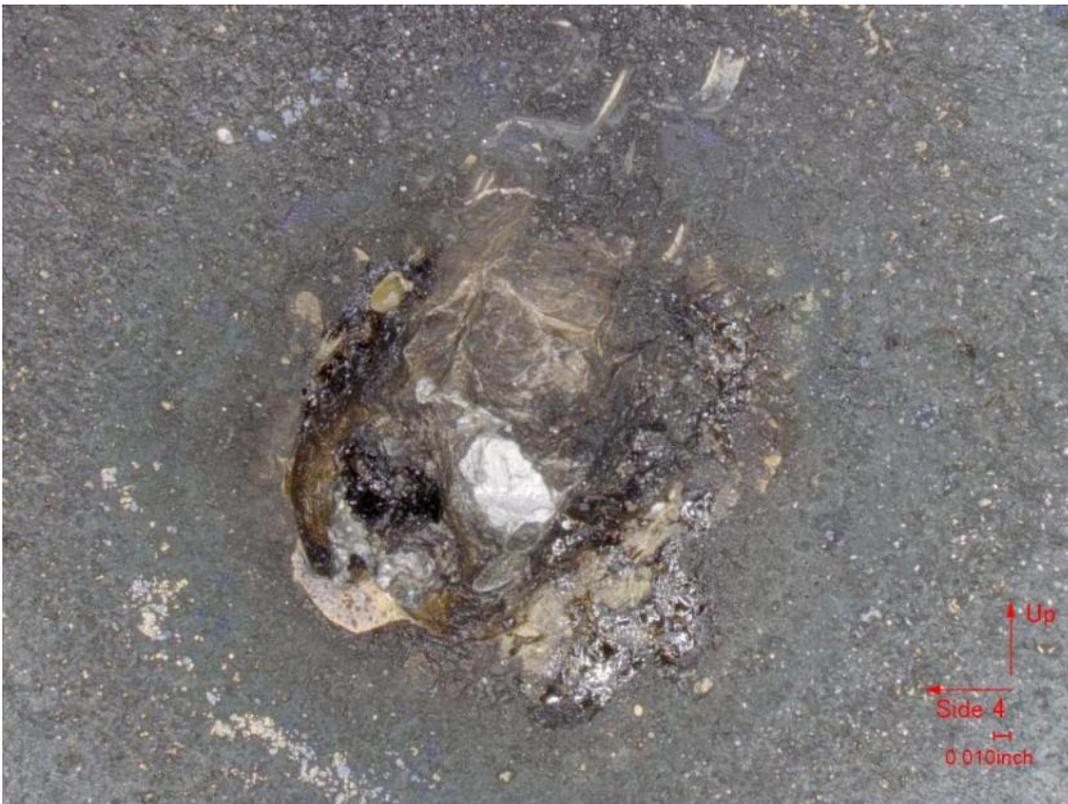
Figure 50. Close-up view of the protrusion on the battery box exterior, as received (~200X).

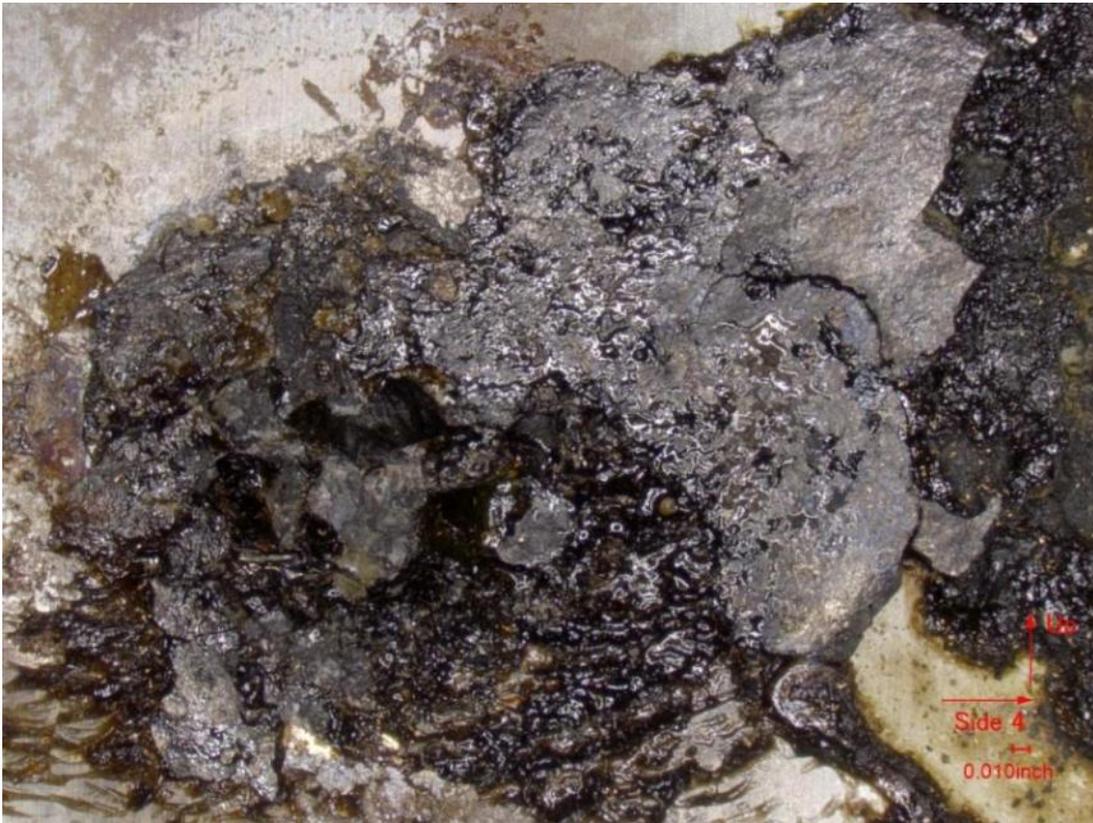
Figure 51. Close-up view of the protrusion on the battery box interior, as received (~200X).

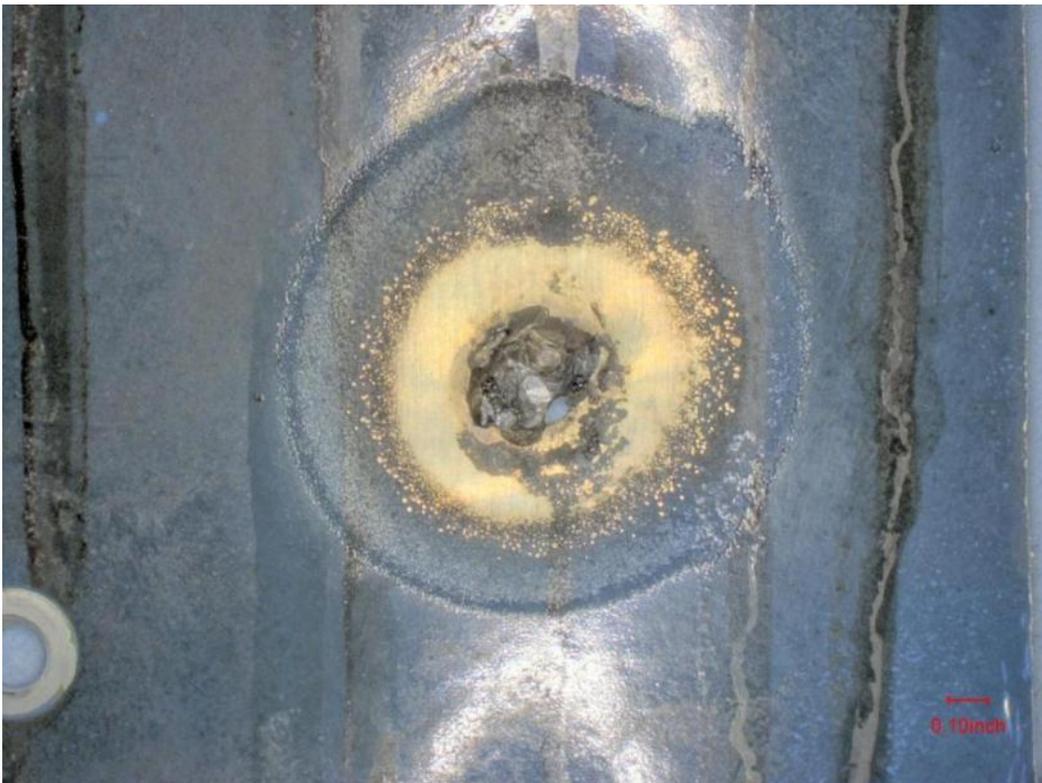
Figure 52. The protrusion on the exterior of the battery box, after cleaning (~50X).

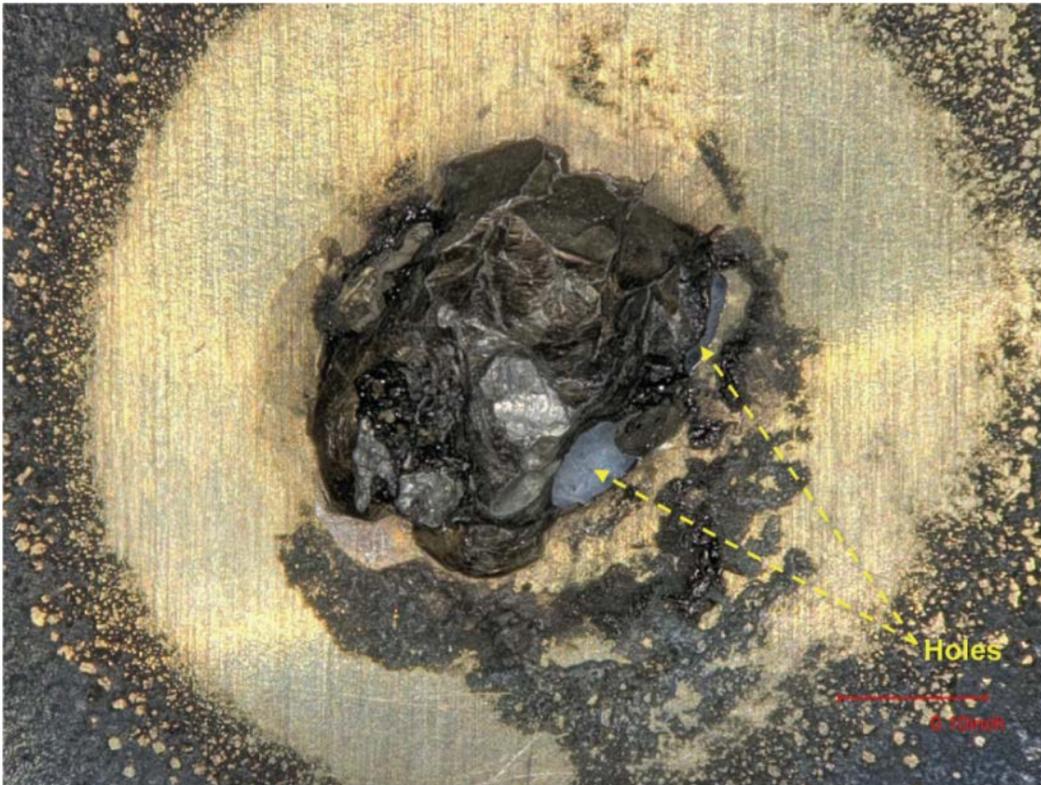
Figure 53. The protrusion on the exterior of the battery box, after cleaning (~200X). The largest holes (arrows) are labeled and exhibit a light-blue color from the backing paper used during photographing.
