NATIONAL TRANSPORTATION SAFETY BOARD

MATERIALS LABORATORY FACTUAL REPORT

Report No. 13-013

Place : Boston, Massachusetts
Date : January 7, 2013
Vehicle : Boeing 787, Registration JA829J
NTSB No. : DCA13IA037
Investigator-in-Charge : David Helson

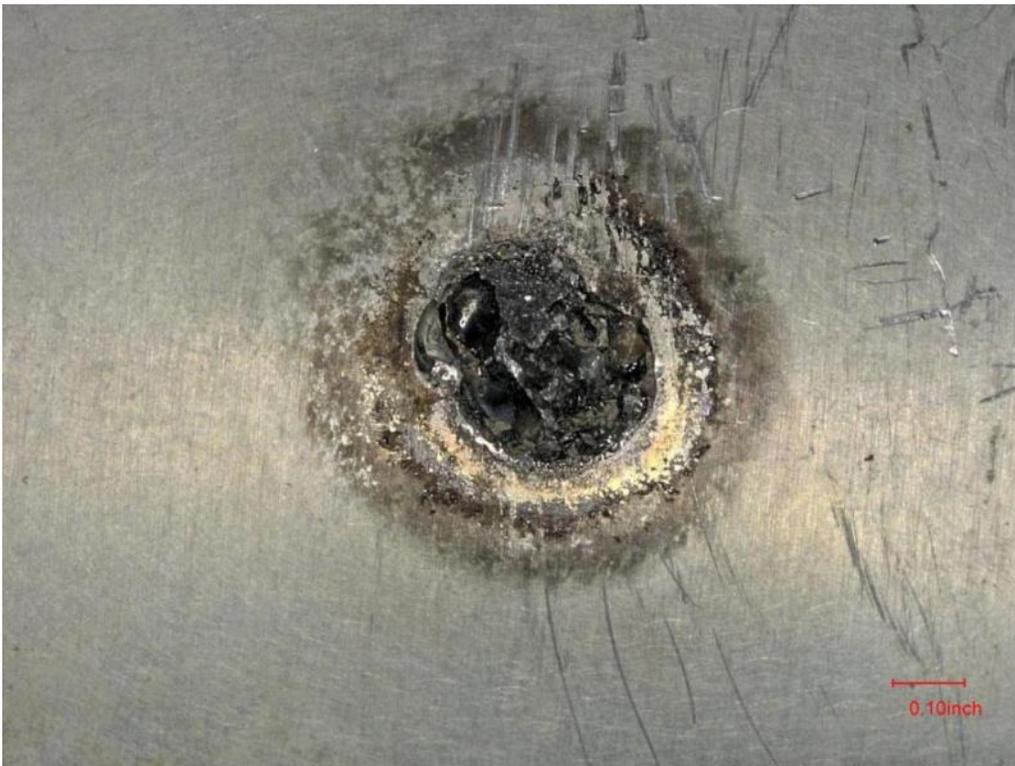
Figure 54. The protrusion on the interior of the battery box, after cleaning (~200X).

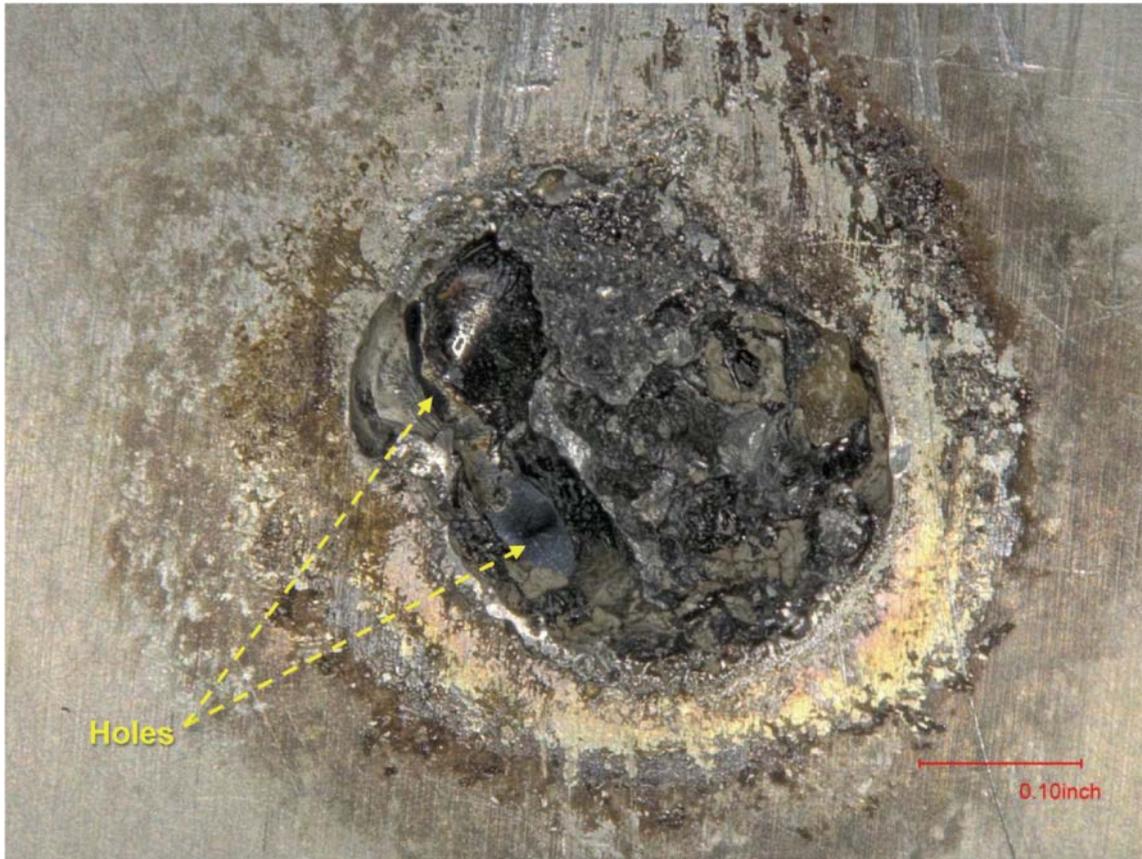
Figure 55. The protrusion on the interior of the battery box, after cleaning (~200X). The largest holes (arrows) are labeled and exhibit a light-blue color from the backing paper used during photographing.

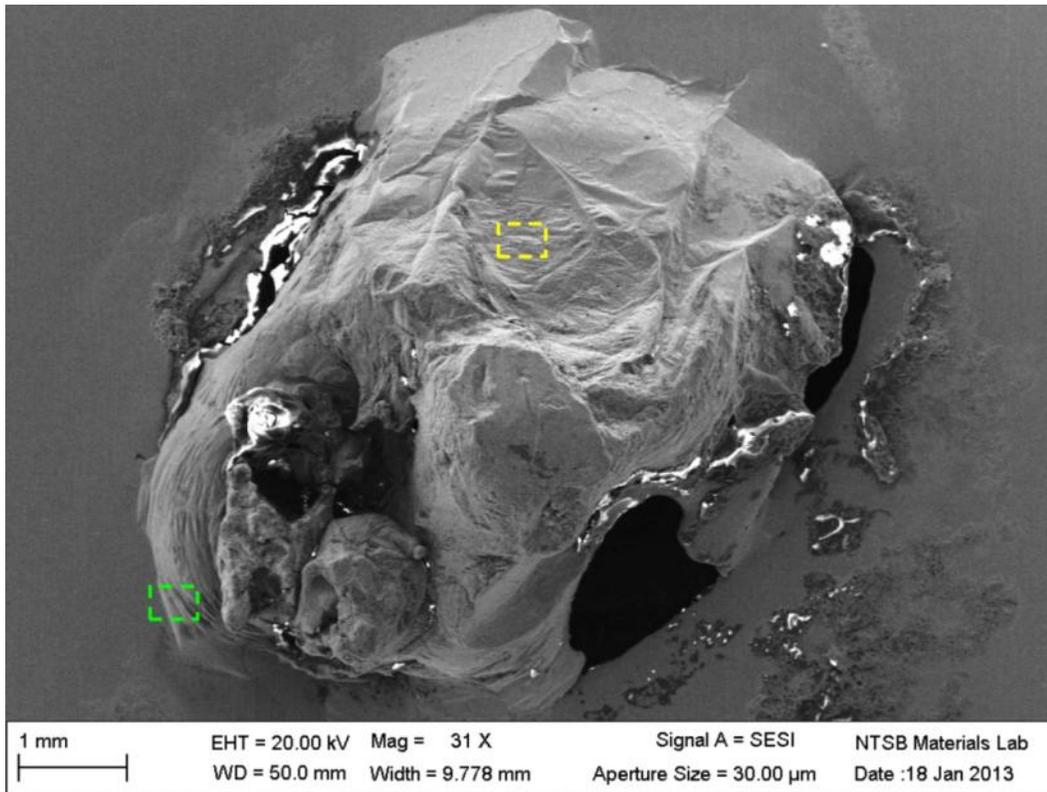
Figure 56. SEM micrograph of the protrusion from the exterior. The yellow boxed area is highlighted in Figure 57, and the green boxed area is highlighted in Figure 58.

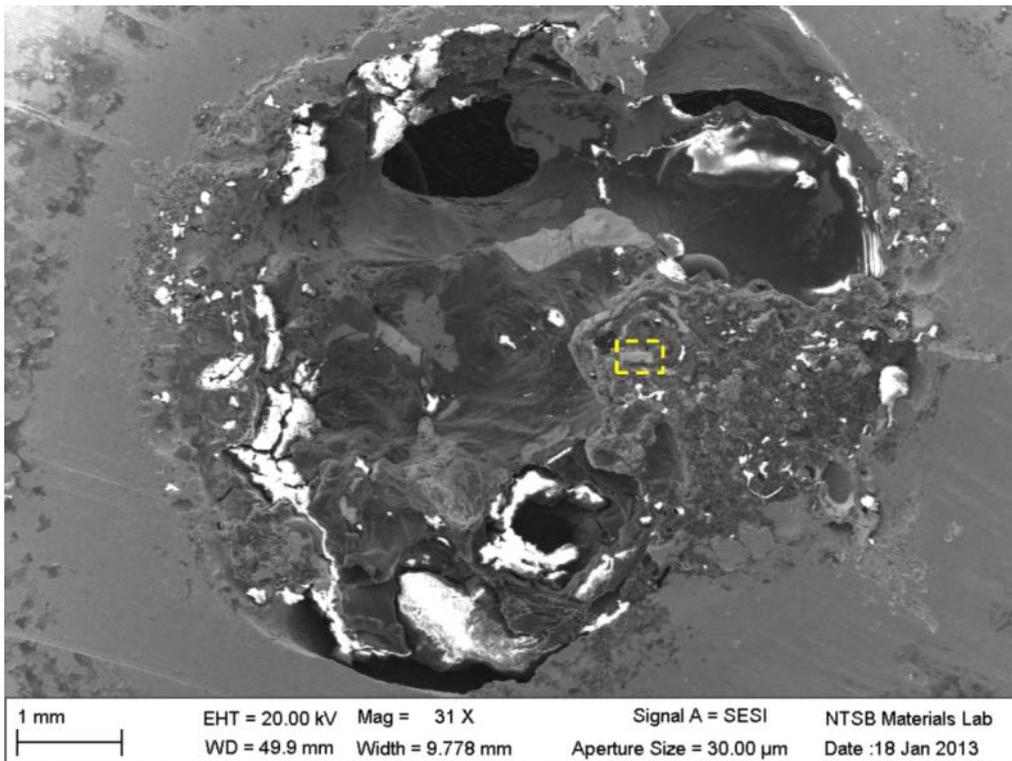
Figure 59. SEM micrograph of the protrusion from the interior. The boxed area is highlighted in Figure 60.

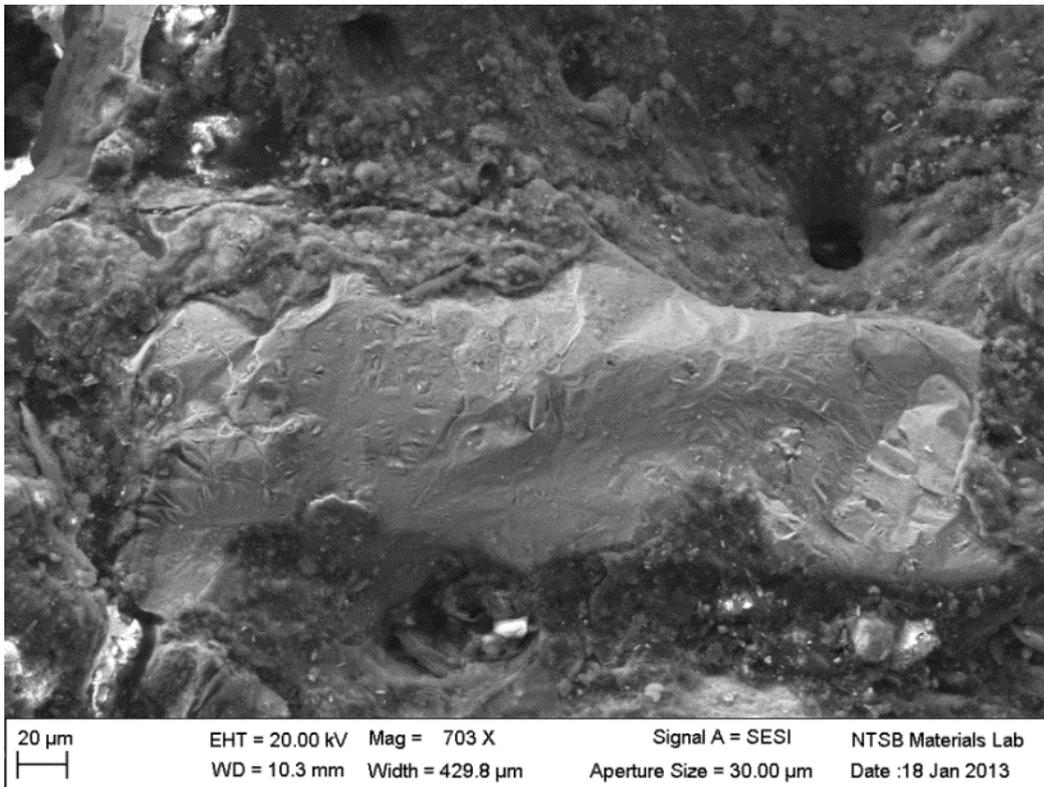
Figure 60. SEM micrograph of an embedded iron-based compound, showing reticulation consistent with solidification.

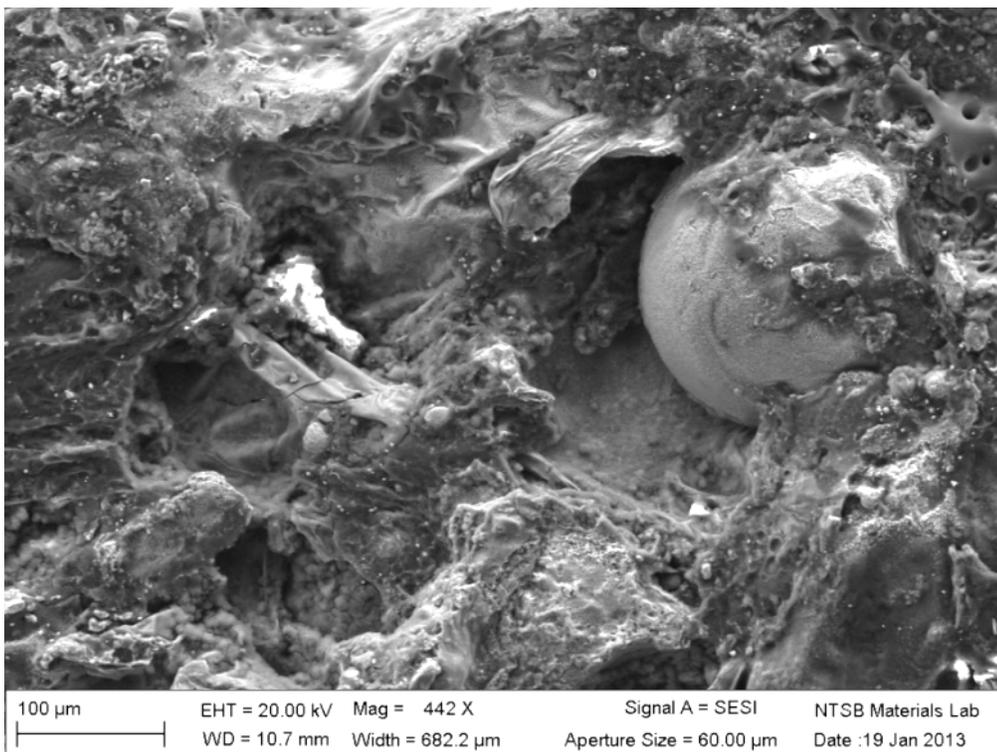
during cooling. There were a variety of spherical particles found embedded in the combustion compounds in hole 1 (see Figure 66). The composition of the spheres was consistent with the cell case material (stainless steel). Spherical particles on or near resolidified areas is consistent with the melting, separation, and solidification processes typical of electric arc damage. For reference, the temperatures that would be required to melt aluminum alloys are in excess of 1250° F, while those required to completely melt this stainless steel alloy are typically in excess of 2700° F.

Figure 66. SEM micrograph of steel sphere embedded in combustion products in the interior of hole 1 on the C5 cell case.

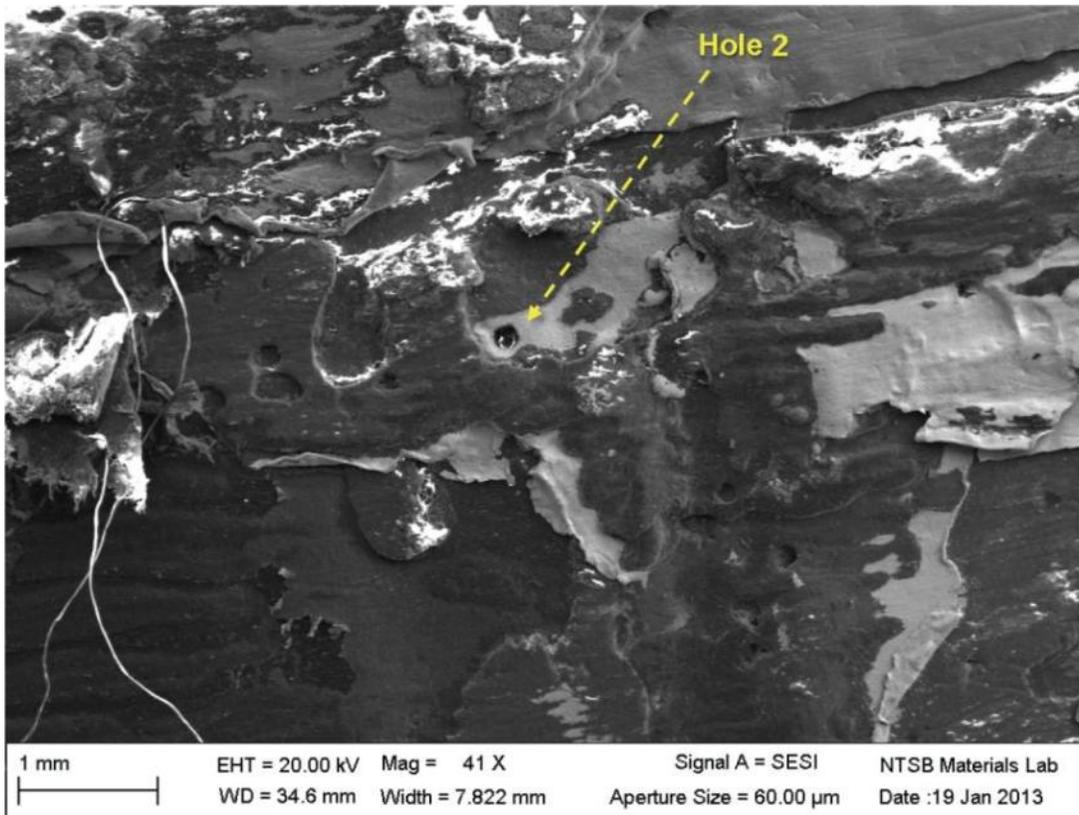
Examination of the three other holes on the C5 cell case revealed similar results. Figure 67 and Figure 68 display holes 2 and 3, respectively, from the interior of the case. Of note was the spherical globule located near hole 3 on the exterior of the case. The globule was consistent with type 304 stainless steel, and it exhibited a reticulated surface pattern. The case material was wrinkled near hole 3. There were also indications of metallization “splats” of aluminum alloy near the hole (Figure 69). The flattened shape of this metallization is consistent with the case material being near the molten aluminum temperature during deposition. Near hole 4, a depressed lamellar structure was observed in the case material (Figure 70). This surface morphology is consistent with incipient melting of the material, which occurs at temperatures high enough to cause some of the alloy constituents to liquefy.⁸

Figure 67. SEM micrograph of hole 2, from the interior of the C5 cell case.

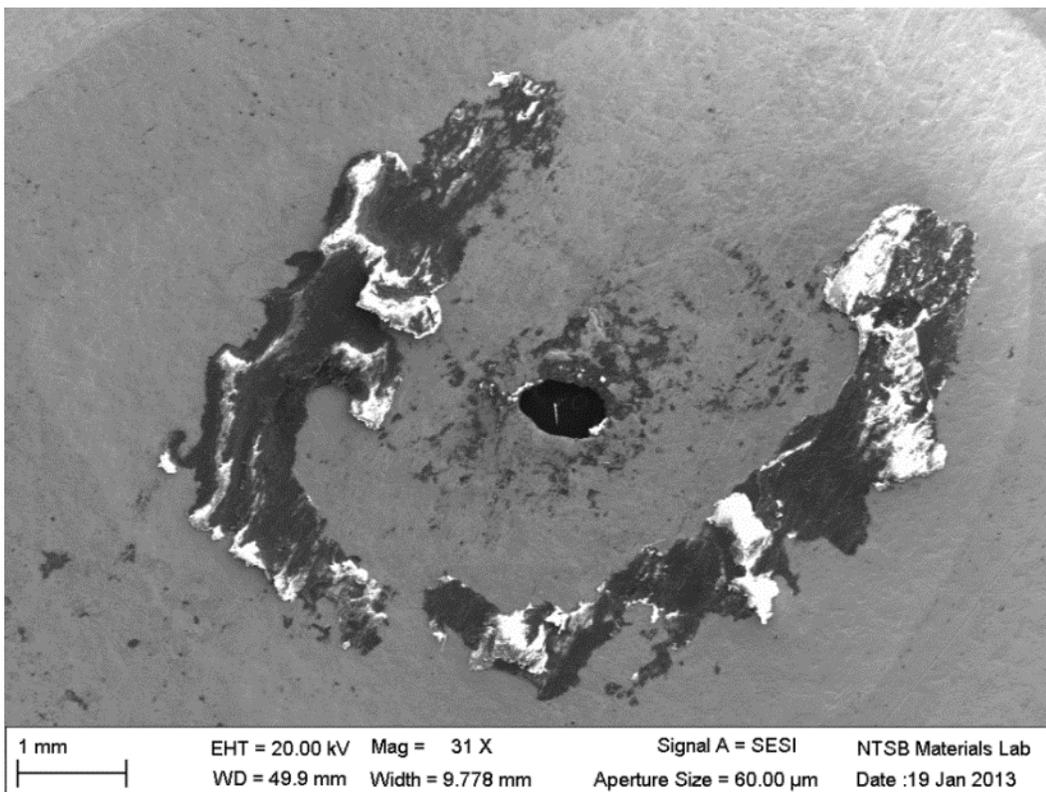
Figure 68. SEM micrograph of hole 3, from the interior of the C5 cell case.

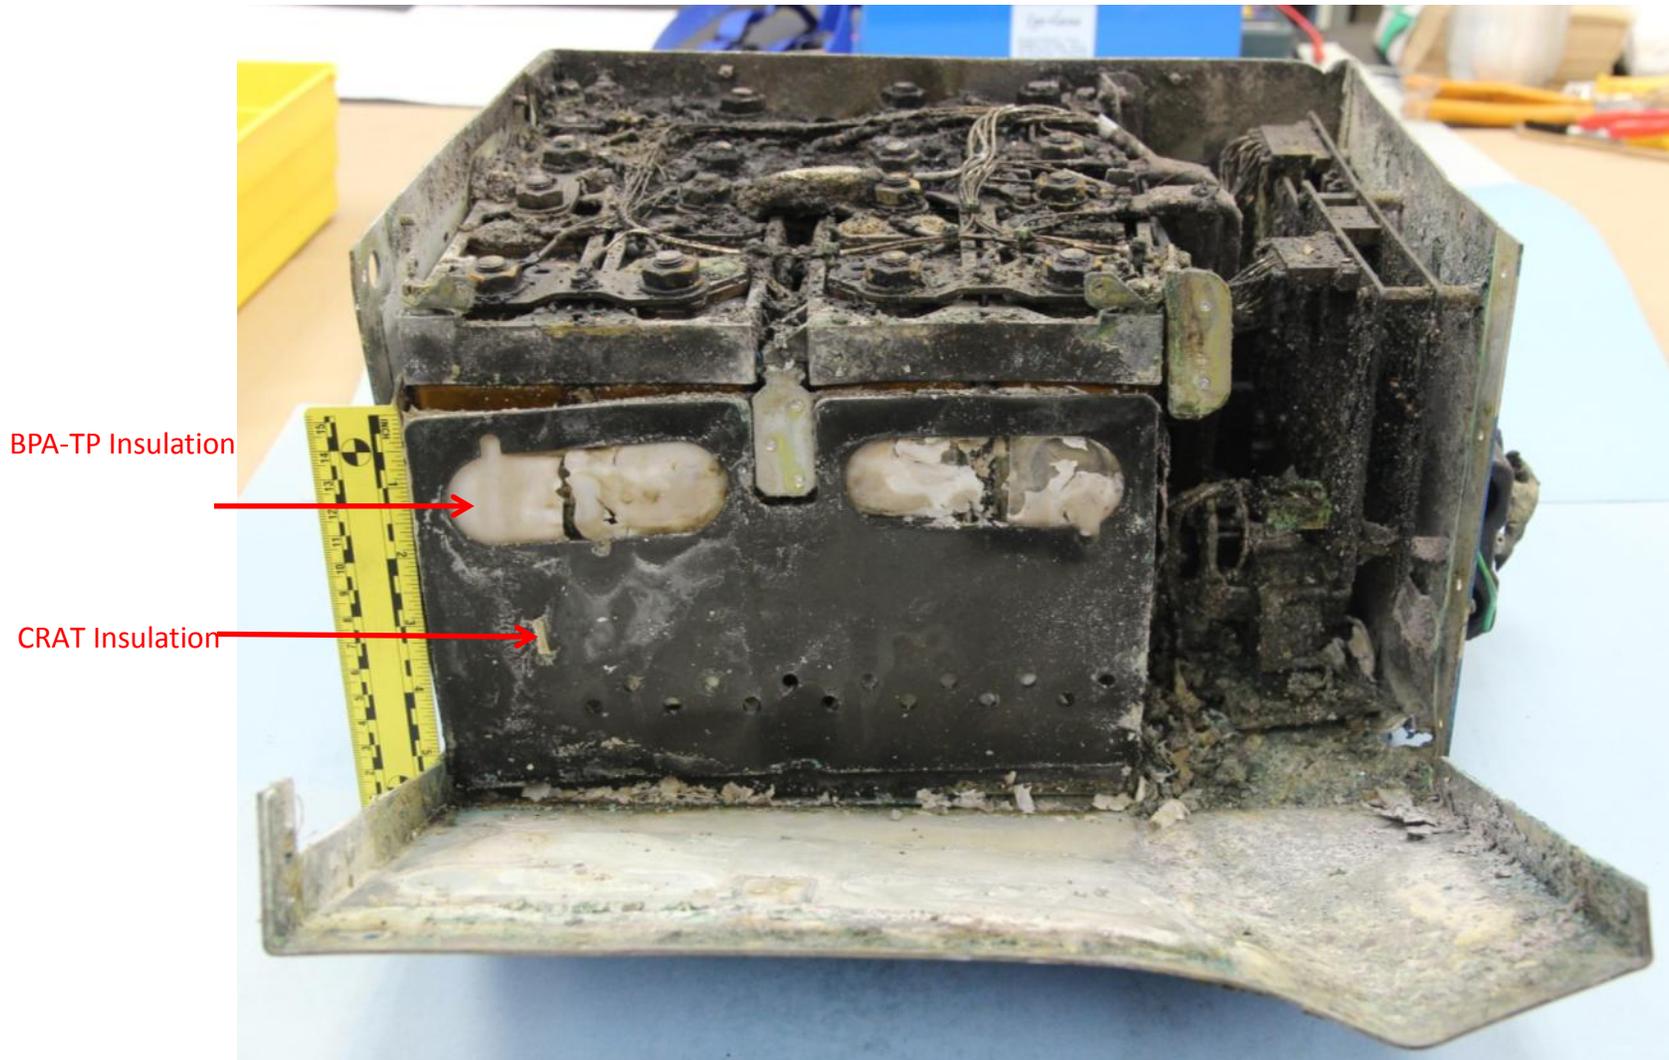
Figure 84. S2 folded down.

Figure 84 shows the appearance of the insulation on S2 of the battery pack after the side was peeled down. The outermost insulation layer, consisting of a black sheet of CRAT with oval cutouts for the C1 and C2 and the C3 and C4 vents, remained structurally intact. Fragments of white BPA-TP insulation sheath surrounding C1 to C4 can be seen through the cutouts in the CRAT and along the bottom edge of the battery case. The S2 edge of the upper thermoplastic polyester fixation tray appeared structurally intact.

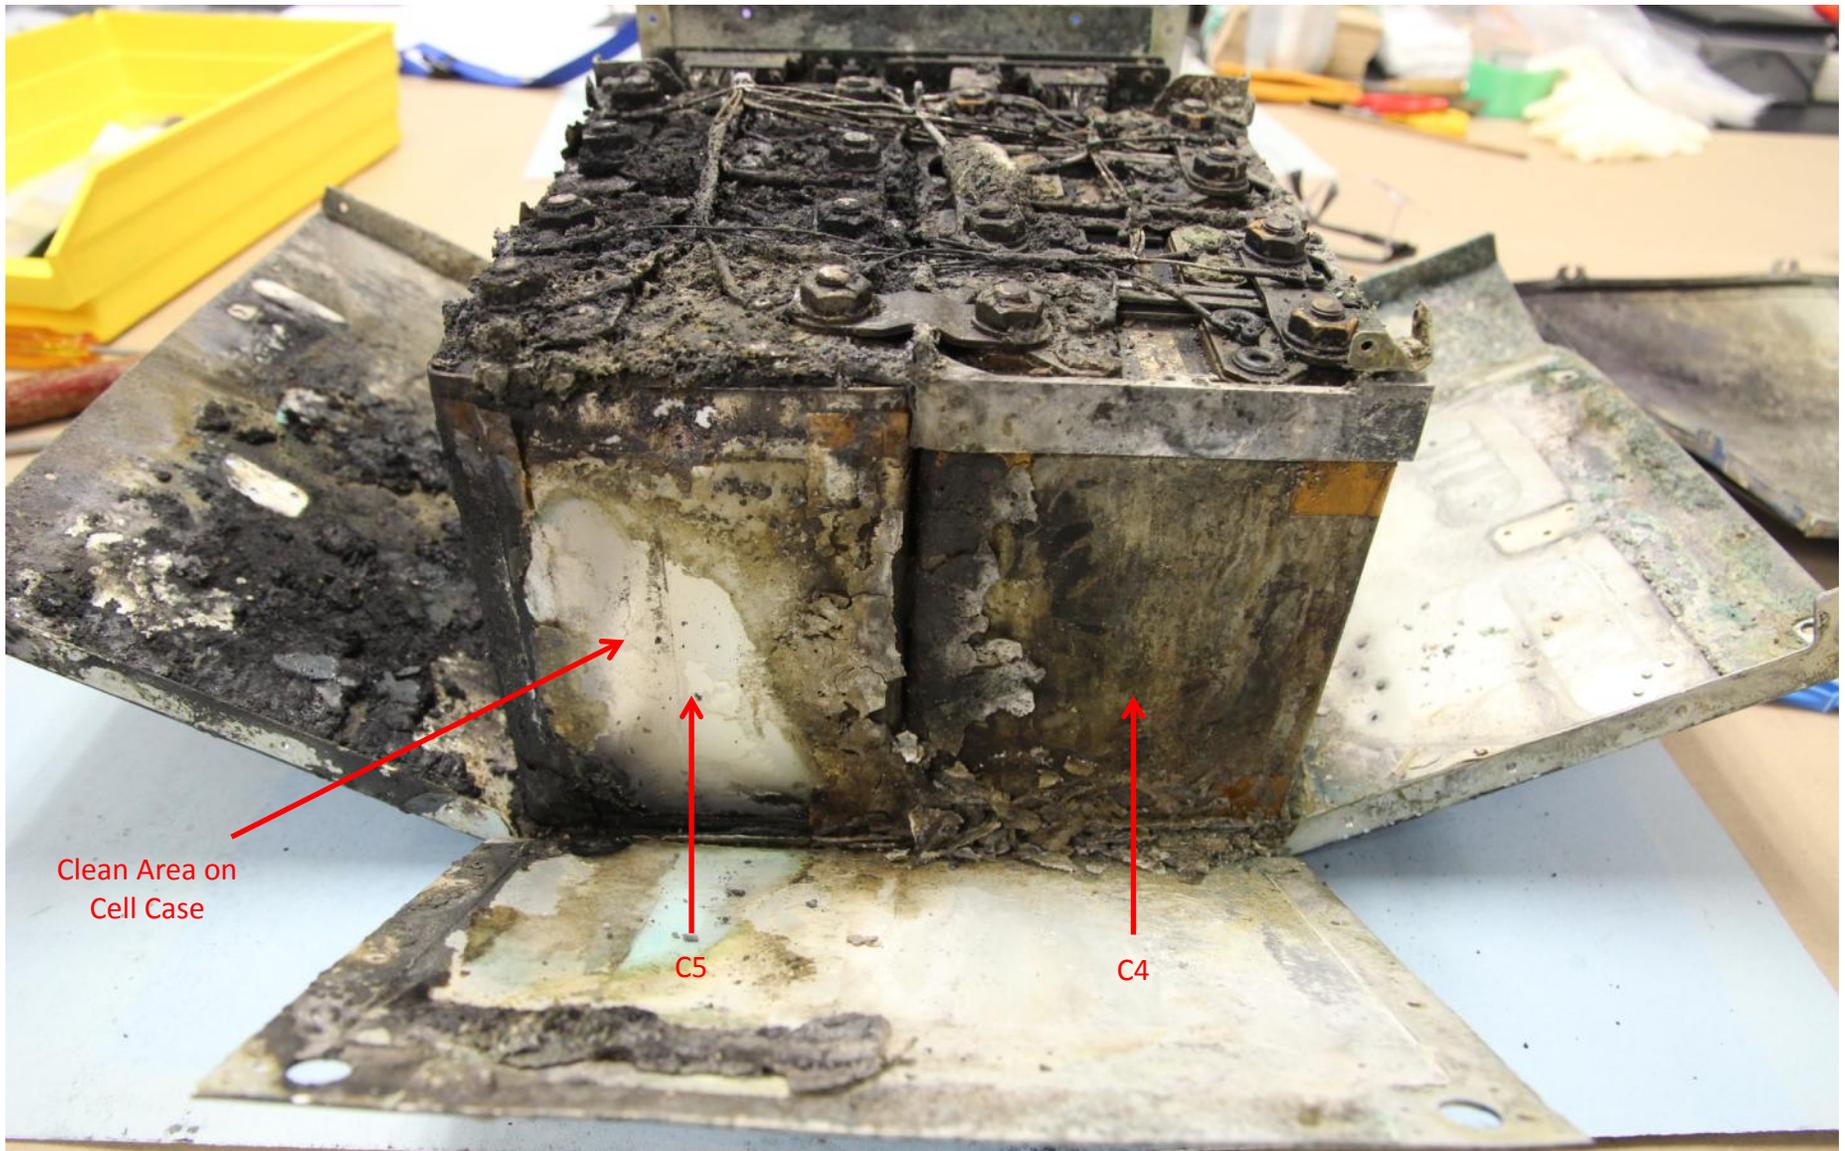
Figure 85. S3 folded down.

Figure 85 shows the condition of the single BPA-TP insulation layer between the cell cases and S3 of the battery box case. Darkened BPA-TP fragments are visible on the bottom of C4. It appeared that C5 sealed itself to the battery box case, but there is no evidence of electrical shorting between the cell and the battery box except at the protrusion in the lower corner, documented in Section F8. The upper fixation tray appears intact along C4 but is no longer present along the S3 edge of C5.

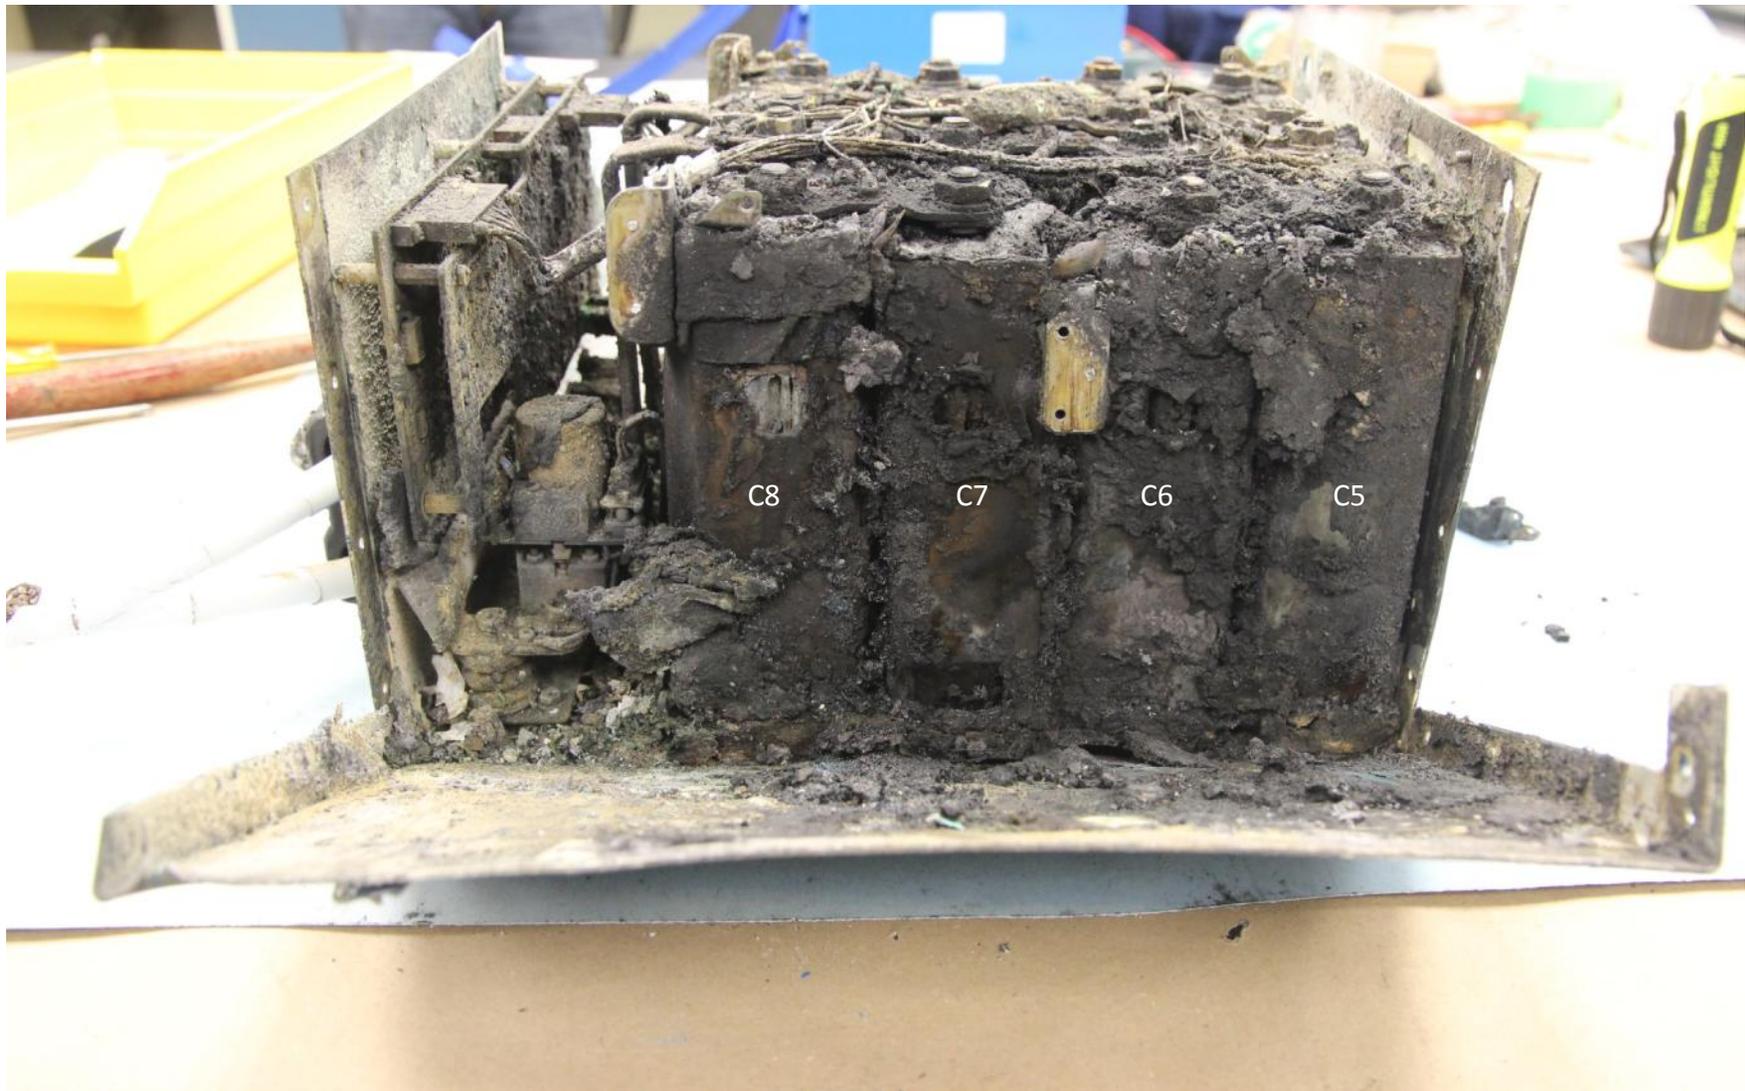
Figure 86. S4 folded down.

Figure 86 shows the condition of the insulation on S4 of the battery pack. The layers of insulation on the side, as well as the majority of the upper and lower fixation trays, were heavily damaged and no longer distinguishable.

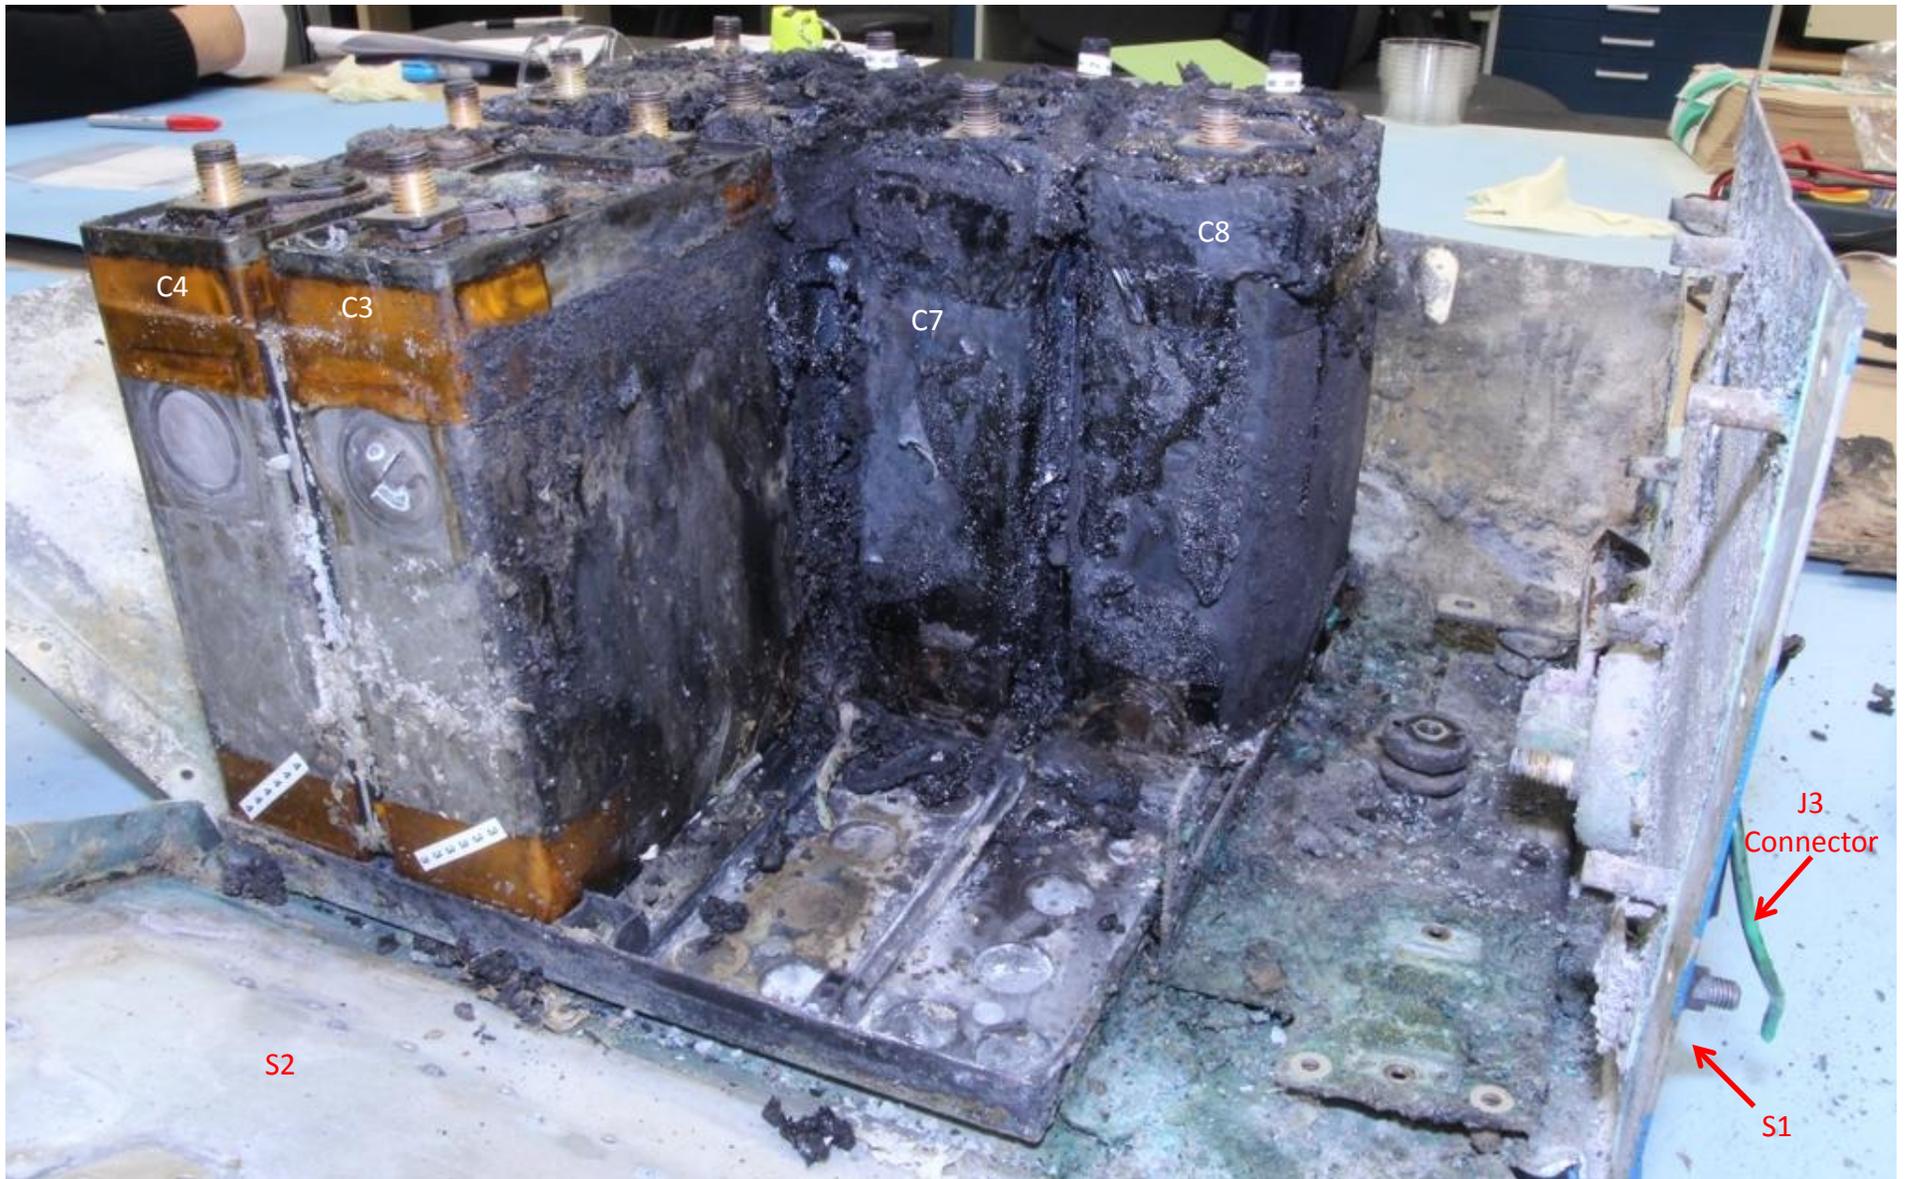
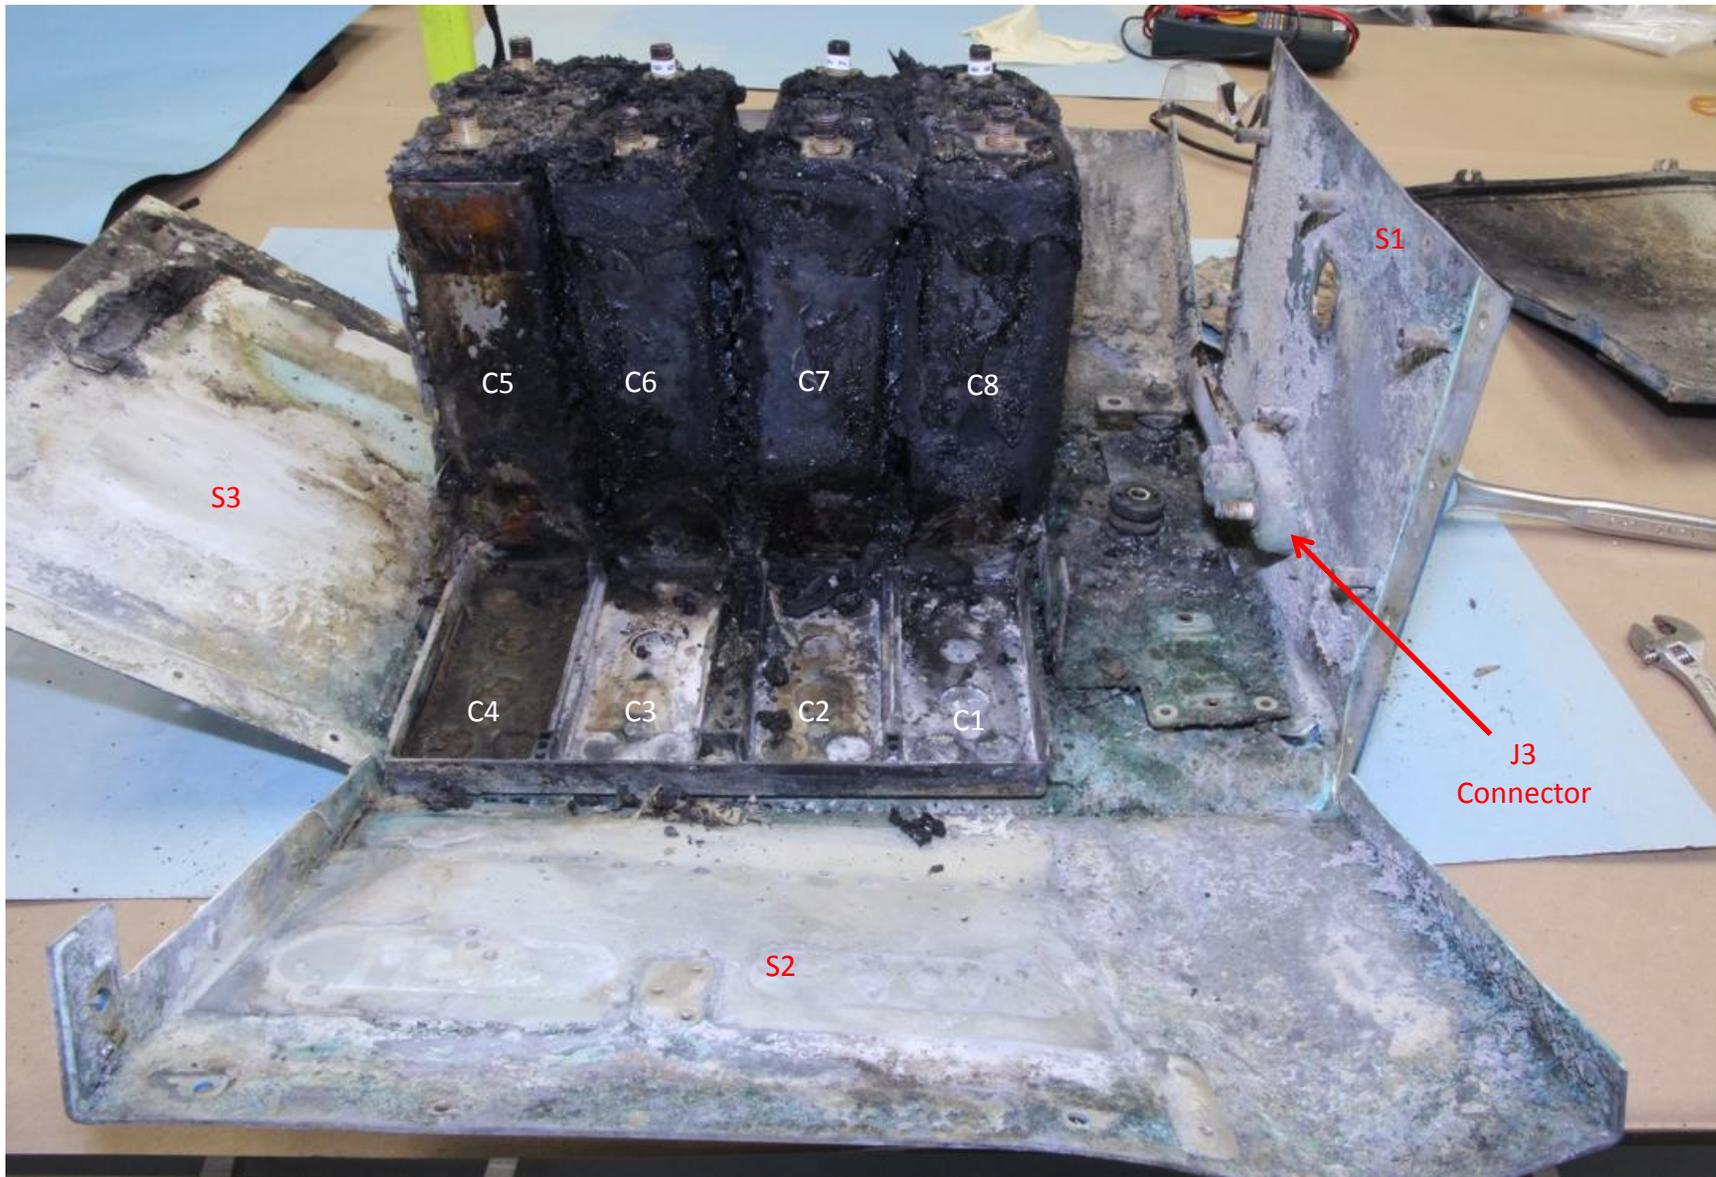
Figure 87 and Figure 88 show the condition of the insulation between the row of C1 through C4 and the row of C5 through C8. Little of the insulation is distinguishable.

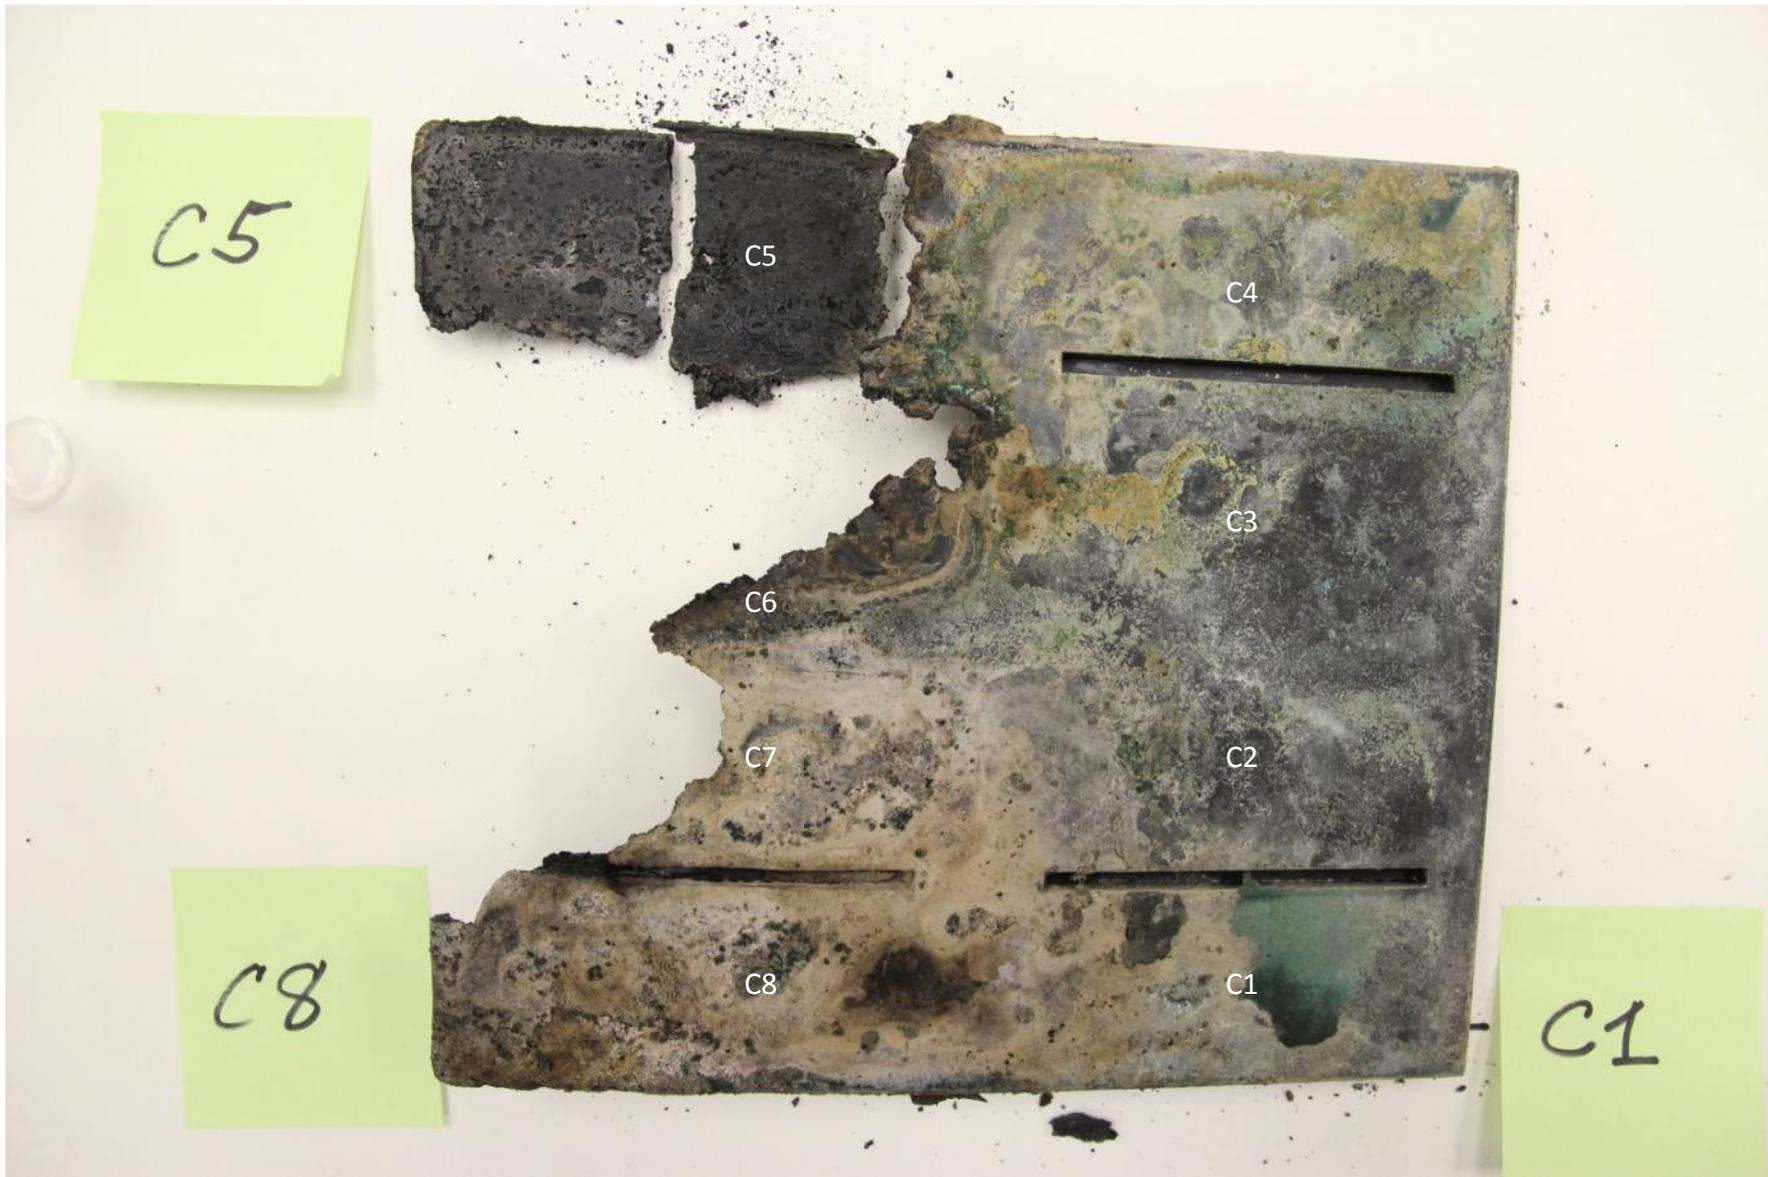
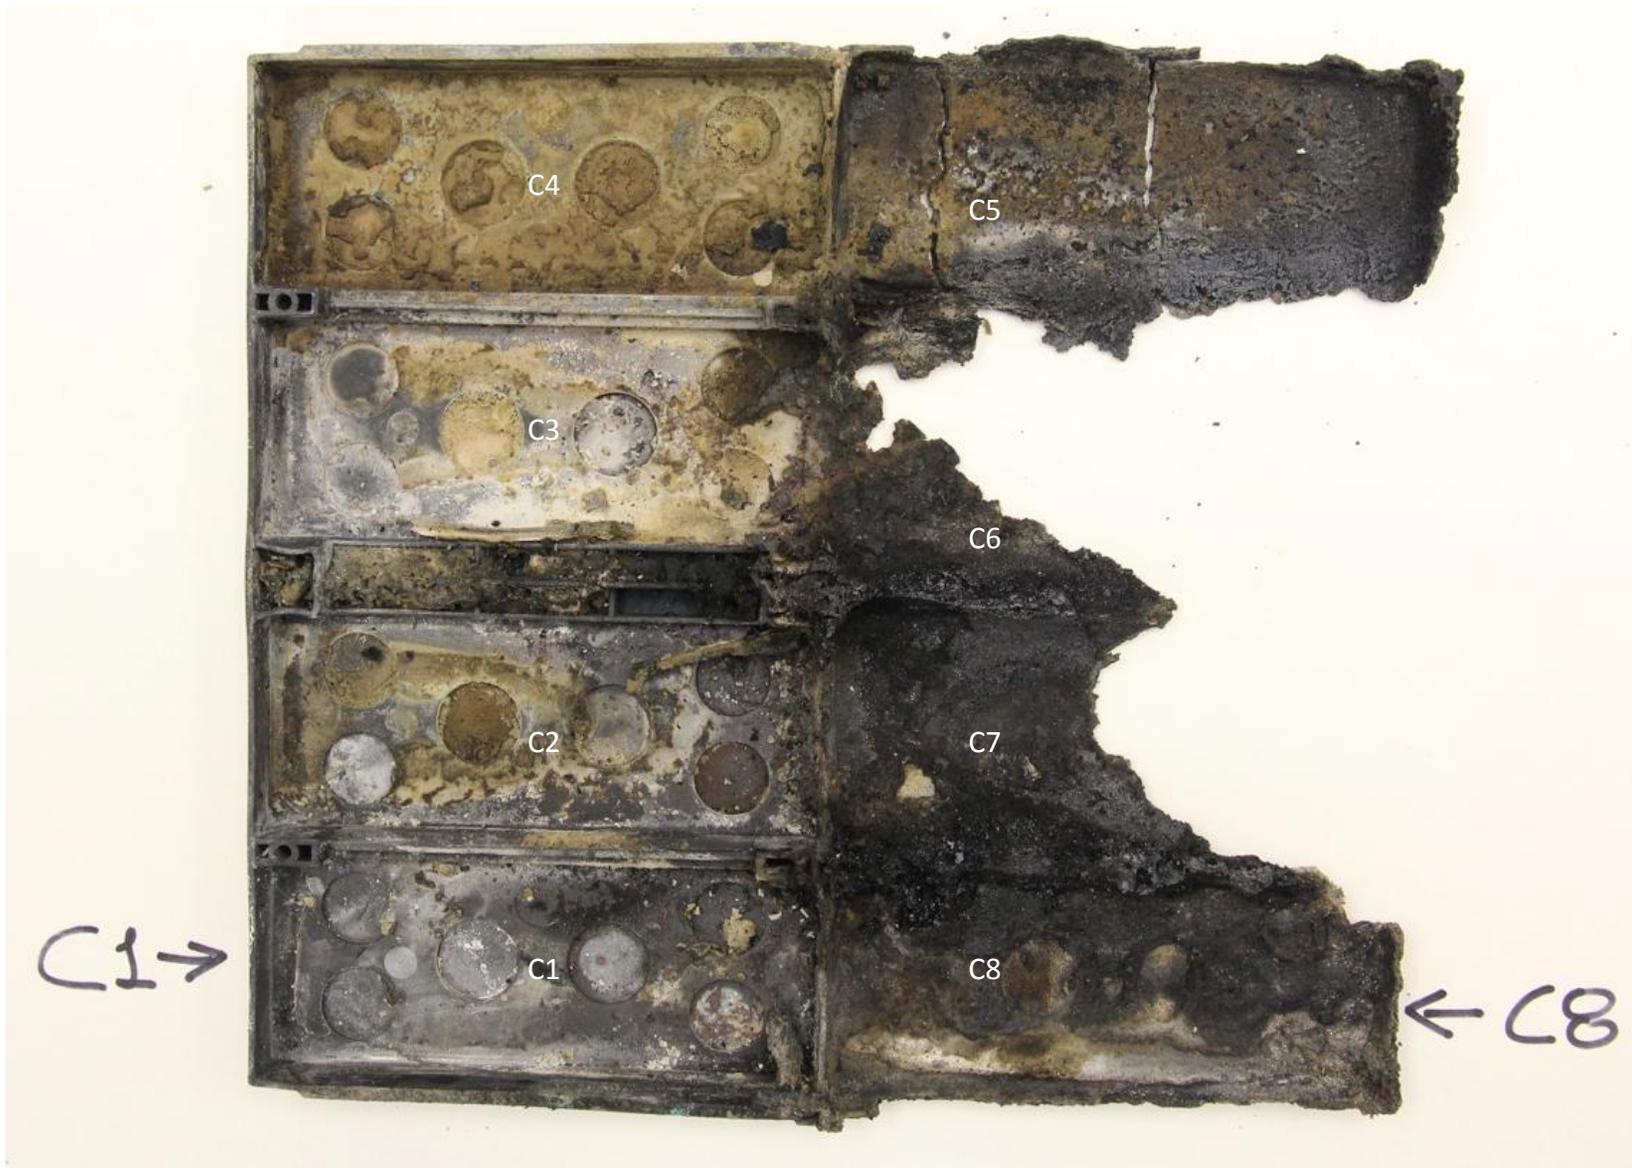
Figure 89 and Figure 90 show the condition of the lower fixation tray. Debris and discoloration consistent with thermal damage was present on the C1 through C4 footprints. The footprints of C5 through C8 were pyrolyzed. Portions of the tray were not readily removed or distinguishable from other debris in the battery box.
