NATIONAL TRANSPORTATION SAFETY BOARD

MATERIALS LABORATORY FACTUAL REPORT

Report No. 13-013

Place : Boston, Massachusetts
Date : January 7, 2013
Vehicle : Boeing 787, Registration JA829J
NTSB No. : DCA13IA037
Investigator-in-Charge : David Helson

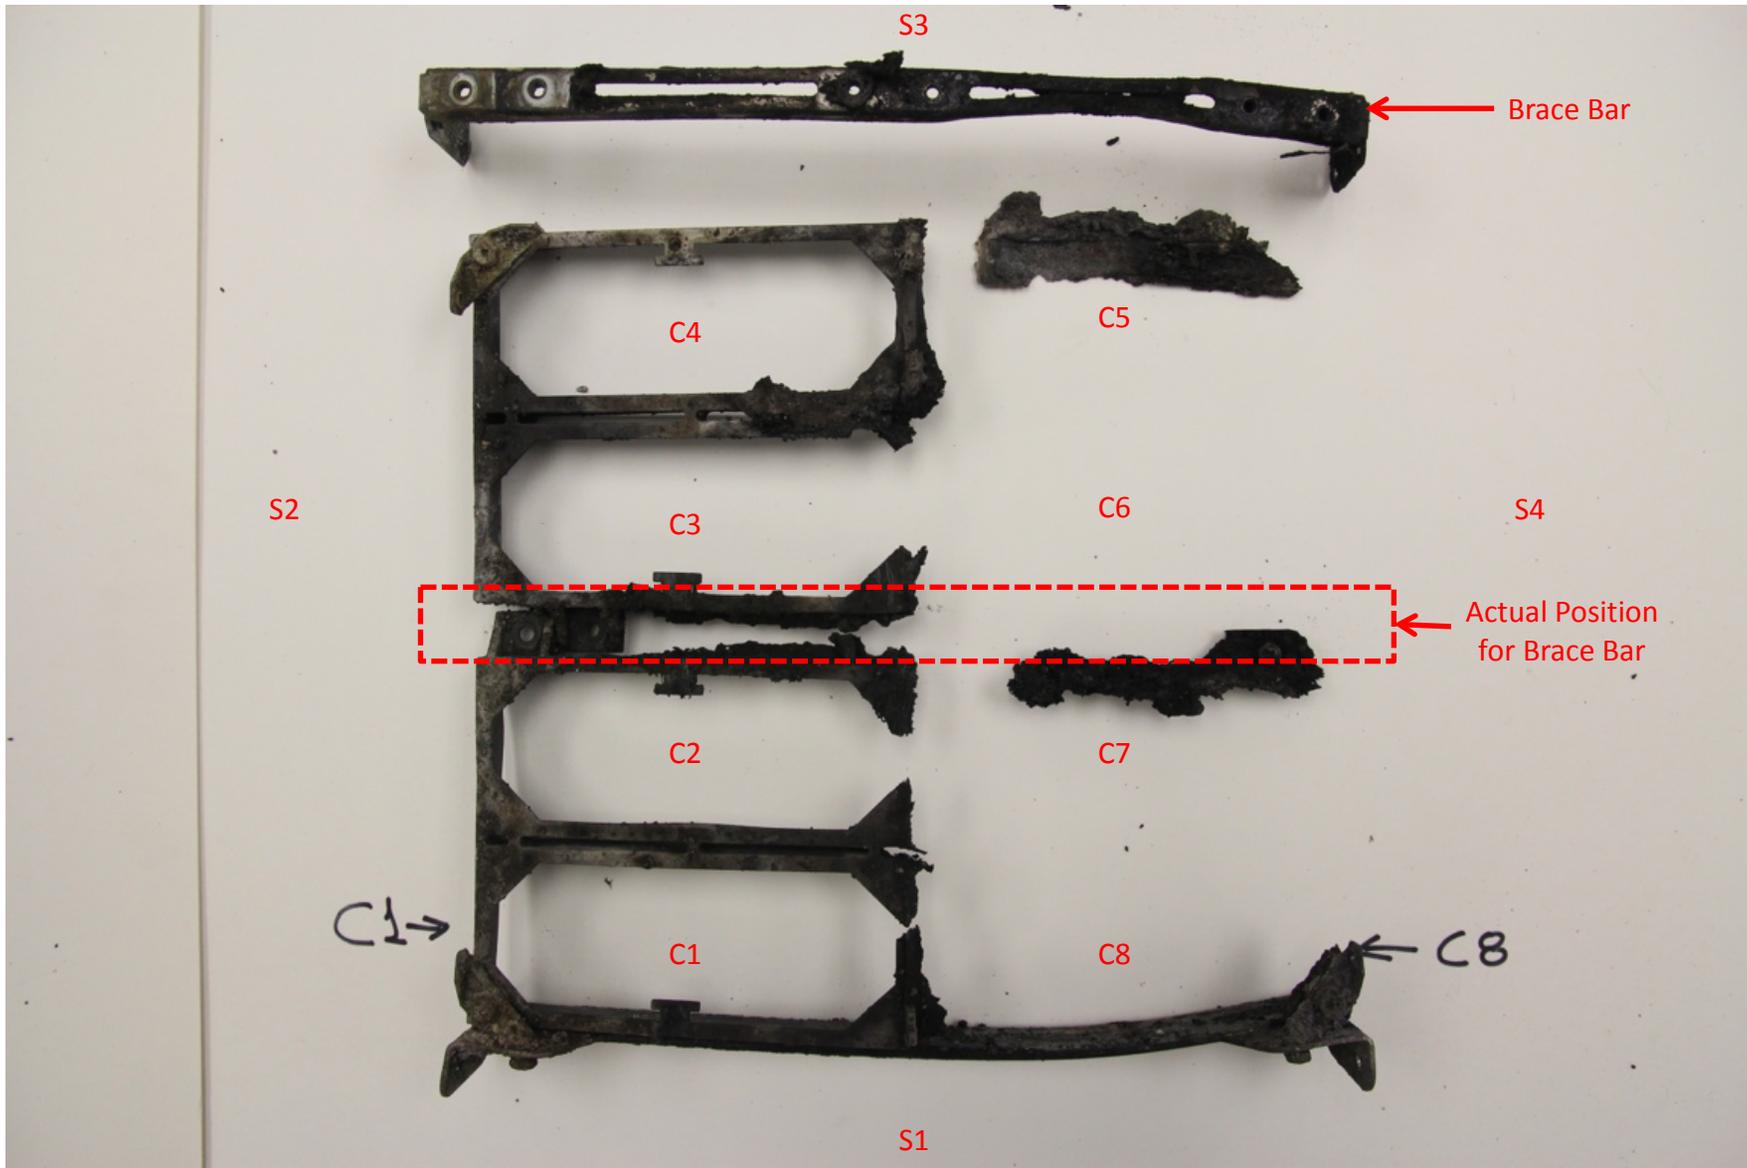
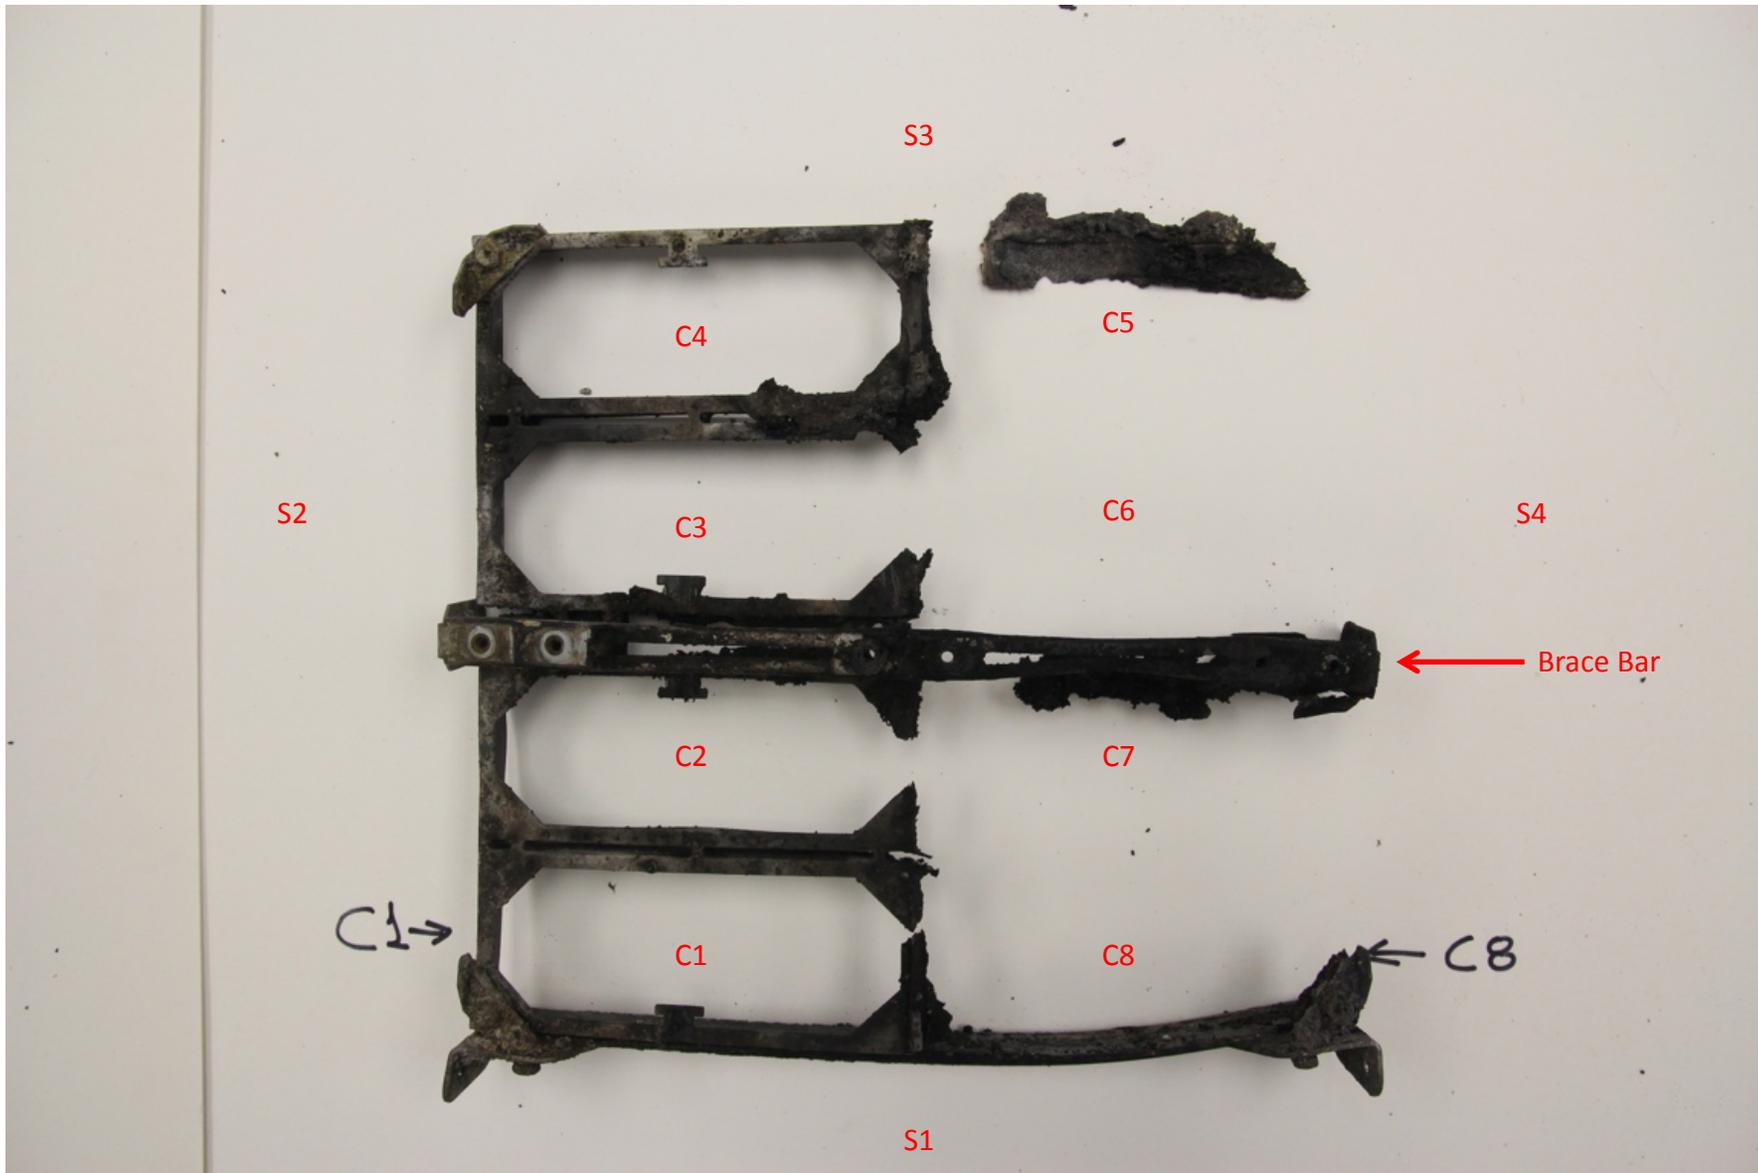
Figure 91 and Figure 92 show the condition of the upper fixation tray. The portions of the tray in contact with C1 through C4 sustained less damage than the portions of the tray in contact with C5 through C8. Debris and discoloration of the tray can be seen on S2. The C4 imprint remained mostly intact, but C1, C2, and C3 showed progressively more damage. Minimal material remained from the C5 through C8 side of the upper fixation tray. Figure 93 documents a damage assessment of the upper fixation tray with a qualitative sliding scale where 10 represents the least damaged and 1 represents the most damaged cell imprints. An assessment of each side of the aluminum brace spanning the middle of the battery is also included.

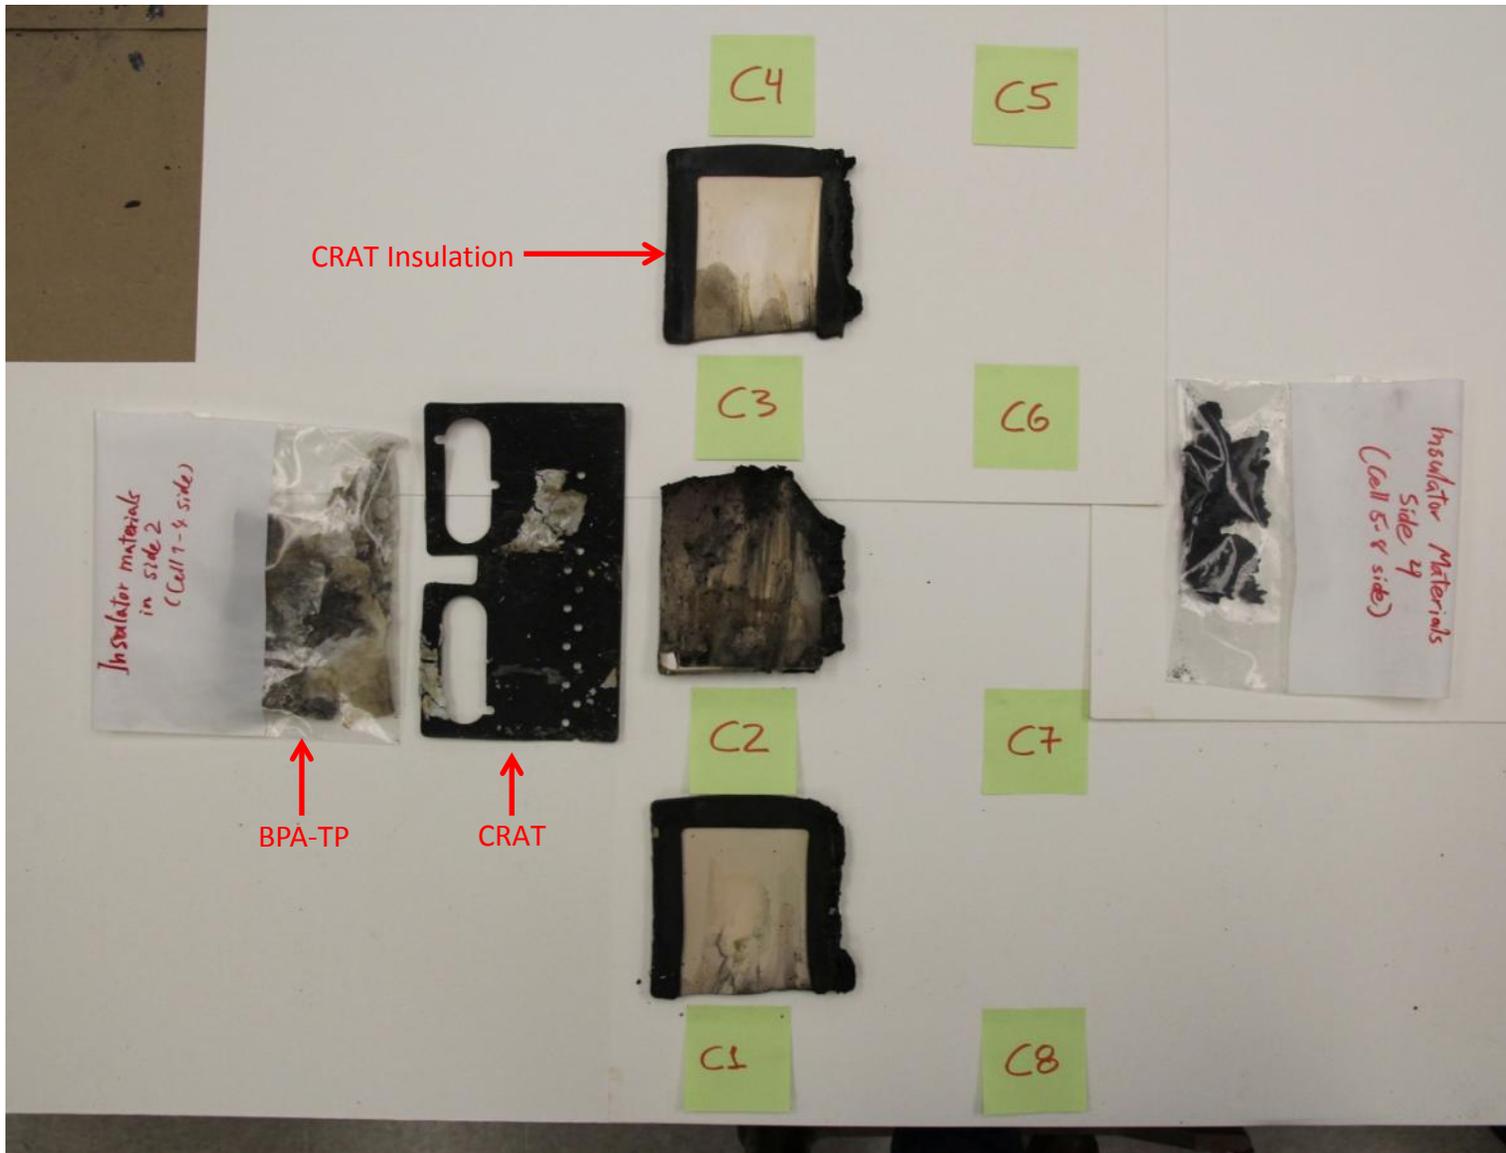
Figure 94. Insulation recovered from the battery box.

Figure 94 shows the condition of the insulation between the cells. The insulation between C1 through C4 was damaged but distinguishable from general debris in the battery box. Figure 95 shows the CRAT insulation between C2 and C3 and between C3 and C4. The insulation for C5 through C8 could not be identified. An example of the remnants of this insulation is shown in Figure 96.

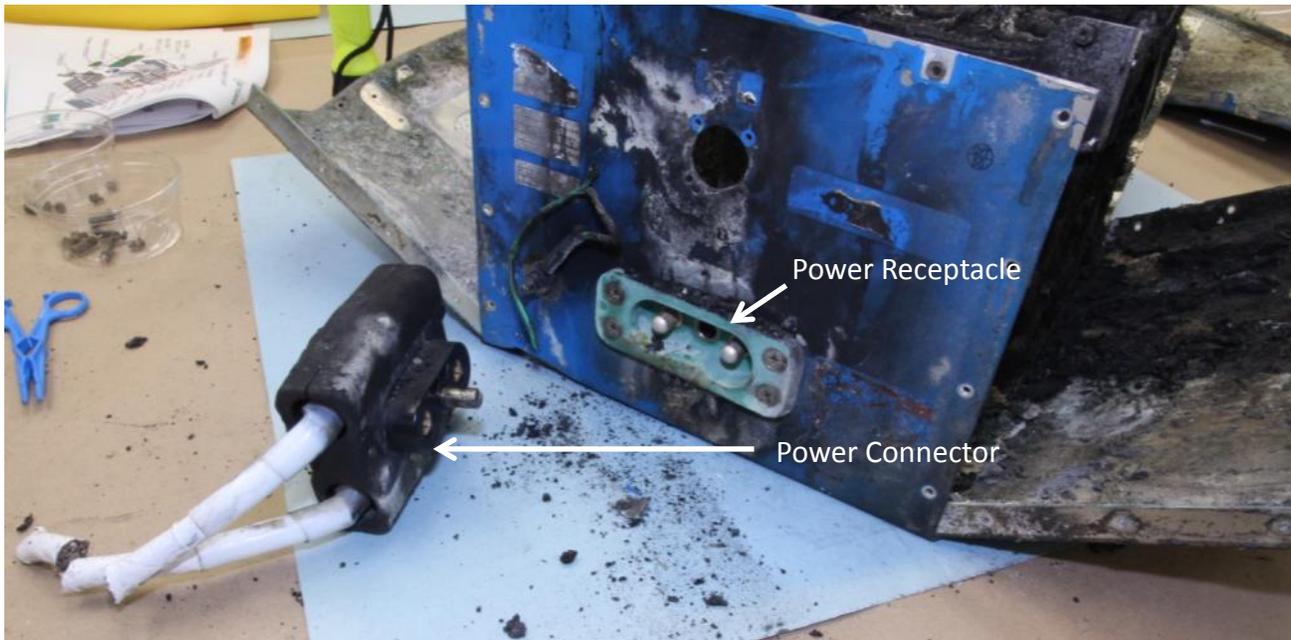
Figure 97. View of the J3 power connector and power receptacle.

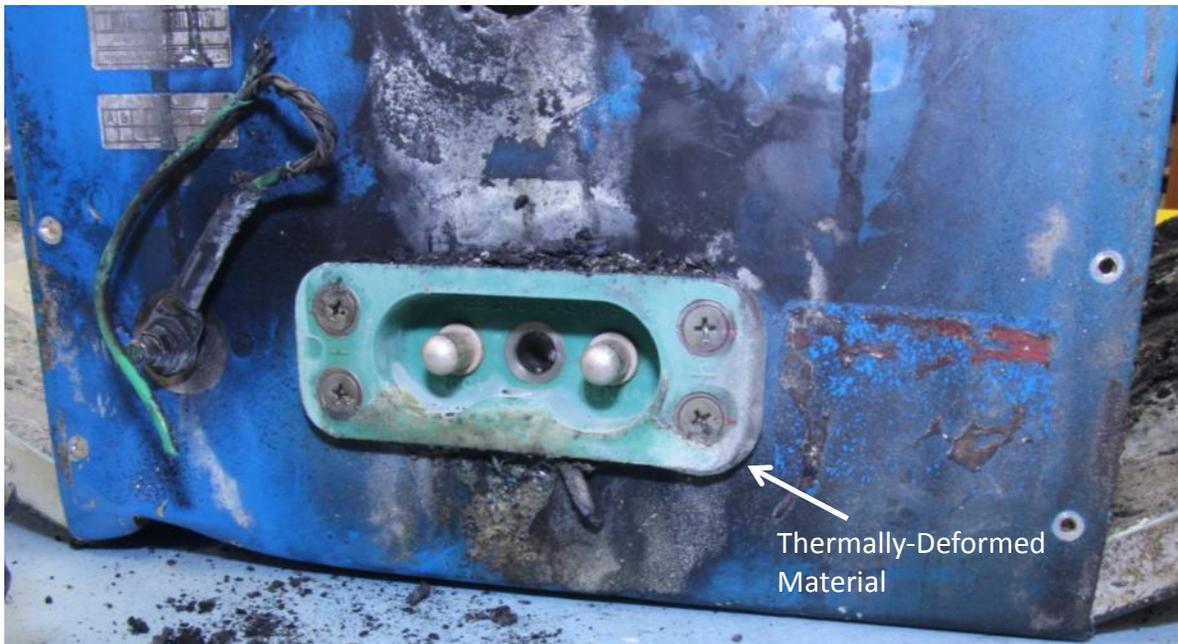
Figure 98. Close-up view of the J3 power receptacle showing thermally-deformed material.

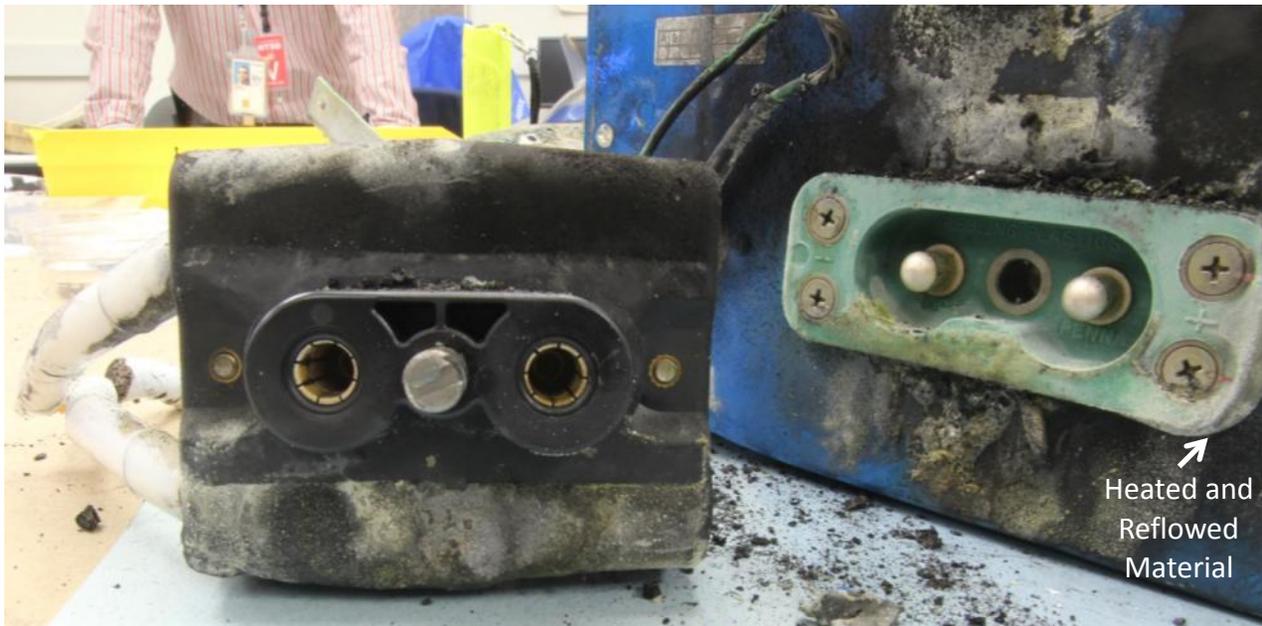
Figure 99. Close-up view of both the J3 power connector and the power receptacle.

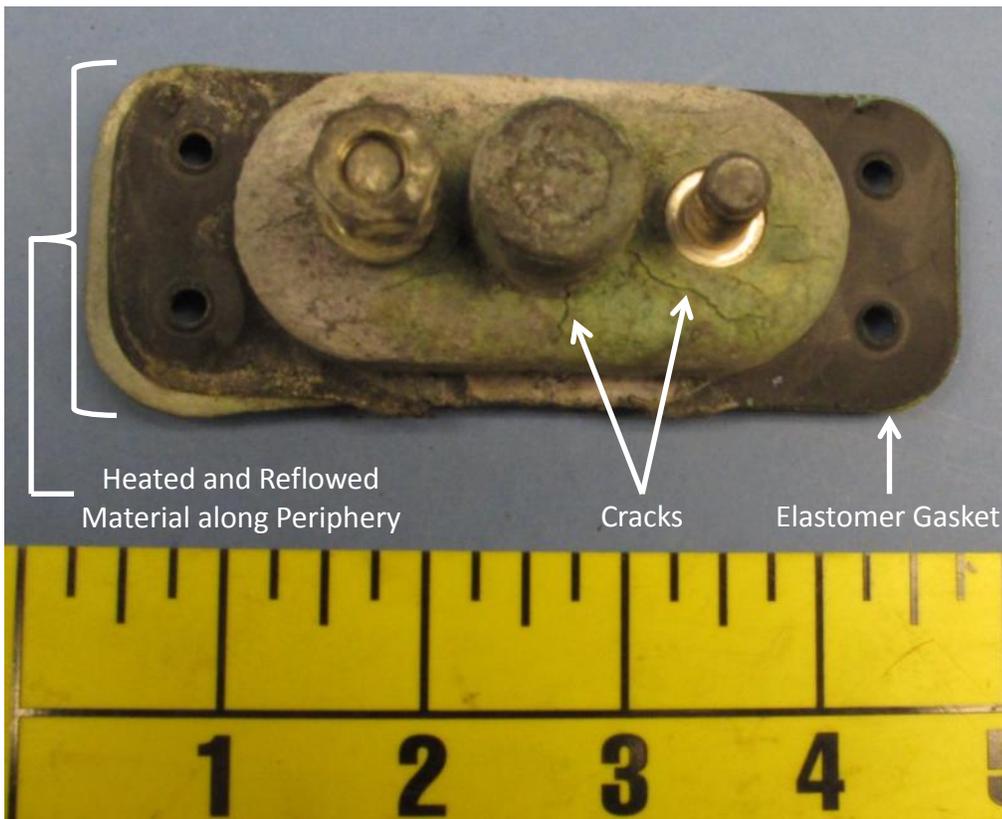
Figure 100. Close-up view of the J3 power receptacle showing heated and reflowed material.

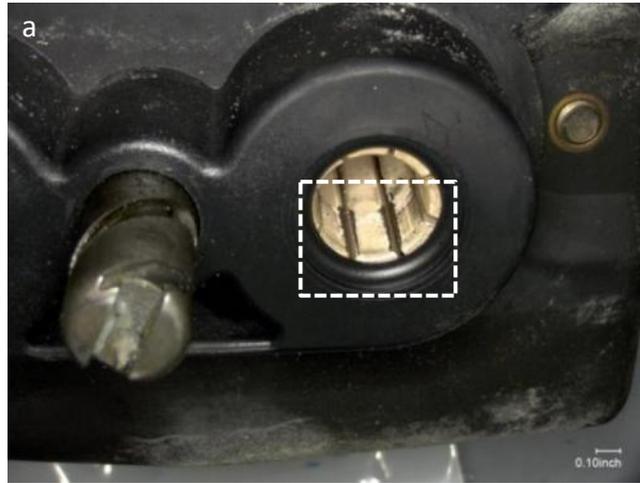
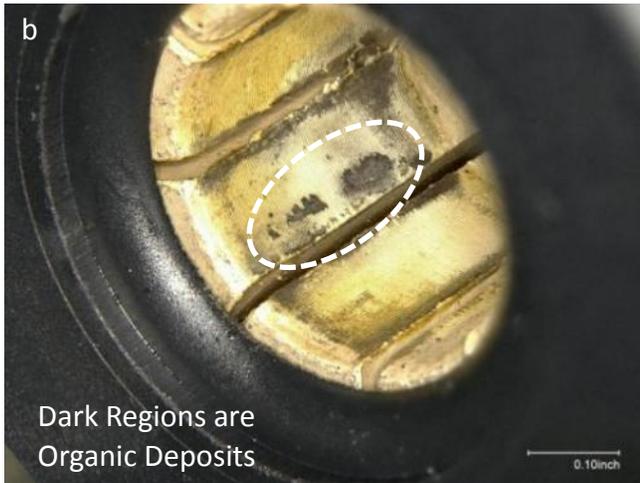
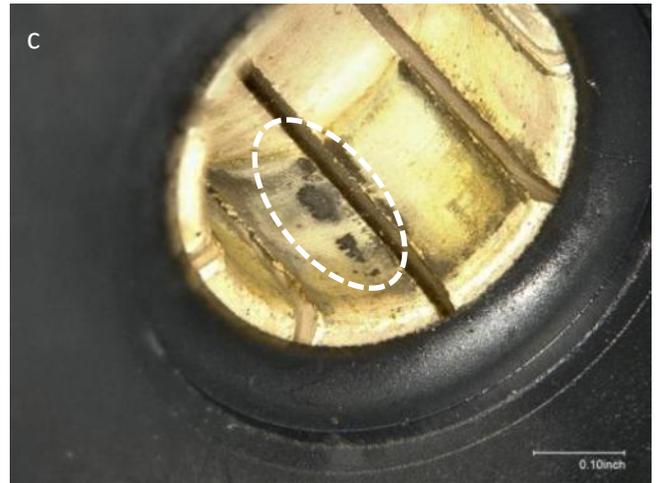
Dark Regions are
Organic Deposits

Figure 101. Close-up views of the J3 power connector showing organic deposits.

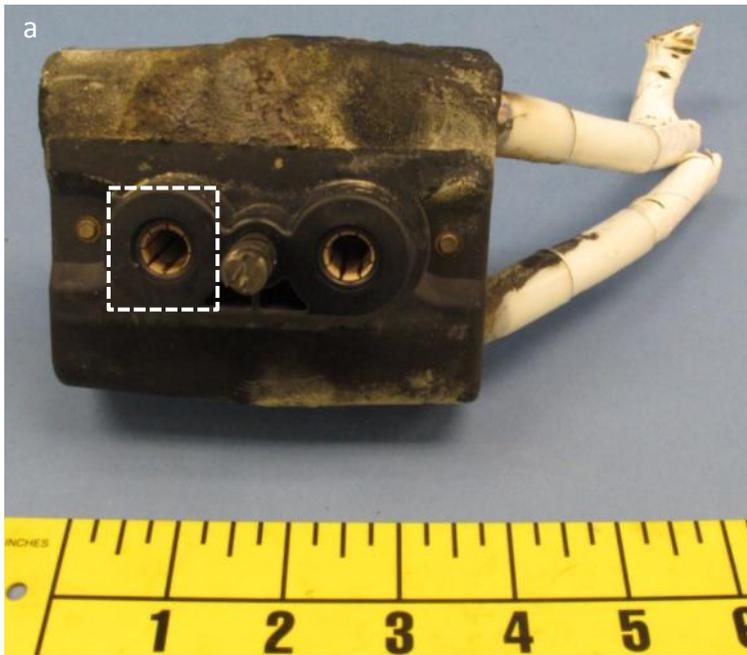
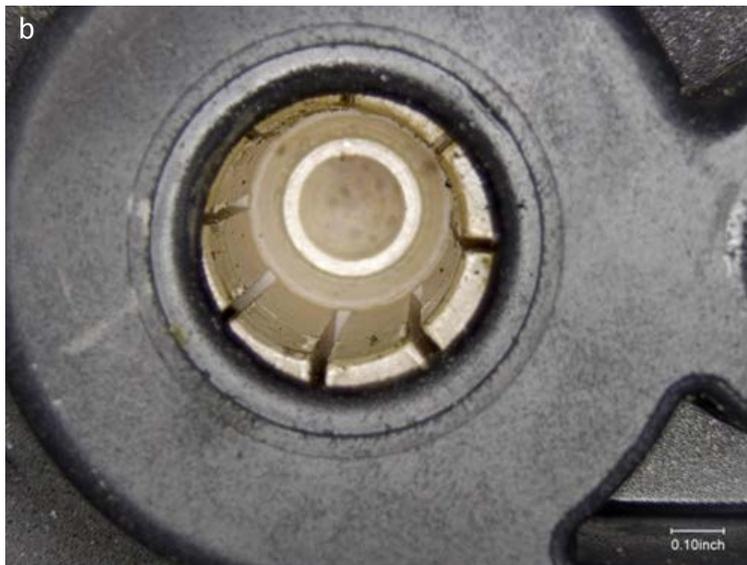
Figure 102. Close-up views of the power connector.

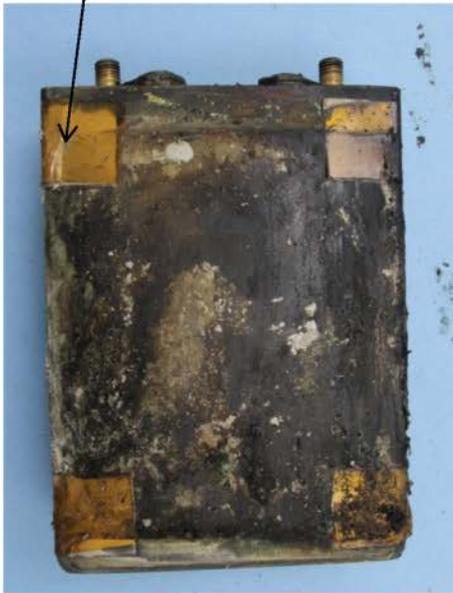
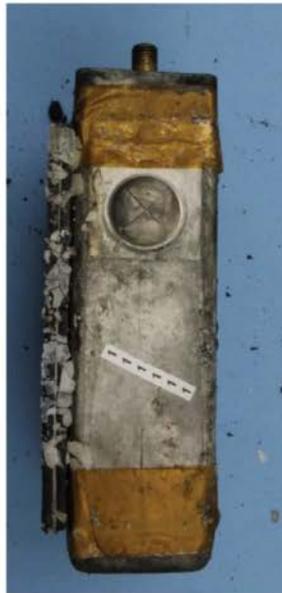
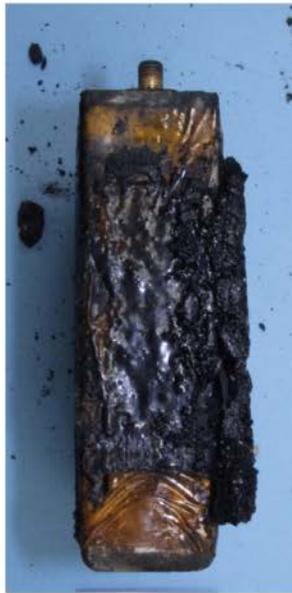
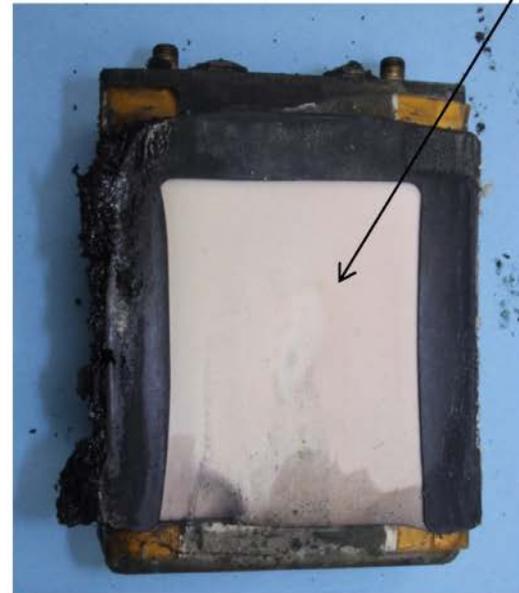
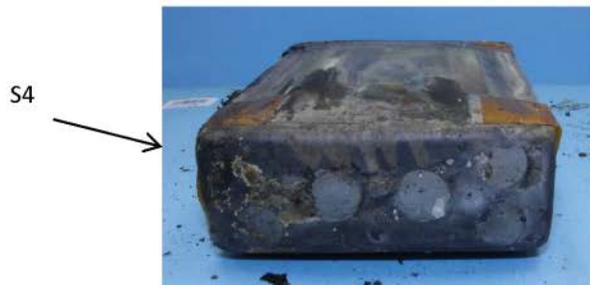
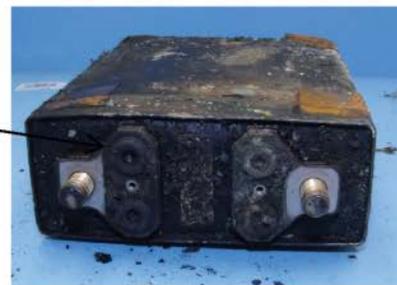
Figure 103. C1 (as removed).

Sulfided
Crystalline
Thermoplastic
Terminal
Insulation

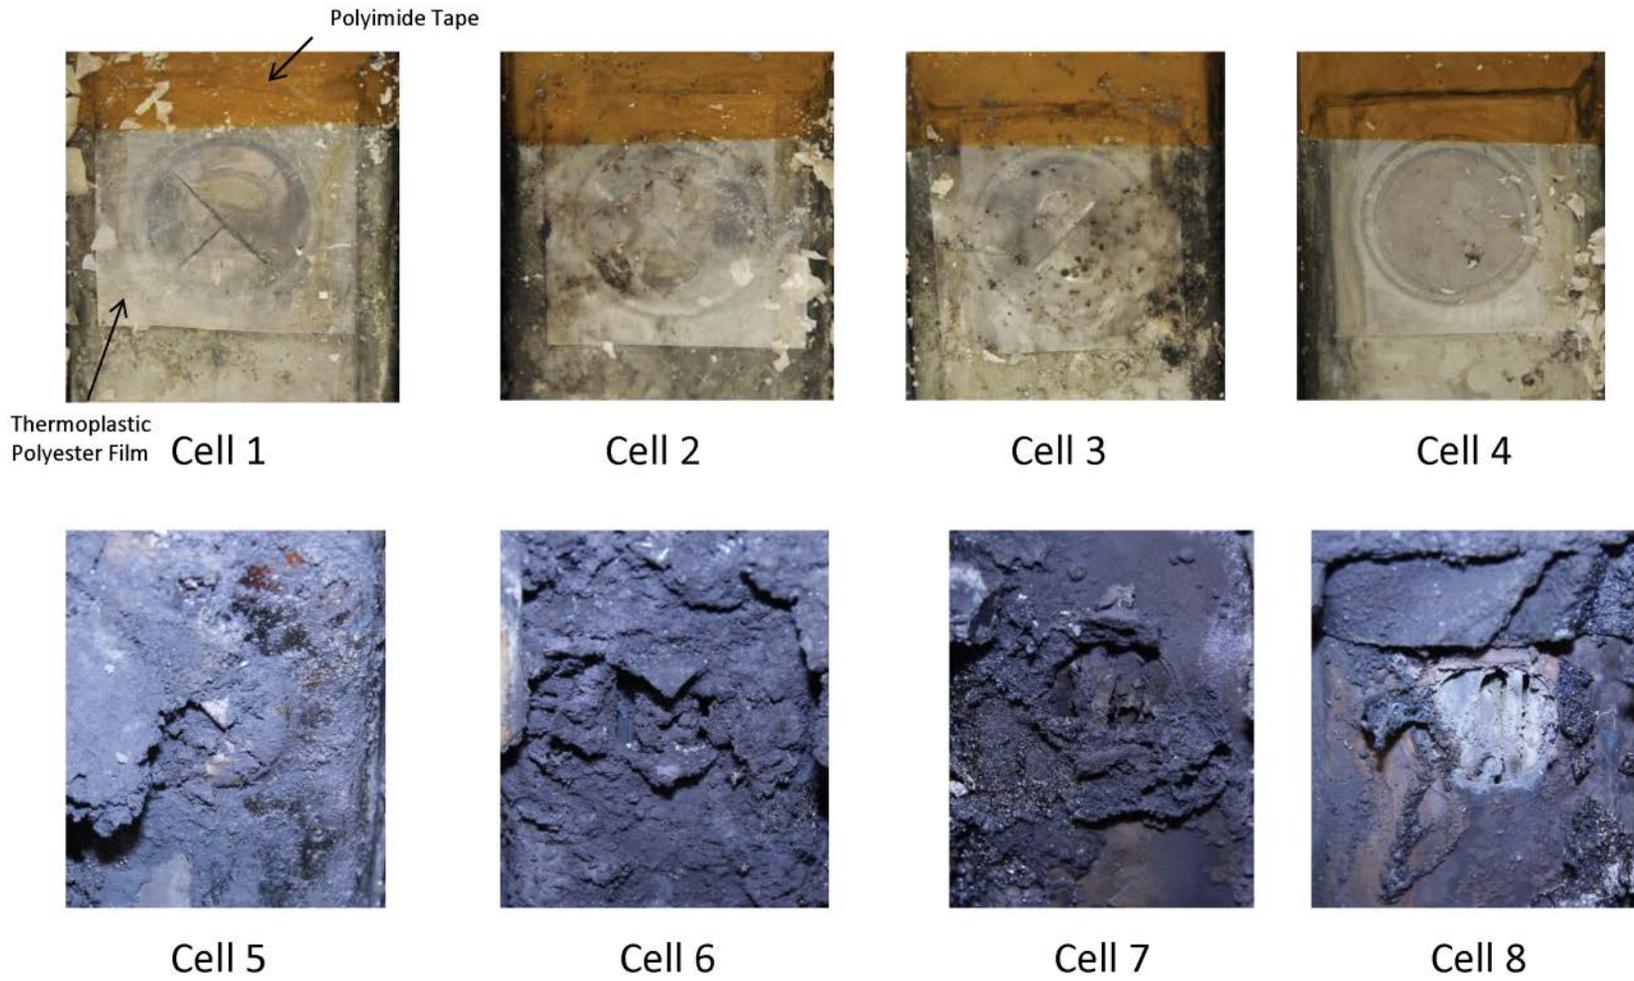
C2 had areas of black staining and charred materials adhering to some surfaces (Figure 106). The thermoplastic polyester film that was covering the vent disc was still intact and secured in place by the polyimide tape. The thermoplastic polyester film was cloudy and exhibited some thermal deformation (Figure 104). The vent disc on this cell had opened. The amber-colored polyimide tape was still intact and firmly adhering to the cell case on all sides except at the upper S3/S4 corner. On S4 of the cell case, the polyimide tape had a wrinkled appearance consistent with thermal distortion and a darker appearance than on S2. The sulfide crystalline thermoplastic stud insulator material on the cell header was intact and did not exhibit signs of thermal degradation. The CRAT insulation material that would have been between C2 and C3 had adhered to S3 of C2. After removal of the insulation, S3 of the case was exposed (Figure 107). S3 of the cell case exhibited staining on its entire surface with a pattern similar to a liquid having flowed down its surface. S4 of the cell had some charred BPA-TP insulation adhering to its surface. The cell's weight after the insulation was removed was 2532.6 grams. The cell's deformation appeared to be slightly convex on S1 and S3 with no appreciable deformation on S2 and S4. The cell header and cell bottom had some convex deformation. There was no evidence of electrical arcing anywhere on the exterior of this cell.

C3 had areas of black staining and charred materials adhering to some surfaces (Figure 108). The thermoplastic polyester film that was covering the vent disc was still intact and secured in place by the polyimide tape. The thermoplastic polyester film was cloudy and exhibited some thermal deformation (Figure 104). The vent disc on this cell had opened. The amber-colored polyimide tape was still intact and firmly adhering to the cell case on all sides. On S4 of the cell case, the polyimide tape had a wrinkled appearance consistent with thermal distortion and a darker appearance than on S2. The sulfide crystalline thermoplastic stud insulator material on the cell header was intact and did not exhibit signs of thermal degradation. The CRAT insulation material that would have been between C3 and C4 adhered to the S3 side of C3. After removal of the insulation, the S3 side of the case was exposed (Figure 109). S3 of the cell case exhibited some dark

C4 had areas of black staining and charred materials adhering to some surfaces (Figure 110). The thermoplastic polyester film that was covering the vent disc was still intact and secured in place by the polyimide tape. The thermoplastic polyester film was cloudy but did not exhibit signs of decomposition or thermal deformation (Figure 104). The vent disc on this cell had not opened. The amber-colored polyimide tape was still intact and firmly adhered to the cell case on all sides. On S4 of the cell case, the polyimide tape, on the bottom portion, had a wrinkled area in its center consistent with thermal distortion. Additionally, portions of charred BPA-TP insulation had adhered to the polyimide tape on the top of S4 of C4. The sulfide crystalline thermoplastic stud insulator material on the cell header was intact and did not exhibit signs of thermal degradation. Part of the BPA-TP insulation that would have been between S3 of the cell and the battery box case was charred and adhered to the S3 side of the cell case, primarily along the edge closer to the cell's S4 side. S4 of the cell had some charred BPA-TP insulation adhering to its surface. The cell's weight after removing the debris stuck to it was 2645.5 grams. The cell's deformation appeared to be slightly convex on S1 and S3 with no appreciable deformation on S2 and S4 or the header and bottom. The deformation to this cell was less than that of C1 through C3. There was no evidence of electrical arcing anywhere on the exterior of this cell.

C5 had staining and charred materials adhering to its surfaces (Figure 111). The thermoplastic polyester film that was covering the vent disc was consumed (Figure 104). The vent disc on this cell had opened. The amber-colored polyimide tape was still present only on S2 where it exhibited thermal damage. On S4 of the cell case, the polyimide tape was indistinguishable from the rest of the charred materials adhering to the case. Part of the BPA-TP insulation that would have been between S3 of the cell and the battery box case was charred and adhered to S3 of the cell case. Additionally, on S3 of the cell case, there was an area of clean cell case material with no evidence of staining or residue. S4 of the cell case was completely covered in charred material. The sulfide crystalline thermoplastic stud insulator material on the cell header was charred. The cell's weight after removing some of the more loosely adhering debris that was stuck to it was 2217.9 grams. The cell's deformation appeared to be convex on S1 with a concave to flat area approximately mid-height along this side. On S3, it exhibited a convex appearance. S2 and S4, as well as the bottom and cell header, exhibited a convex appearance (Figure 112). On the exterior of this cell facing S3, there was evidence of electrical arcing between the cell case and battery box case.

C6 appeared to have charred materials adhering to all of its surfaces (Figure 113). The thermoplastic polyester film that was covering the vent disc was consumed (Figure 104). The vent disc on this cell had opened and all four of its quadrants were

C7 appeared to have charred materials adhering to all of its surfaces (Figure 115). The thermoplastic polyester film that was covering the vent disc was consumed (Figure 104). The vent disc on this cell had opened, spreading out into four quadrants. The amber-colored polyimide tape was still present only on S2 where it exhibited a blackened and wrinkled appearance consistent with thermal damage. On S4 of the cell case, the polyimide tape was indistinguishable from the rest of the charred materials adhering to the case. The sulfide crystalline thermoplastic stud insulator material on the cell header was charred. Parts of the CRAT insulation that would have been between this cell and C6 and C8 were charred and adhered to the cell case. The cell's bottom also had charred material adhering to its surface. The cell's weight after removing some of the more loosely adhering debris that was stuck to it was 2124.0 grams. The cell's deformation appeared to be concave on S1 and convex on S3 (Figure 116). S2 and S4, as well as the bottom and cell header, exhibited a convex appearance. The exterior of this cell did not exhibit any evidence of electrical arcing.

C8 appeared to have charred materials adhering to all of its surfaces (Figure 117). The thermoplastic polyester film that was covering the vent disc was consumed and indistinguishable (Figure 104). The vent disc on this cell had opened and all four of its quadrants were spread out. The amber-colored polyimide tape was still present on S2, where it exhibited a blackened and wrinkled appearance consistent with thermal damage. On S4 of the cell case, the polyimide tape was more thermally damaged than on S2. The sulfide crystalline thermoplastic stud insulator material on the cell header was charred. Parts of the CRAT insulation that would have been between this cell and C7 were charred and adhering to the cell case. The cell's weight after removing some of the more loosely adhering debris that was stuck to it was 2156.1 grams. The cell's deformation appeared to be convex on S1 and convex on S3. S2 and S4, as well as the bottom and cell header, exhibited a convex appearance. The exterior of this cell did not exhibit any evidence of electrical arcing.

Figure 104. Close-up views of the vent disc for C1 through C8.

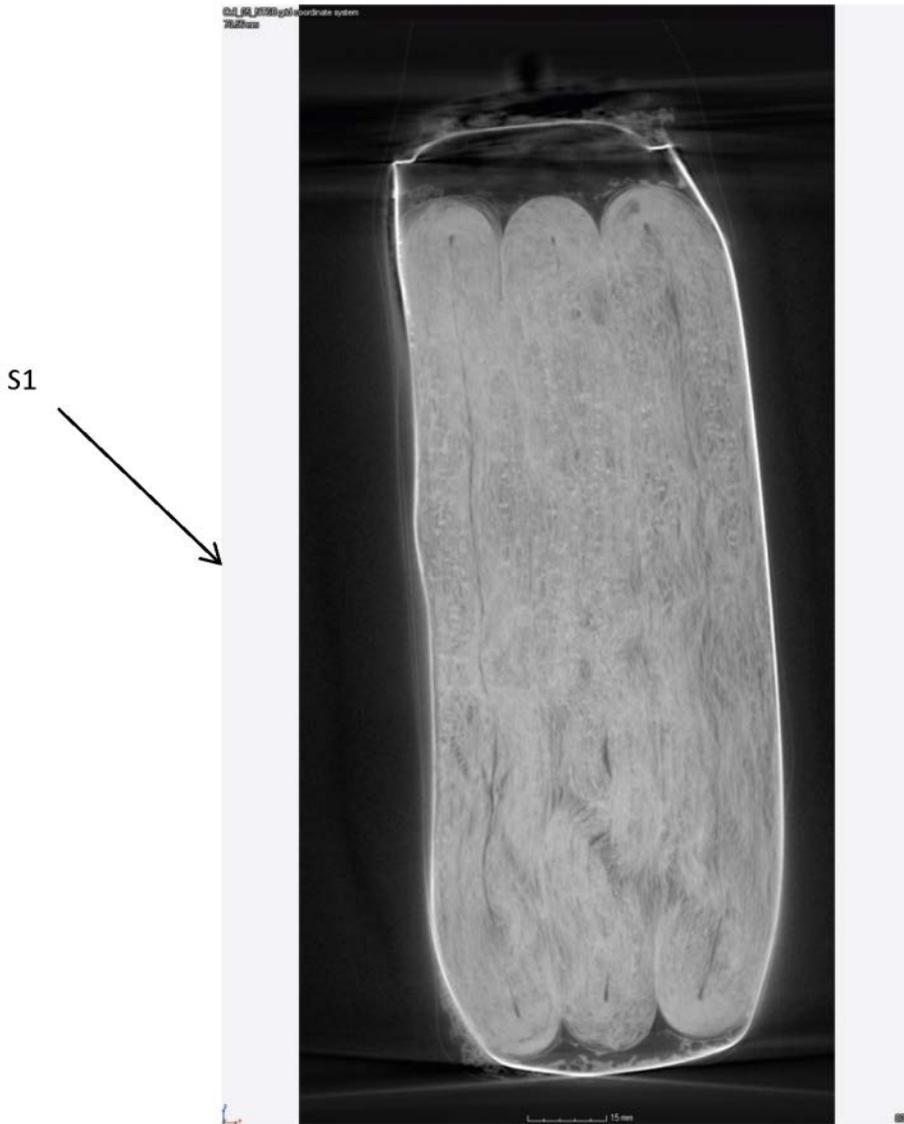
Figure 112. C5 CT scan image. The exemplar CT scan was taken on a plane about midway between the terminals.

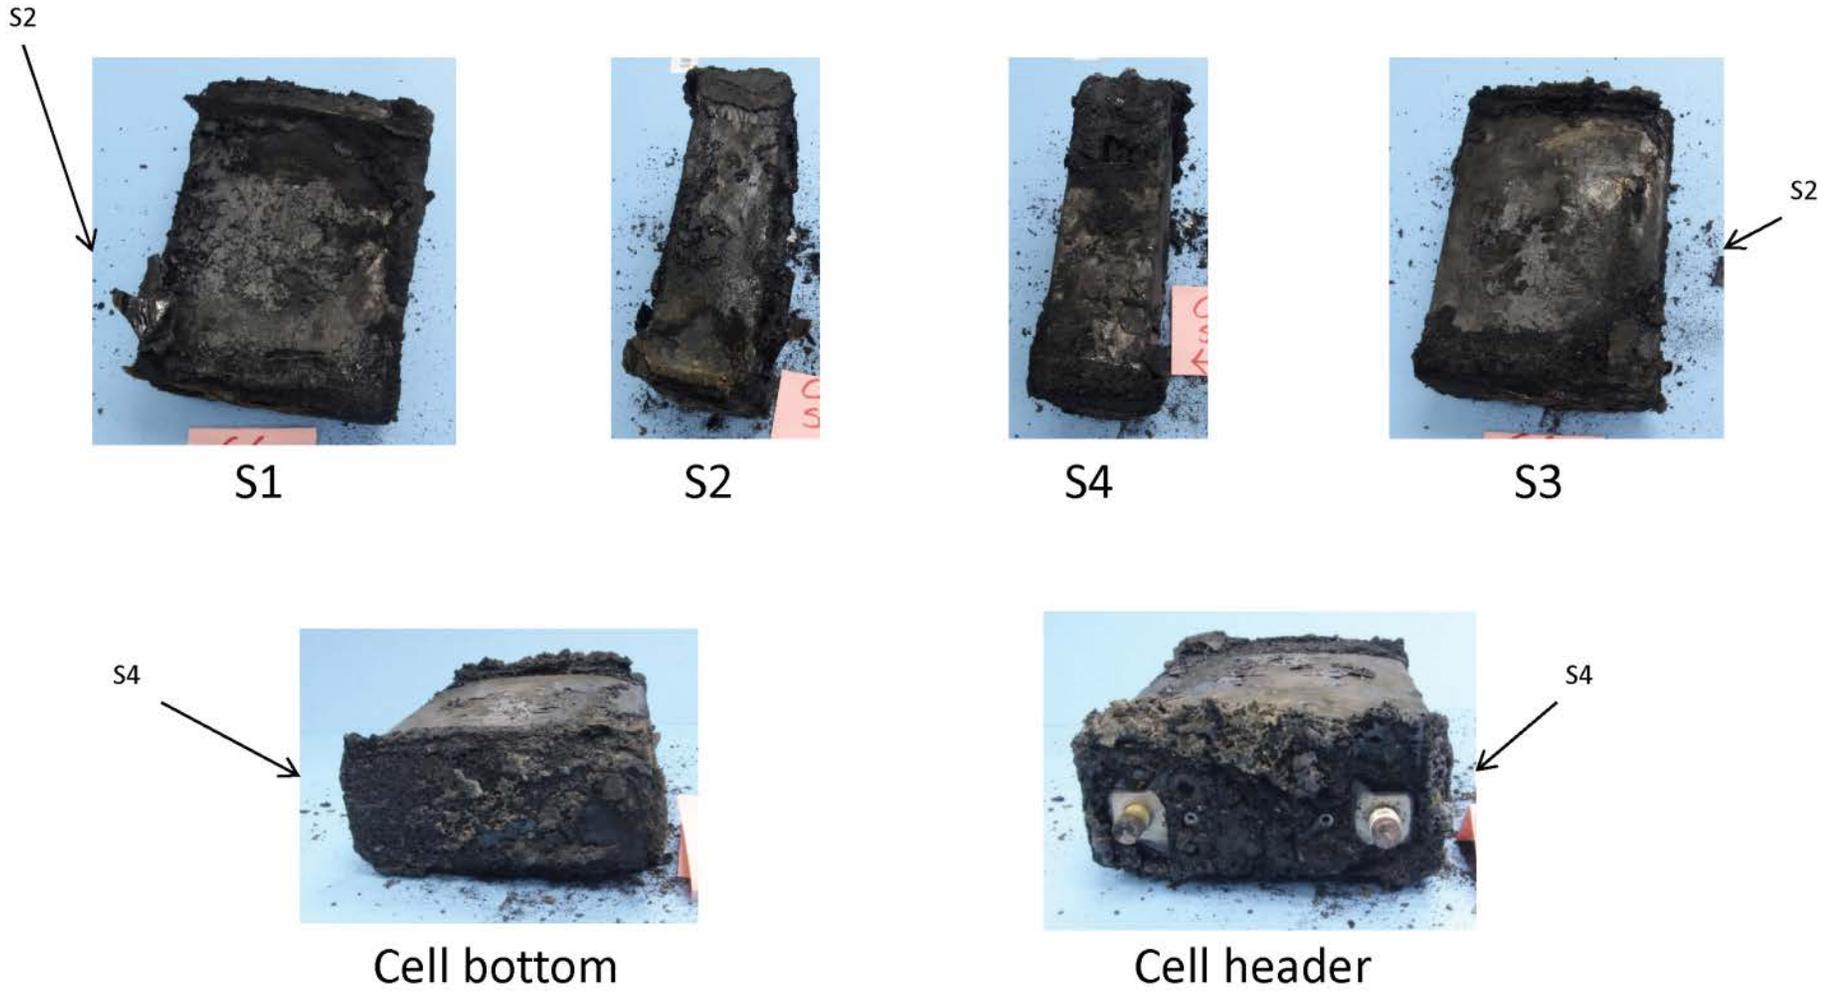
Figure 113. C6 (as removed).

spread out.¹⁰ The amber-colored polyimide tape was still present only on S2, where it exhibited a blackened and wrinkled appearance consistent with thermal damage. On S4 of the cell case, the polyimide tape was indistinguishable from the rest of the charred materials adhering to the case. The sulfide crystalline thermoplastic stud insulator material on the cell header was charred. Parts of the CRAT insulation that would have been between this cell and C5 and C7 were charred and adhered to the cell case. The cell's bottom also had charred material adhering to its surface. The cell's weight after removing some of the more loosely adhering debris that was stuck to it was 2160.7 grams. The cell's deformation appeared to be concave on S1 and slightly convex with a flat area in the middle on S3 (Figure 114). S2 and S4, as well as the bottom and cell header, exhibited a convex appearance. The exterior of this cell did not exhibit any evidence of electrical arcing.

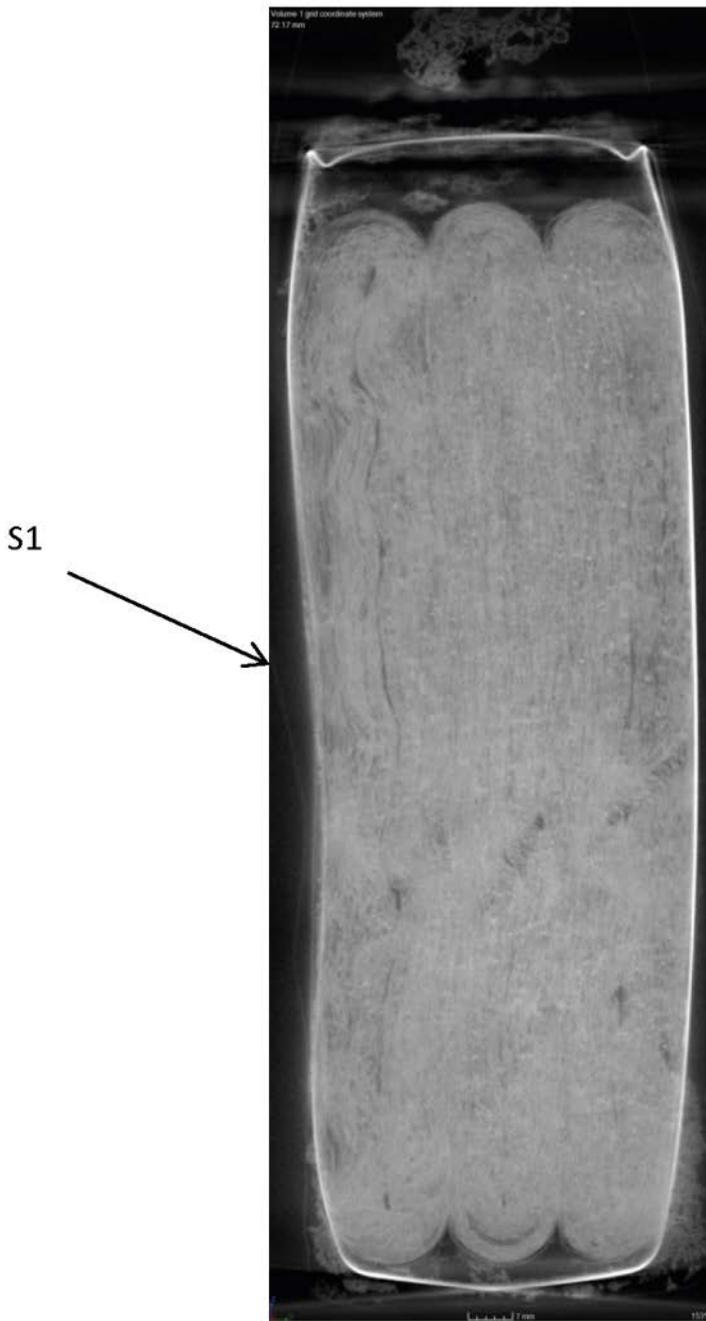
Figure 114. C6 CT scan image. The exemplar CT scan was taken on a plane about midway between the terminals.

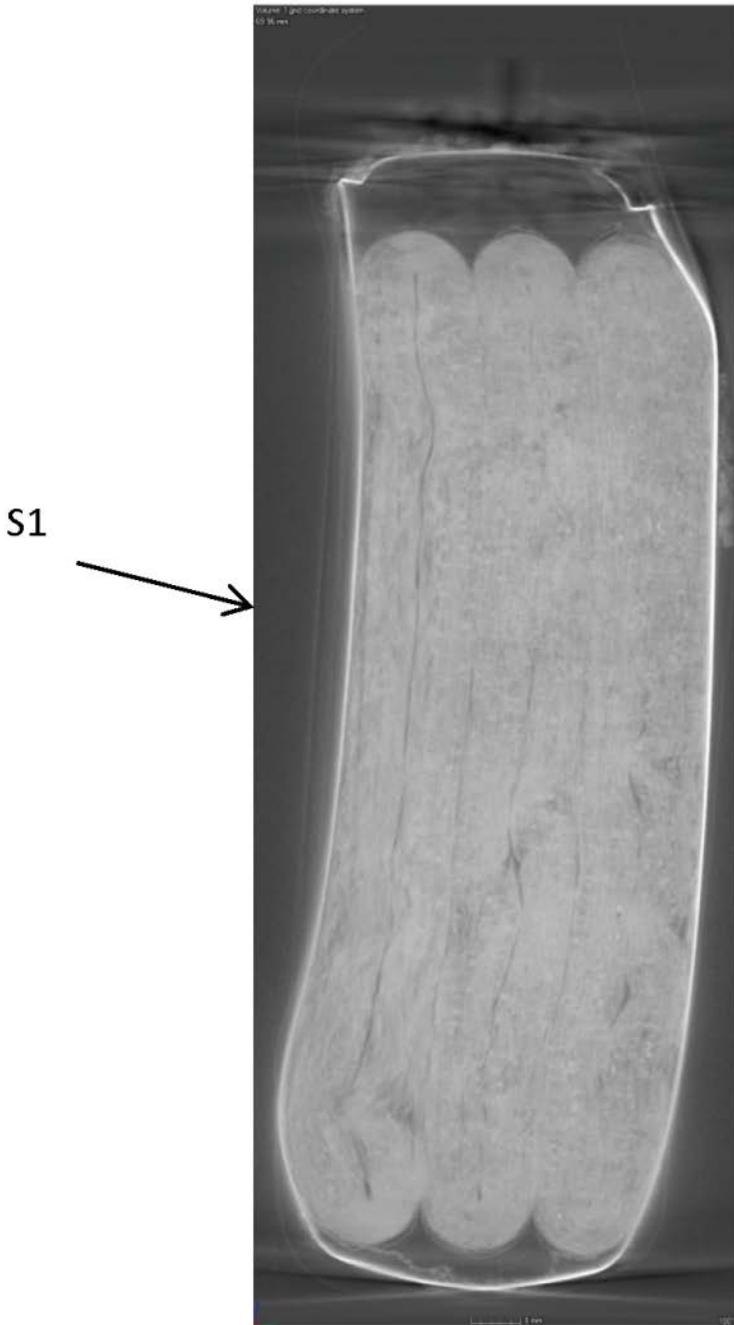
Figure 116. C7 CT scan image. The exemplar CT scan was taken on a plane about midway between the terminals.
