NATIONAL TRANSPORTATION SAFETY BOARD

MATERIALS LABORATORY FACTUAL REPORT

Report No. 13-013

Place : Boston, Massachusetts
Date : January 7, 2013
Vehicle : Boeing 787, Registration JA829J
NTSB No. : DCA13IA037
Investigator-in-Charge : David Helson

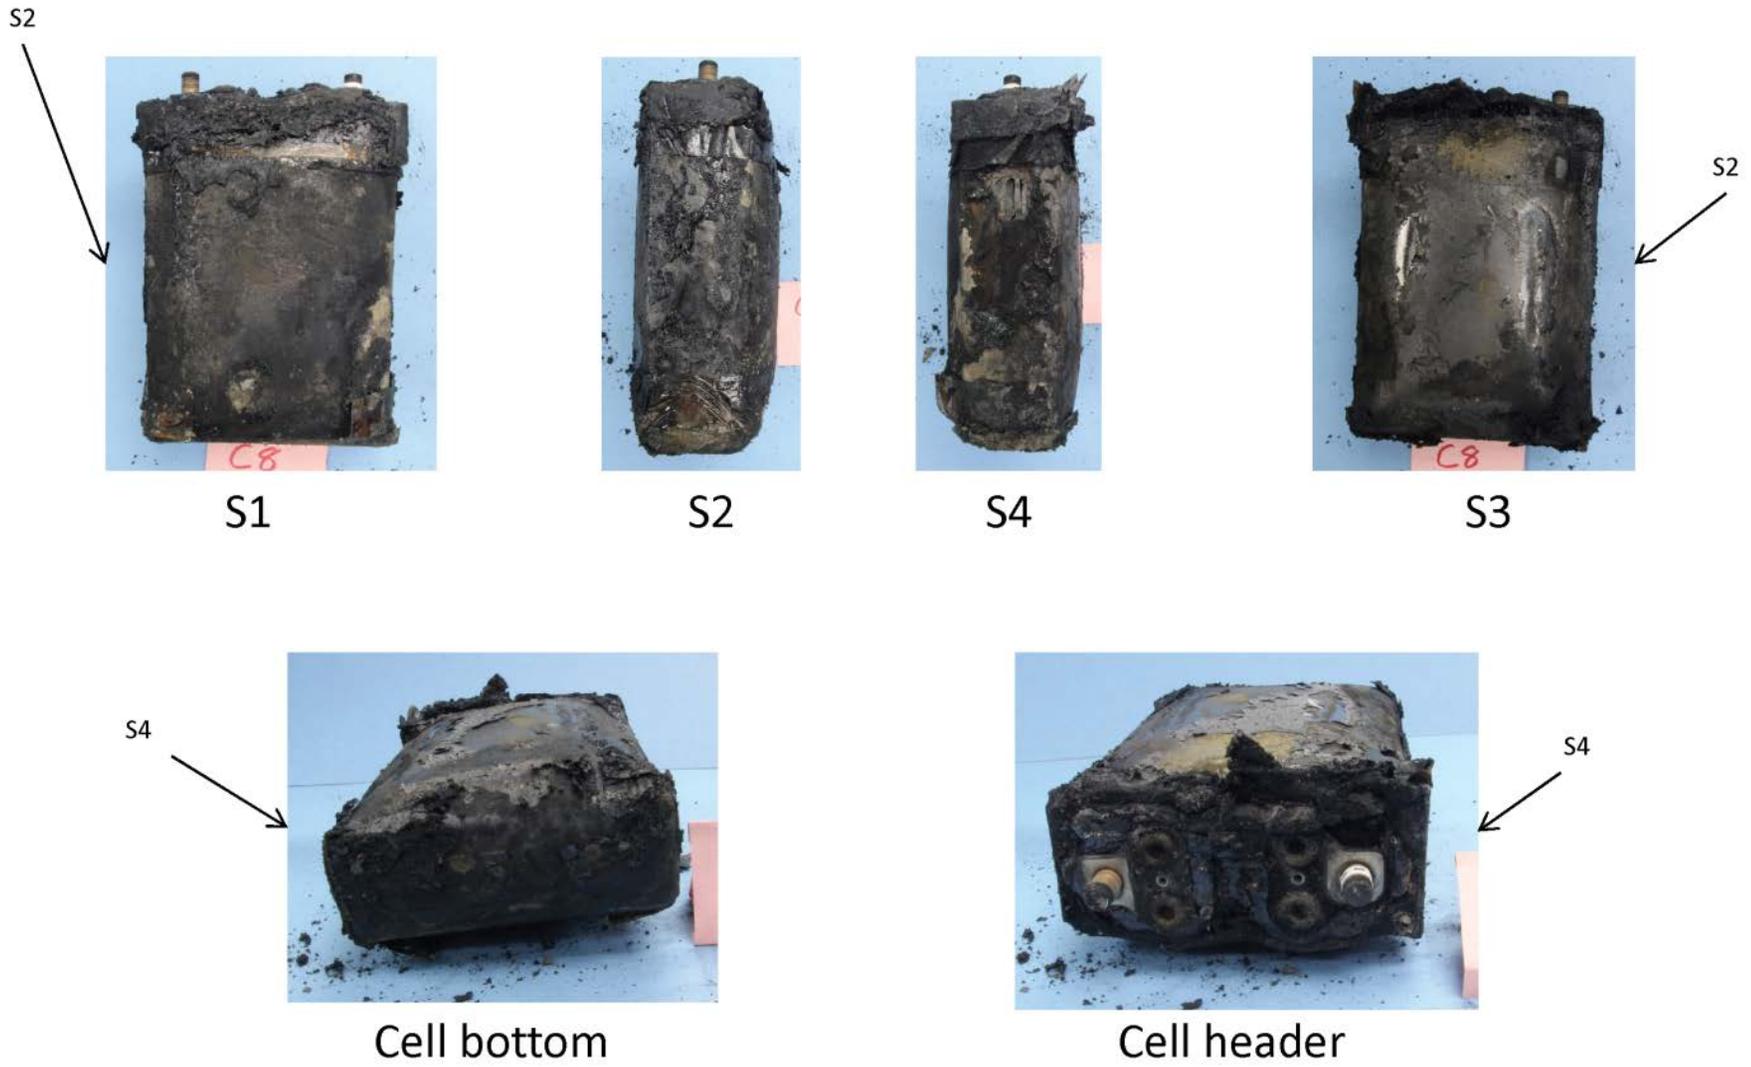
Figure 117. C8 (as removed).

C8 appeared to have charred materials adhering to all of its surfaces (Figure 117). The thermoplastic polyester film that was covering the vent disc was consumed and indistinguishable (Figure 104). The vent disc on this cell had opened and all four of its quadrants were spread out. The amber-colored polyimide tape was still present on S2, where it exhibited a blackened and wrinkled appearance consistent with thermal damage. On S4 of the cell case, the polyimide tape was more thermally damaged than on S2. The sulfide crystalline thermoplastic stud insulator material on the cell header was charred. Parts of the CRAT insulation that would have been between this cell and C7 were charred and adhering to the cell case. The cell's weight after removing some of the more loosely adhering debris that was stuck to it was 2156.1 grams. The cell's deformation appeared to be convex on S1 and convex on S3. S2 and S4, as well as the bottom and cell header, exhibited a convex appearance. The exterior of this cell did not exhibit any evidence of electrical arcing.
