SERVICE BULLETIN

No. 250A

Piper Aircraft Corporation

Subject: Installation of Right Fuel Tank Quantity Gauge Placard

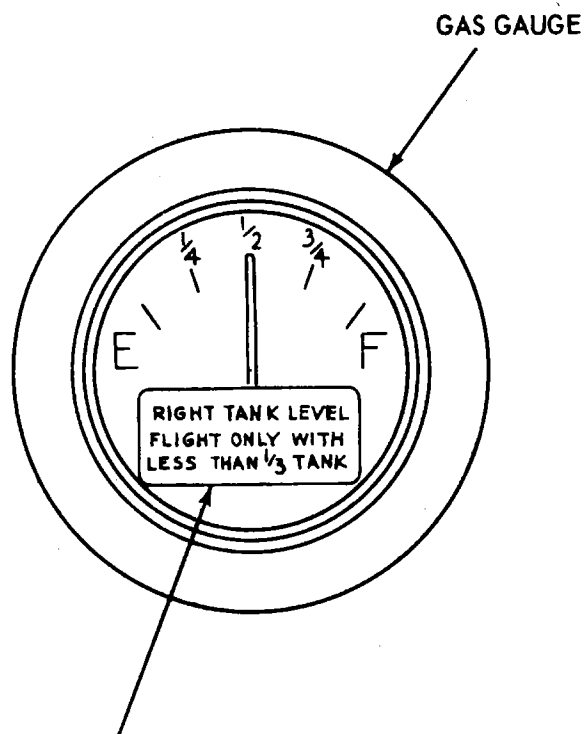
PLACARD ATTACHMENT

Purpose: To provide a revised right fuel tank quantity gauge placard for the above referenced aircraft (see sketch on reverse side of this bulletin for a pictorial description).

Instructions: Please refer to sketch on reverse side of this bulletin for placard application information.

1. REMOVE EXISTING PLACARD.
2. APPLY NEW PLACARD P N 15306-00 AS ILLUSTRATED.
